LEGACY FUND RESTORATION EVALUATION REPORT

Technical Panel Findings and Recommendations—2022

REPORT TO THE MINNESOTA LEGISLATURE

Date of Report: August 2023

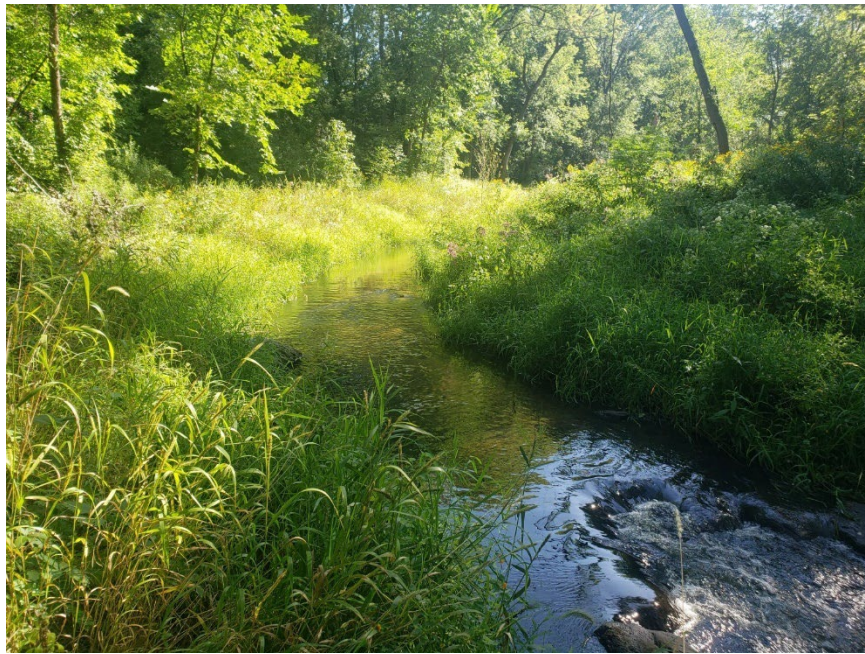
Photo 83. Looking upstream along Sand Creek. Tree thinning allows more sunlight to the riparian understory promoting herbaceous vegetation, which provides long-term bank stabilization. (Photo taken by Mark Prankus, Cardno now Stantec, on 9/1/22).

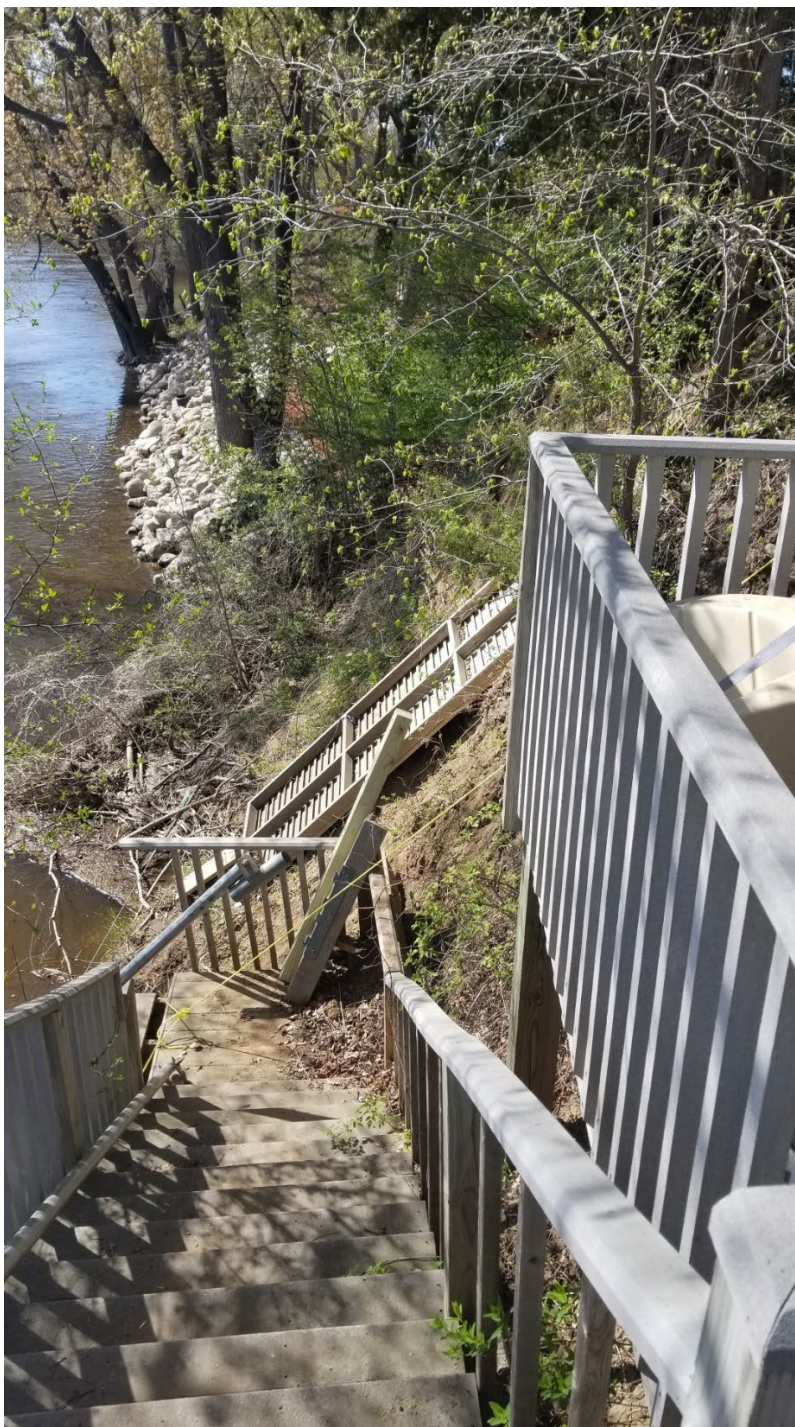
Photo 85. Prior to construction example of how steep the eroding banks were. (Photo provided by Anoka County Conservation District 5/7/2019).

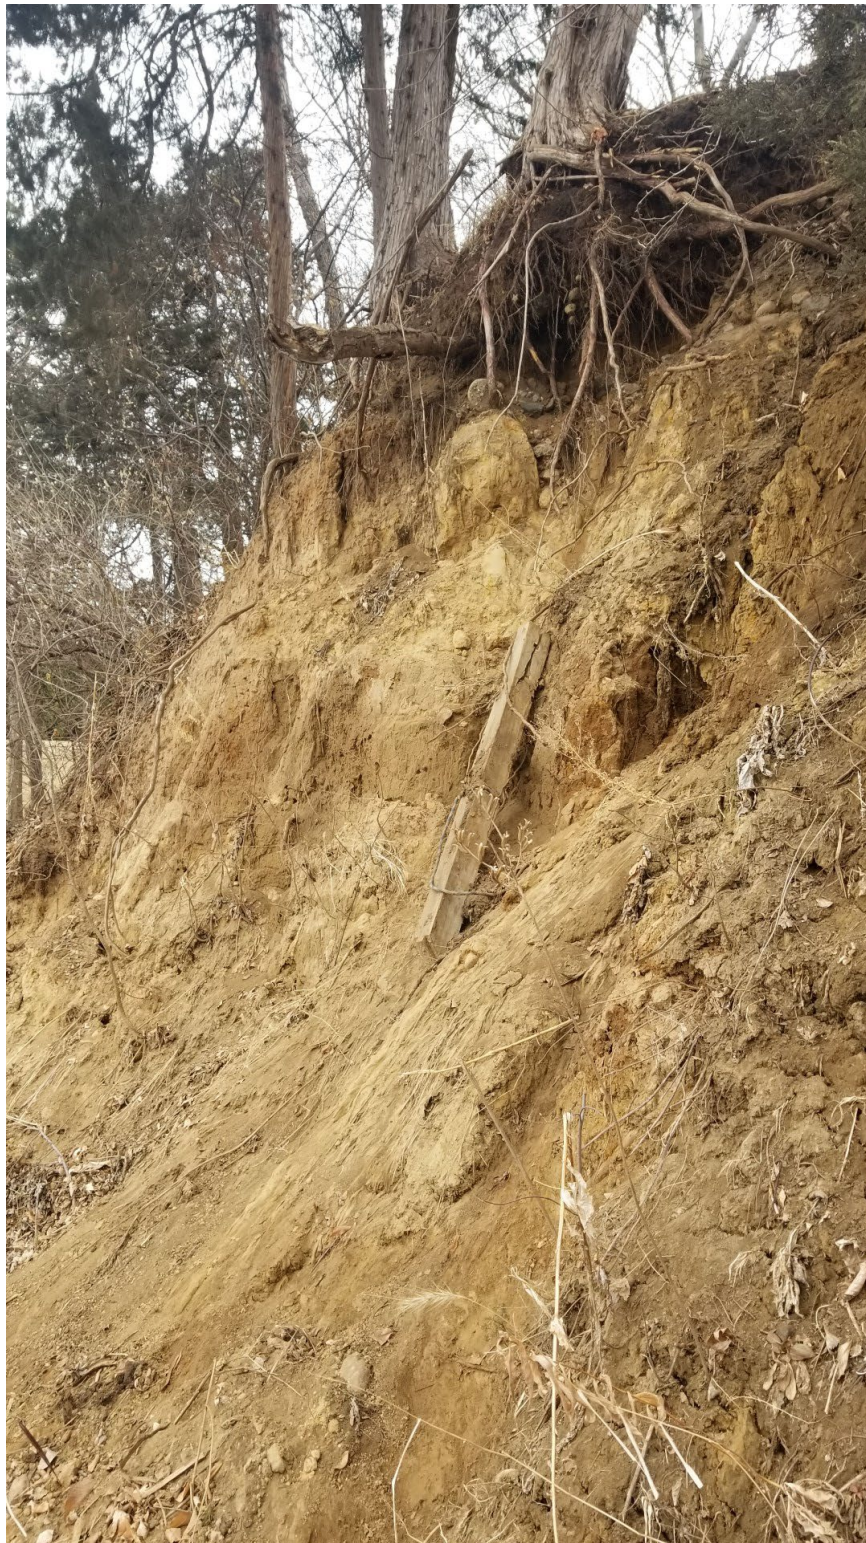
Photo 86. Example of bank eroding before construction. (Photo provided by Anoka County Conservation District, 3/18/2020).

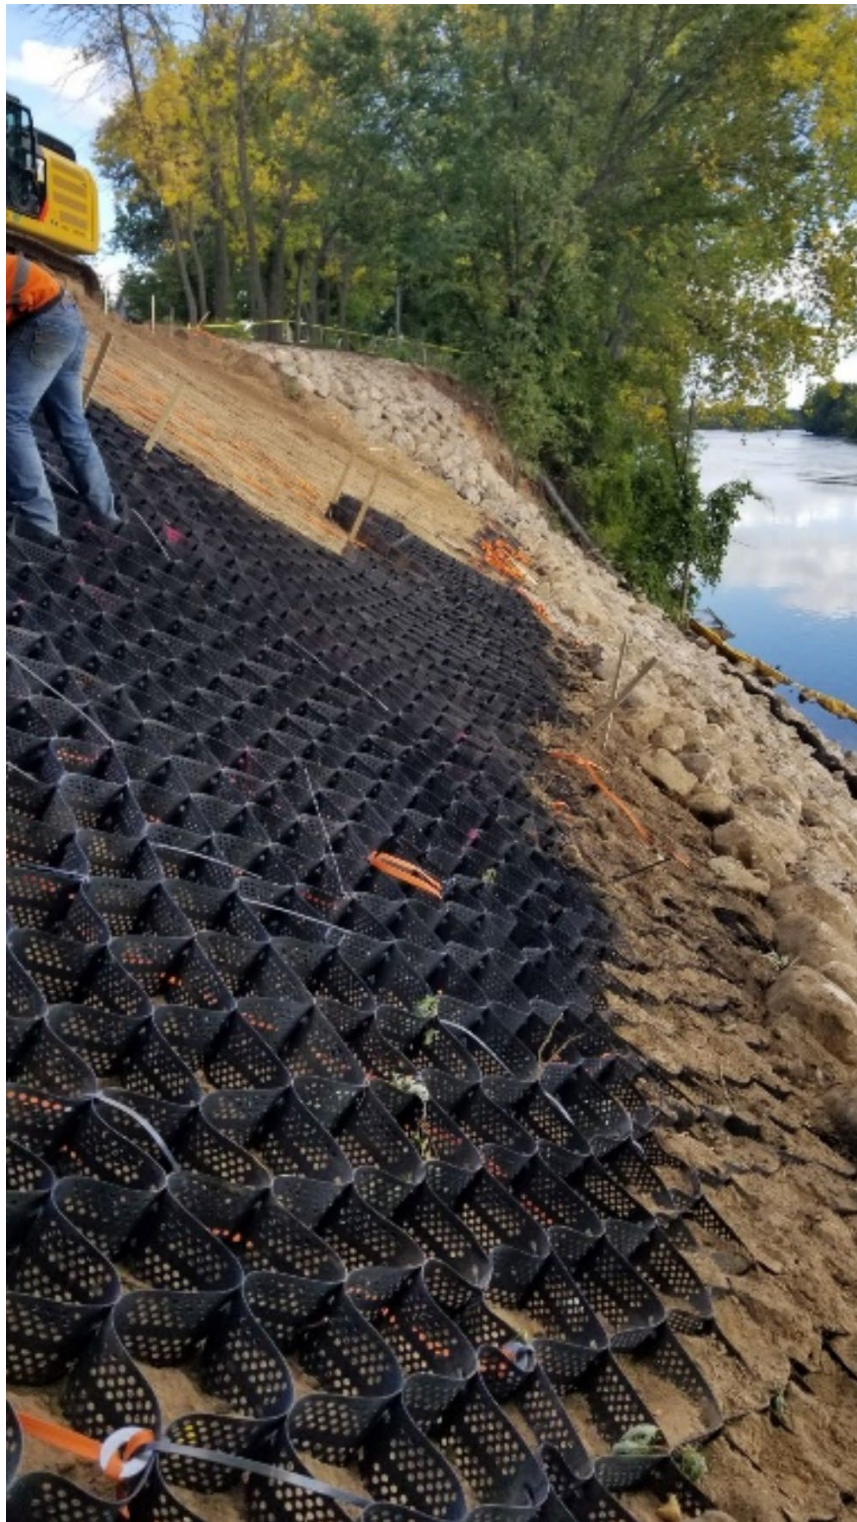
Photo 87. Example of the reinforced soil slope with in-situ soil bioengineering treatment during construction (Photo provided by Anoka County Conservation District, 9/16/2020).

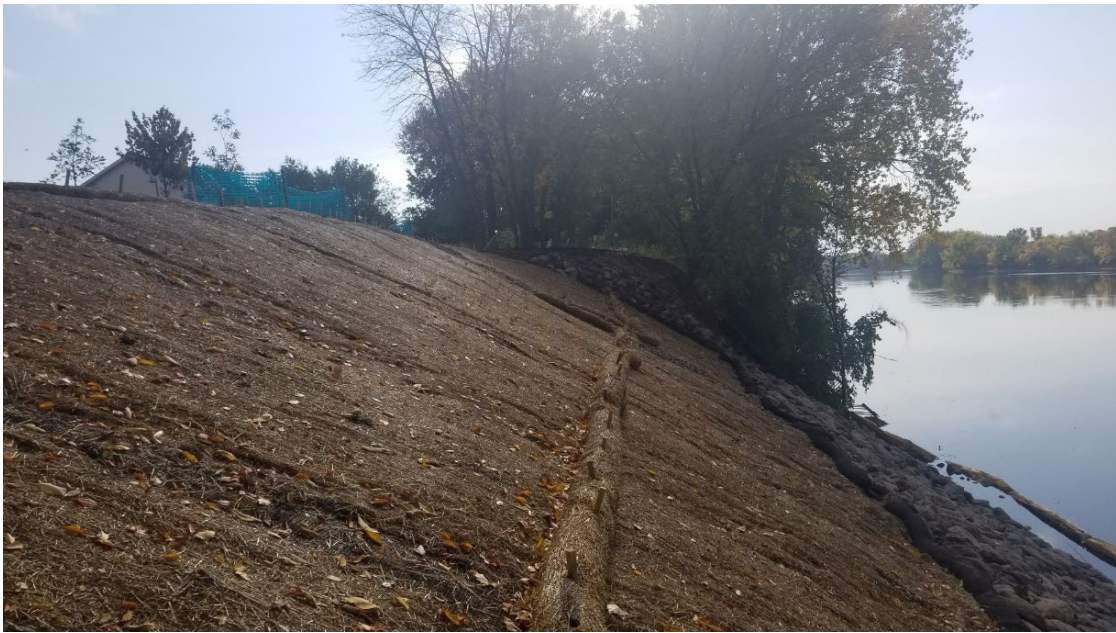
Yes. The engineered components of the project are functioning properly. There was little evidence of stone being scoured away. The reinforced soil slope with aggregate backfill was stable. The reinforced soil slope with in-situ soils and topsoil backfill did show some signs of being unstable, but that was primarily due to the steep slope and lack of established vegetation. Long-term goal achievement may be difficult, if establishment and maintenance activities are not completed as the engineering components to the slope start to degrade through natural processes.

Photo 88. Site post-construction after stabilization measures have been implemented. (Photo Anoka County Conservation District, 9/24/2020).

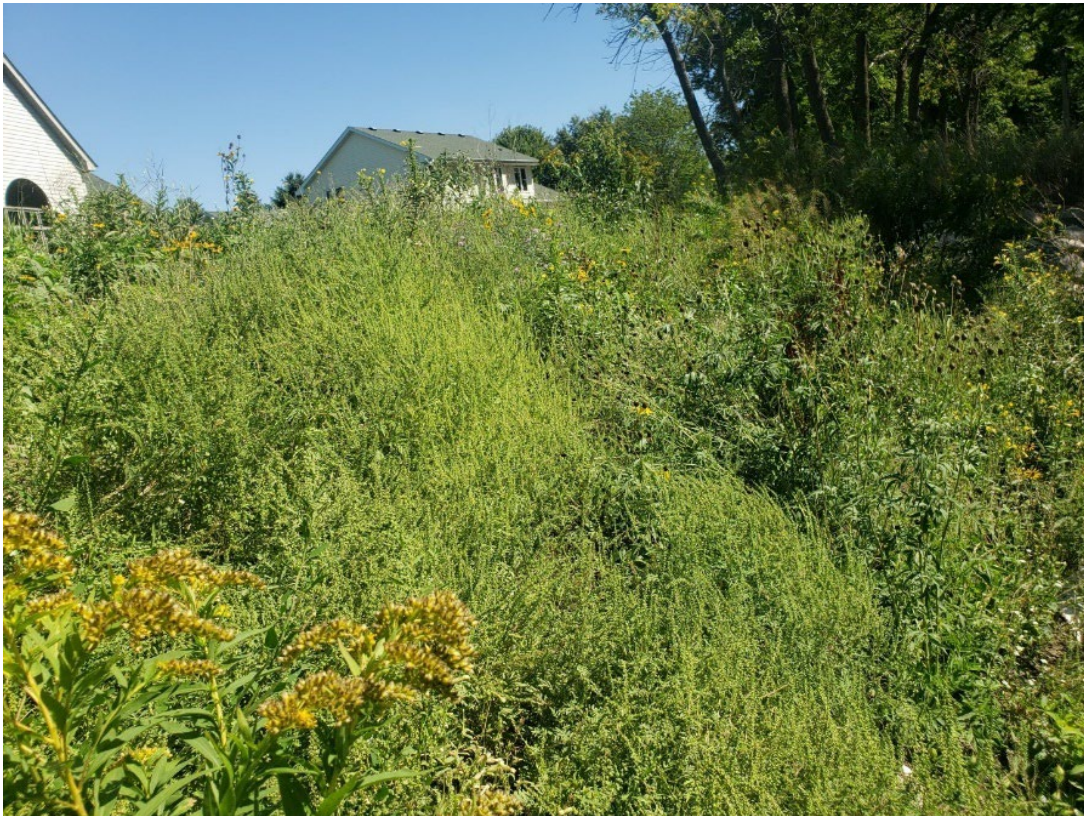
Photo 89. Example of the existing vegetation along the slope. Site is vegetated primarily by weedy, early successional species. (Photo taken by Mark Prancus, Cardno now Stantec, on 9/1/2022).

Establishment and maintenance activities of the planted vegetation on the slope is necessary. The steepness of the slope may present an obstacle for the landowner to self-perform the work, depending on their capabilities or interest. Vegetation management work may need to be contracted out to professionals that have both the knowledge base for native plant management techniques and the equipment and capacity to work under difficult conditions.

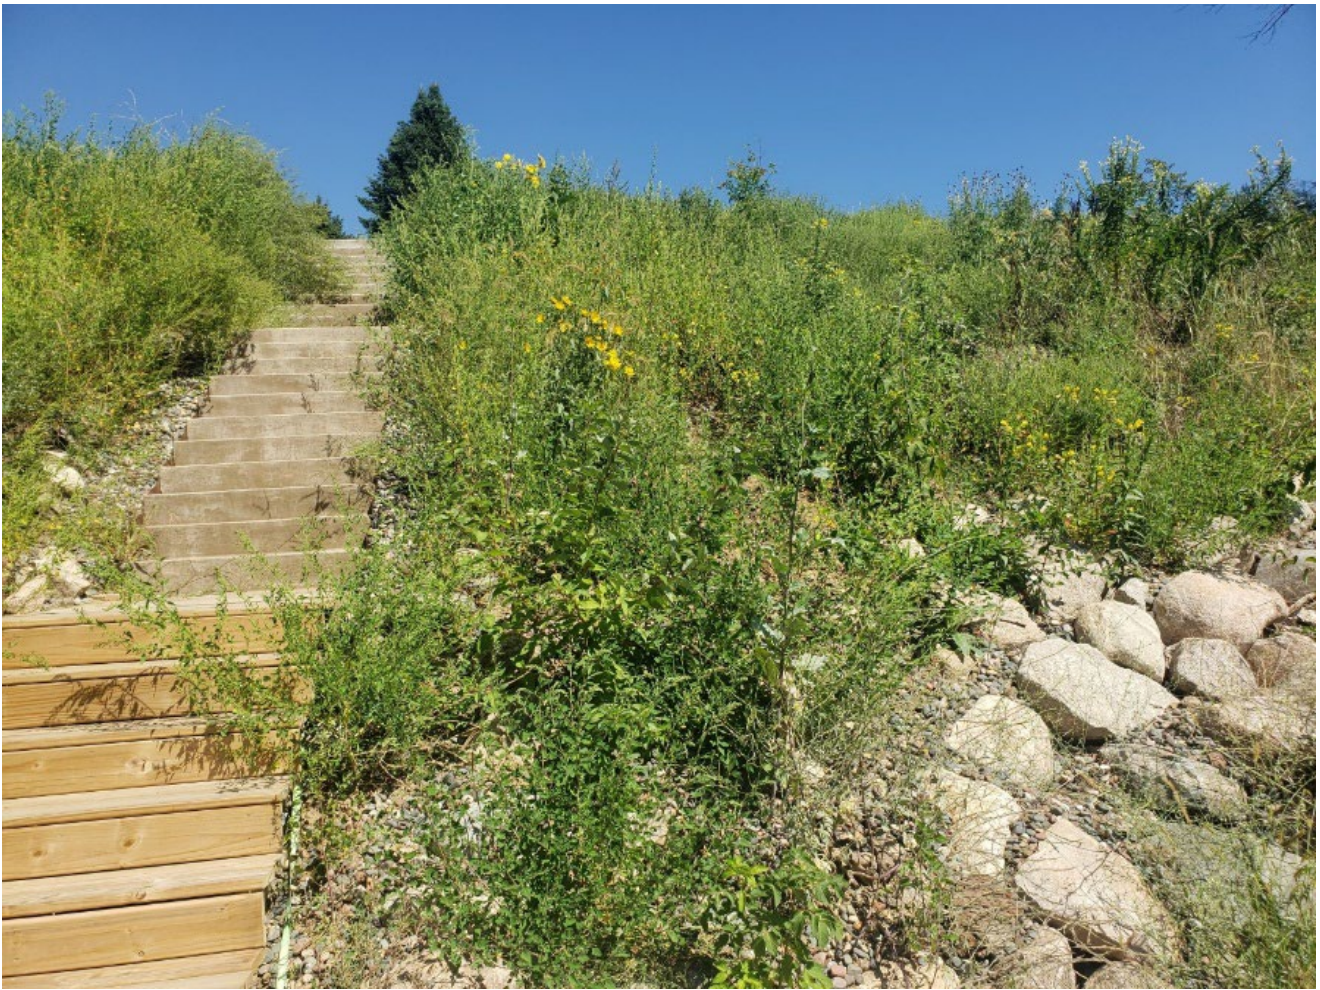
Photo 90. Example of the existing vegetation along the slope. Site is vegetated primarily by weedy, early successional species. (Photo taken by Mark Prancus, Cardno now Stantec, on 9/1/2022).

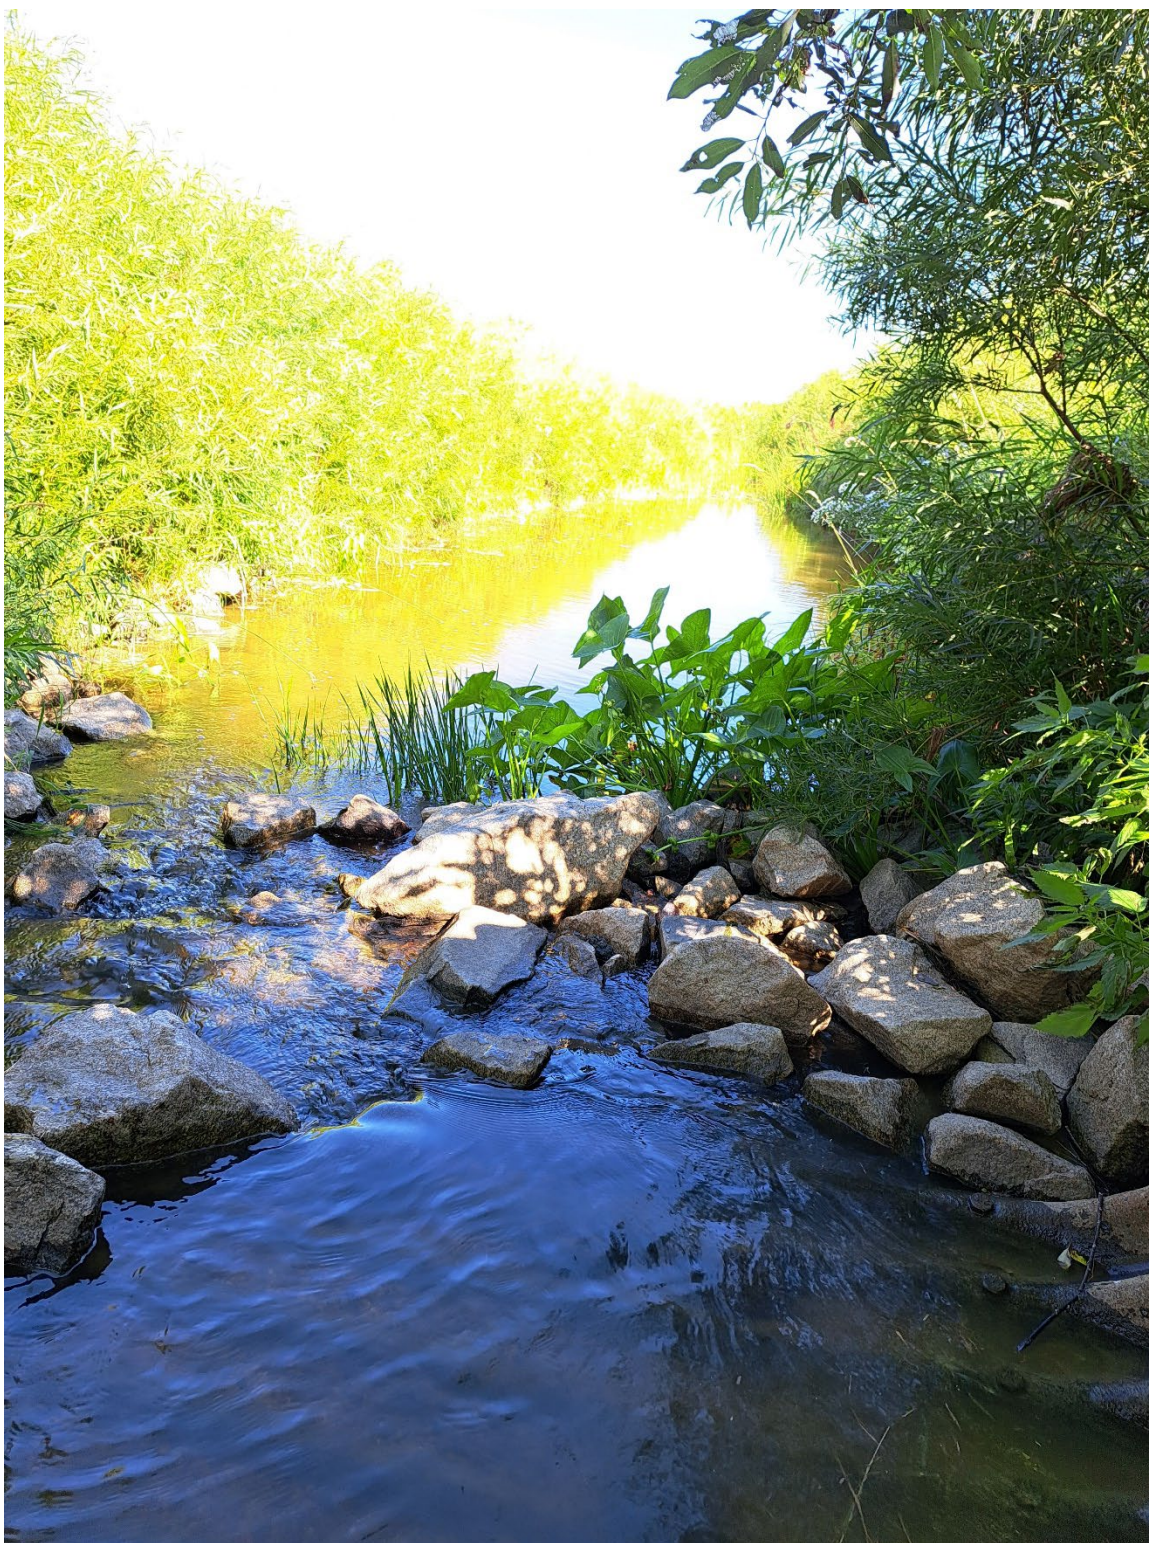
Photo 96. Looking north from County Hwy 4 (Graceton Beach Rd) at a rock bar installed downstream from a culvert (Bostic Creek Grade Stabilization, photo taken during site visit 8/30/2022).

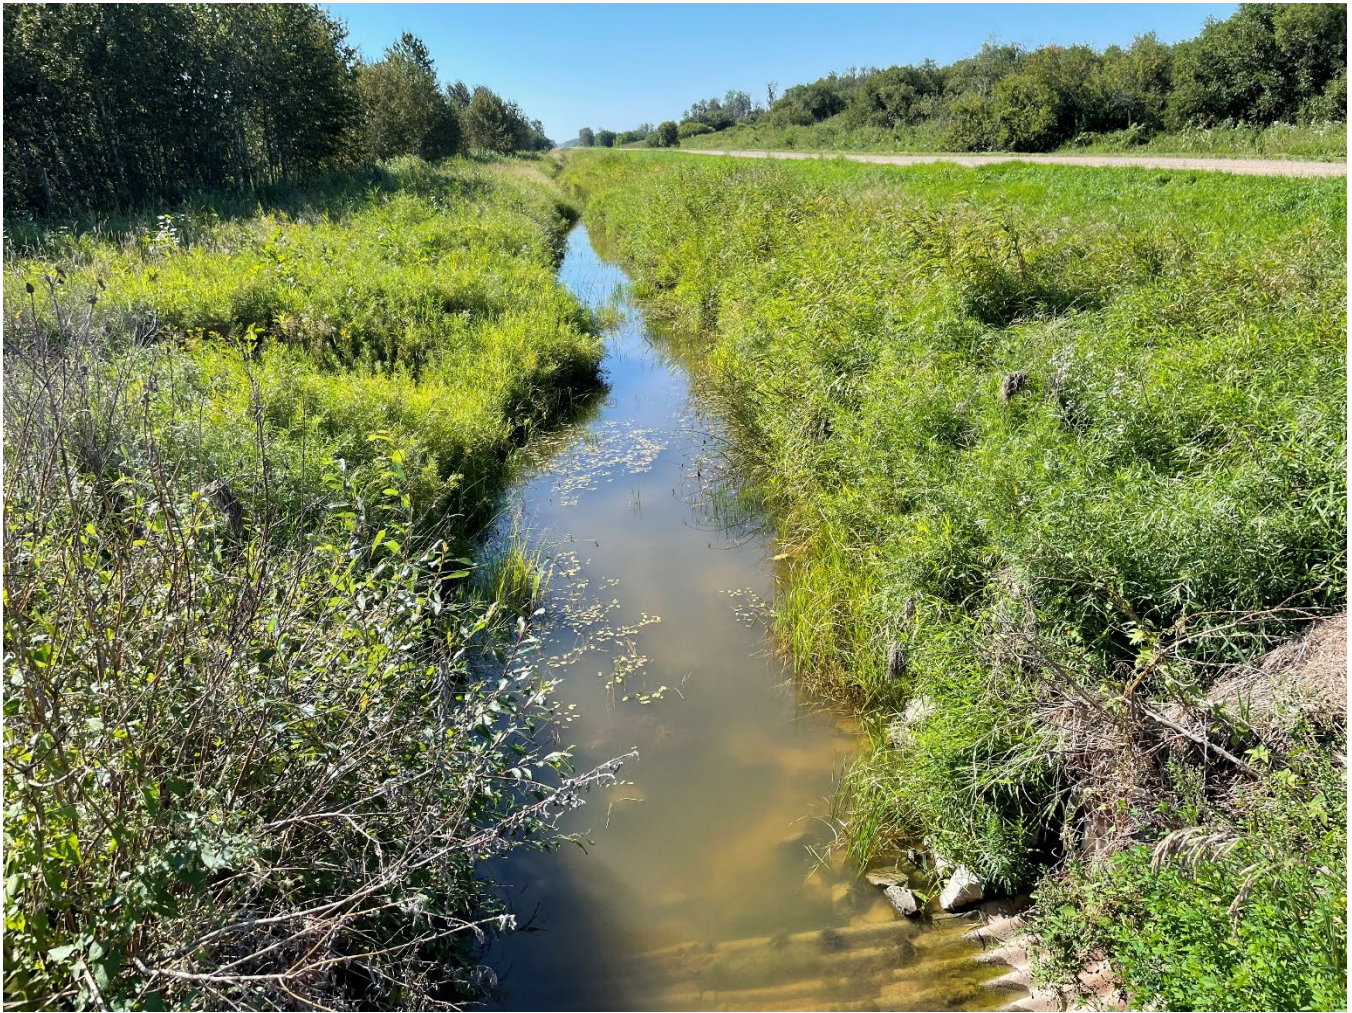
Photo 97. Looking south from County Hwy 4 (Graceton Beach Rd) at the other end of the drainage culvert (Bostic Creek Grade Stabilization, photo taken during site visit 8/30/2022).

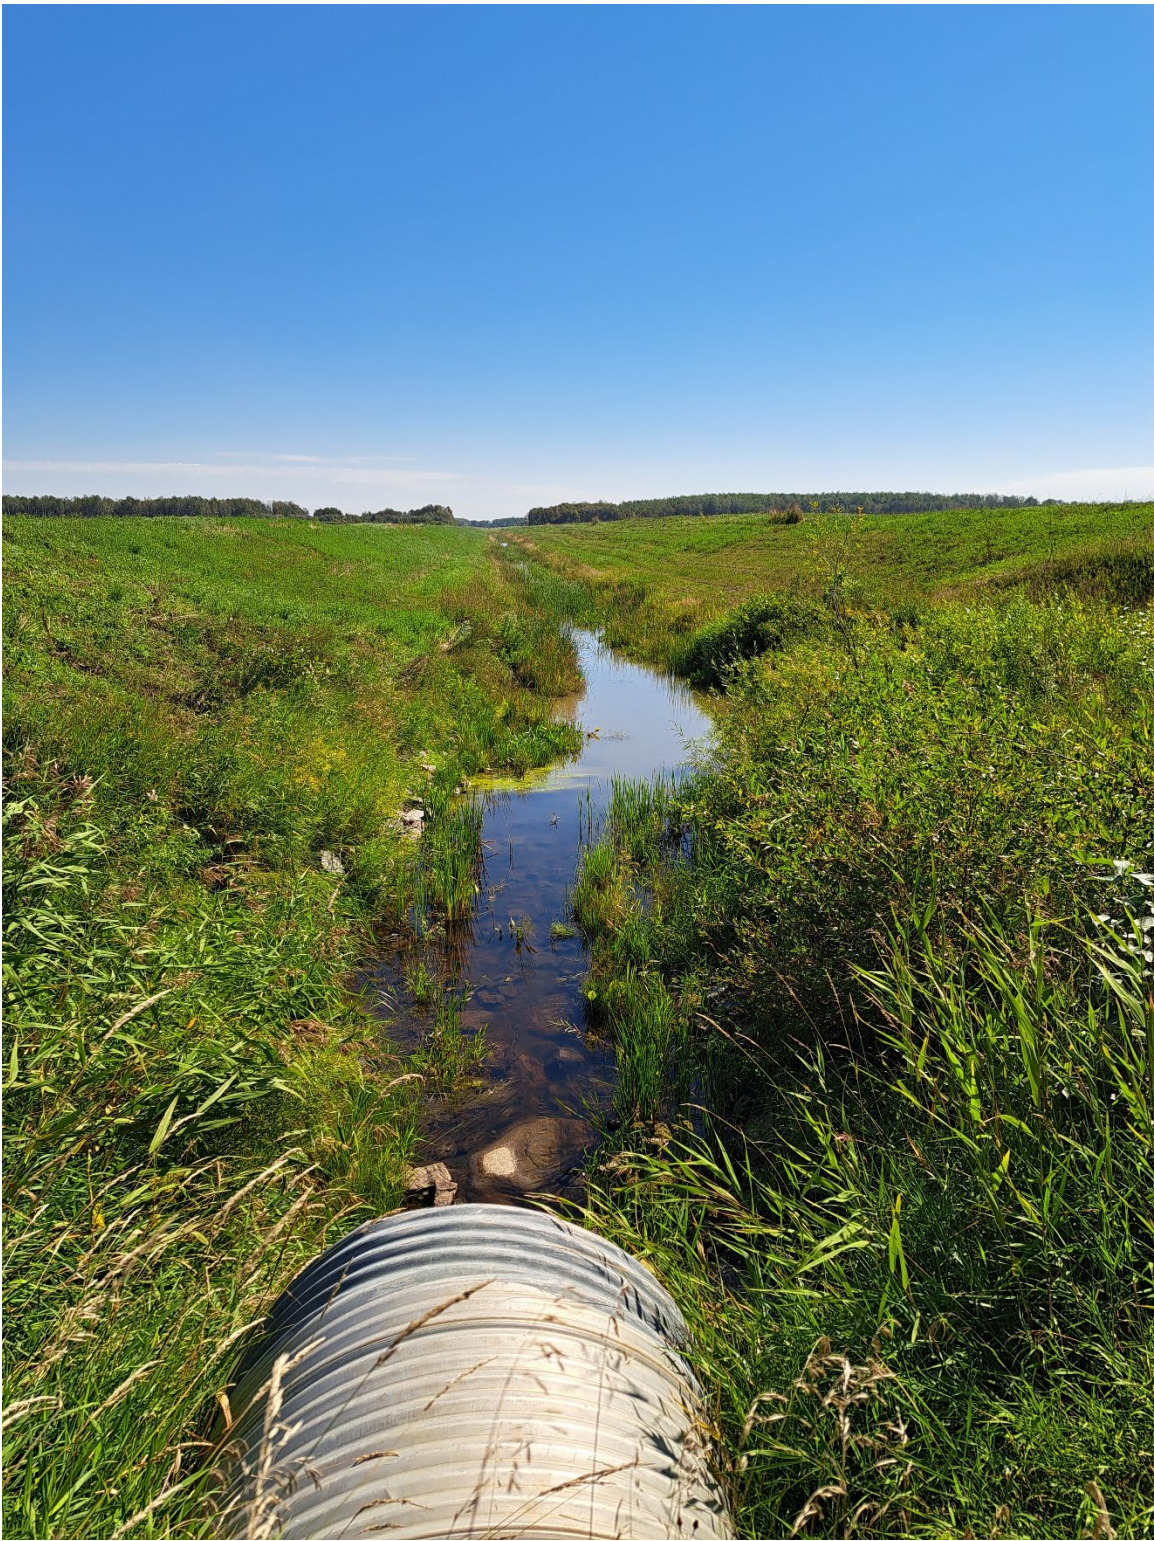
Photo 98. Looking east from County Hwy 4 (Graceton Beach Rd) where the 2-stage ditch begins (Bostic Creek Grade Stabilization, photo taken during site visit 8/30/2022).

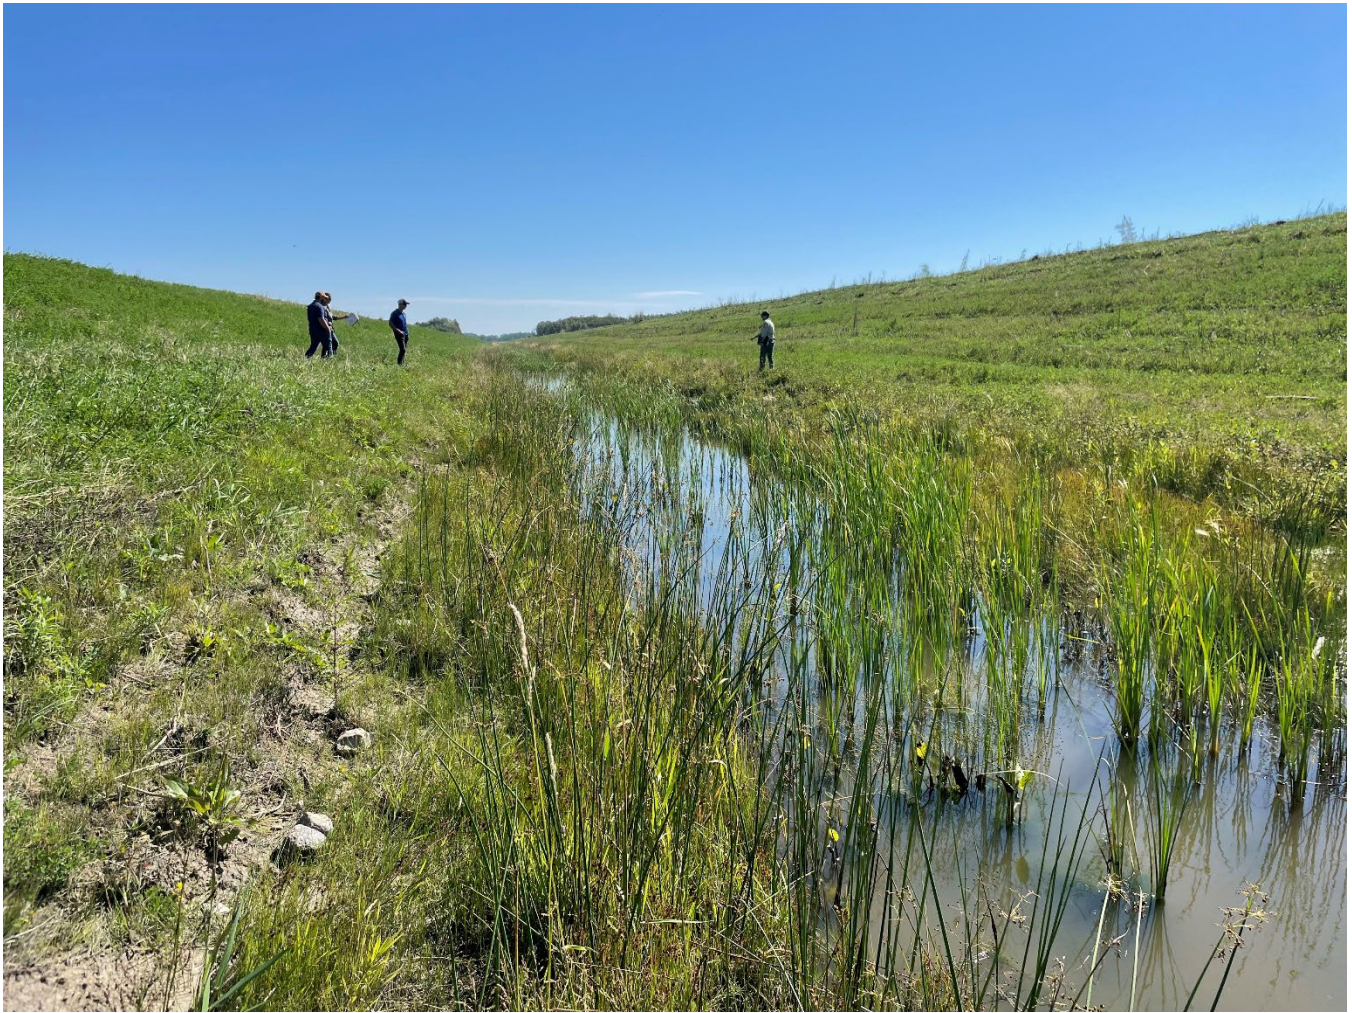
Photo 99. Looking east along 2-stage ditch at Bostic Creek. Note the emergent vegetation including softstem bulrush, northern water plantain and narrow-leaf cattail (Bostic Creek Grade Stabilization, photo taken during site visit 8/30/2022).

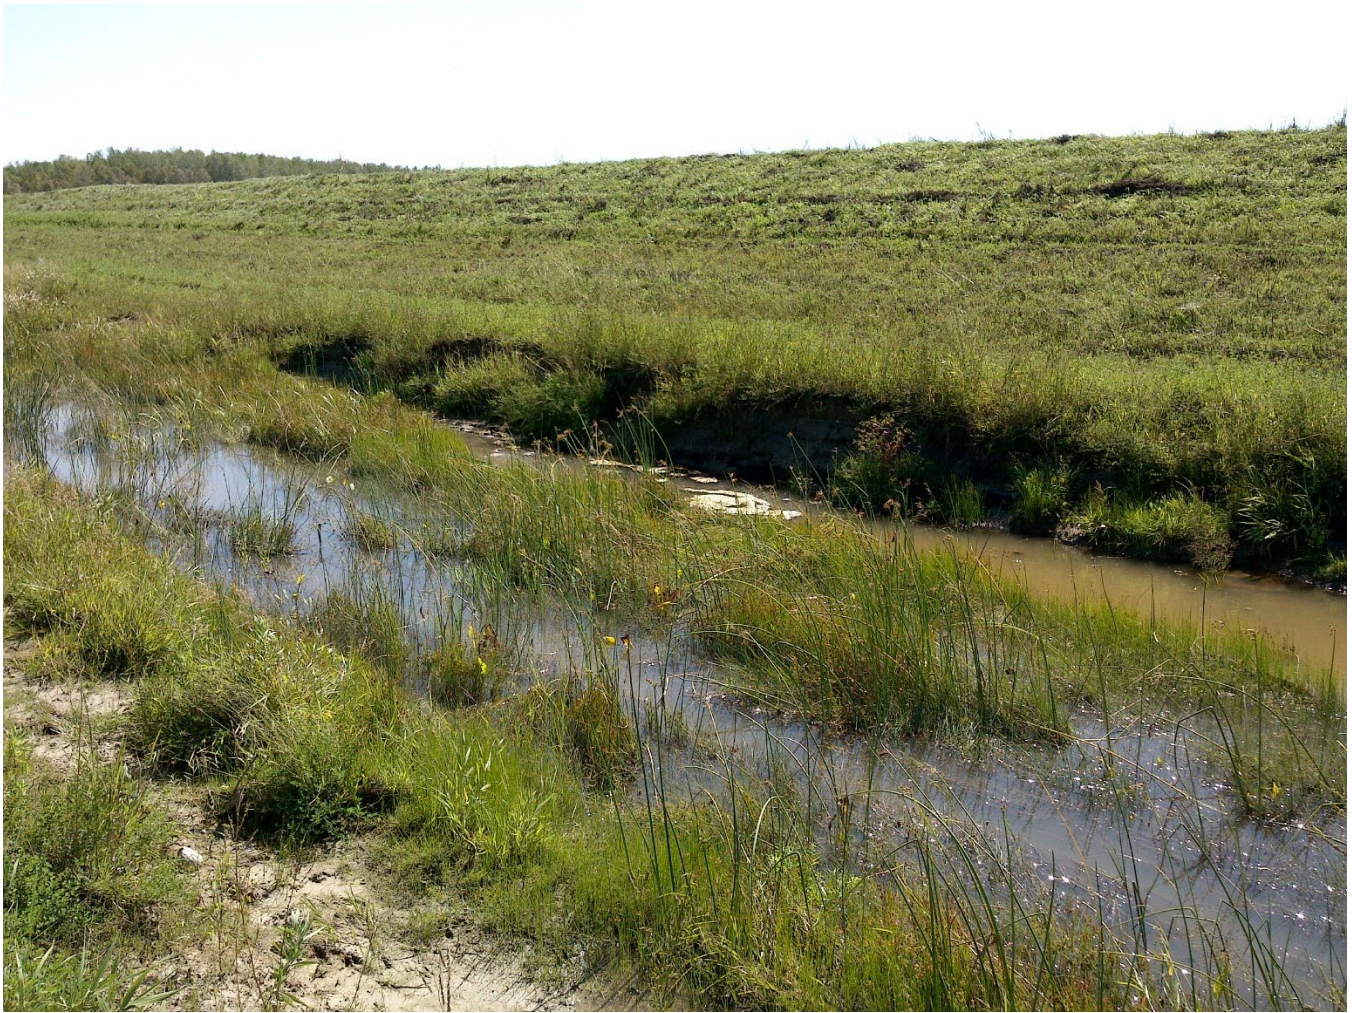
Photo 100. Looking southeast along 2-stage ditch at Bostic Creek where erosion has occurred along southern portion of the bench (Bostic Creek Grade Stabilization, photo taken during site visit 8/30/2022).

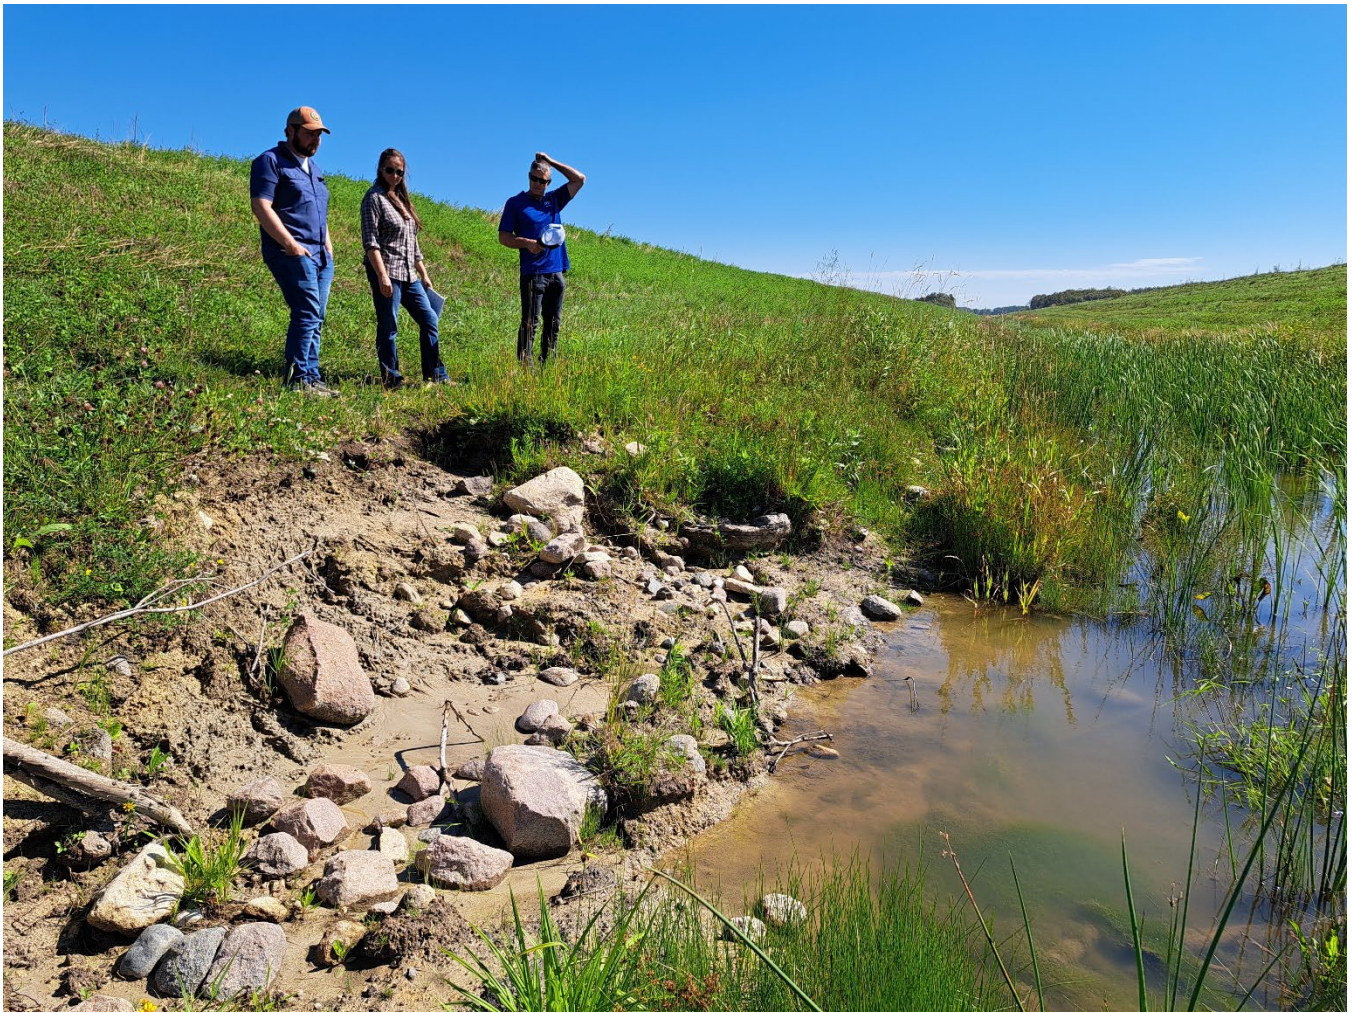
Photo 101. Looking east along 2-stage ditch where spring flooding cut into the bank (Bostic Creek Grade Stabilization, photo taken during site visit 8/30/2022).

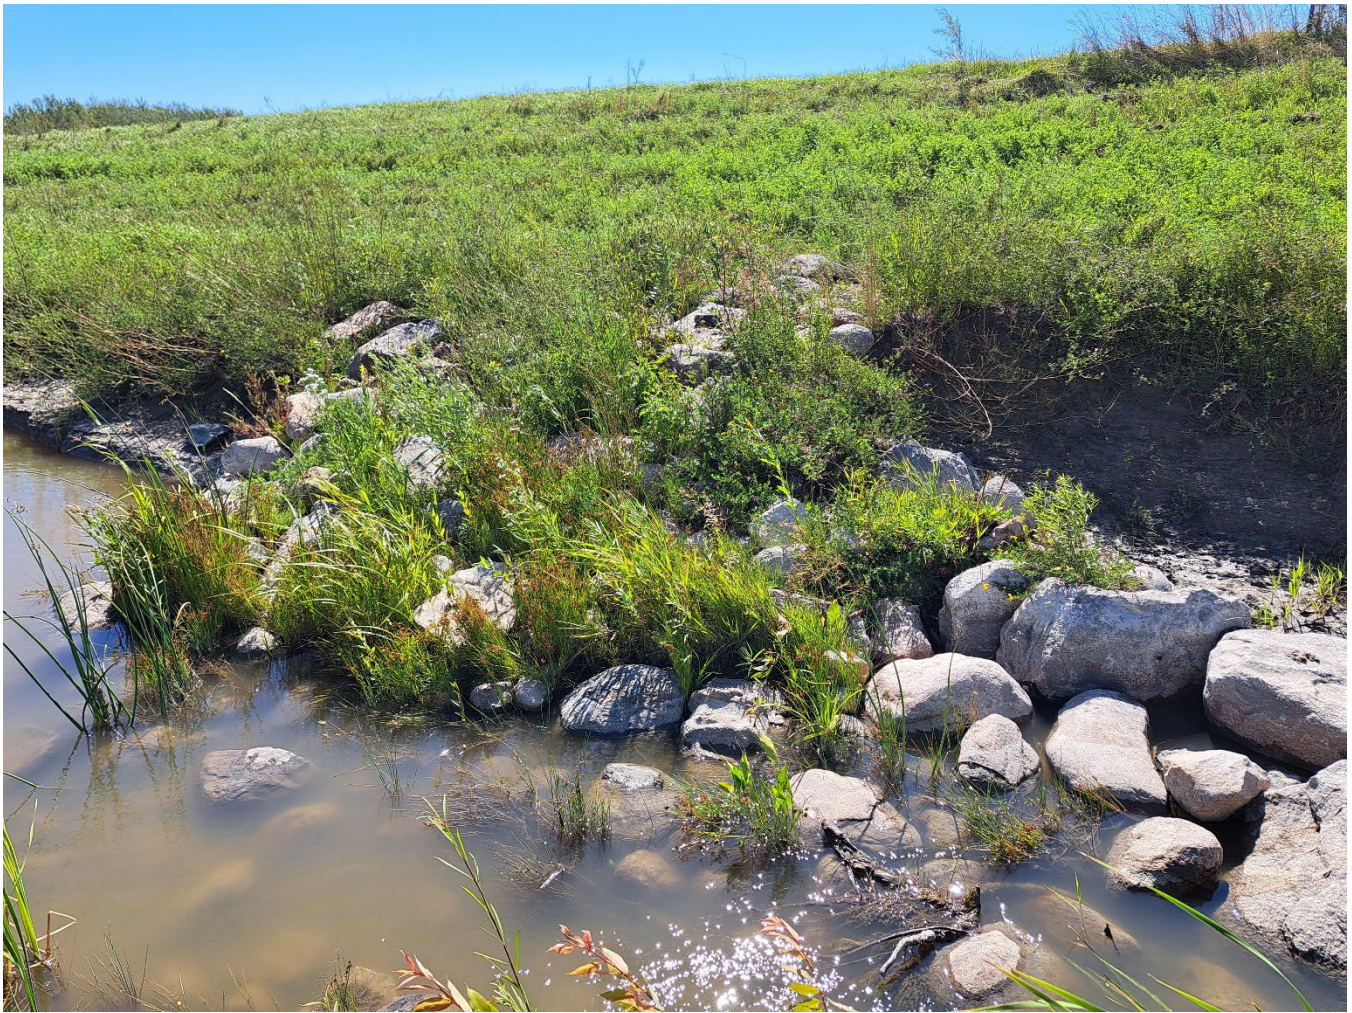
Photo 104. Looking southeast along stream bank at same site where riffle was washed out due to spring flooding (Bostic Creek Grade Stabilization, photo taken during site visit 8/30/2022).

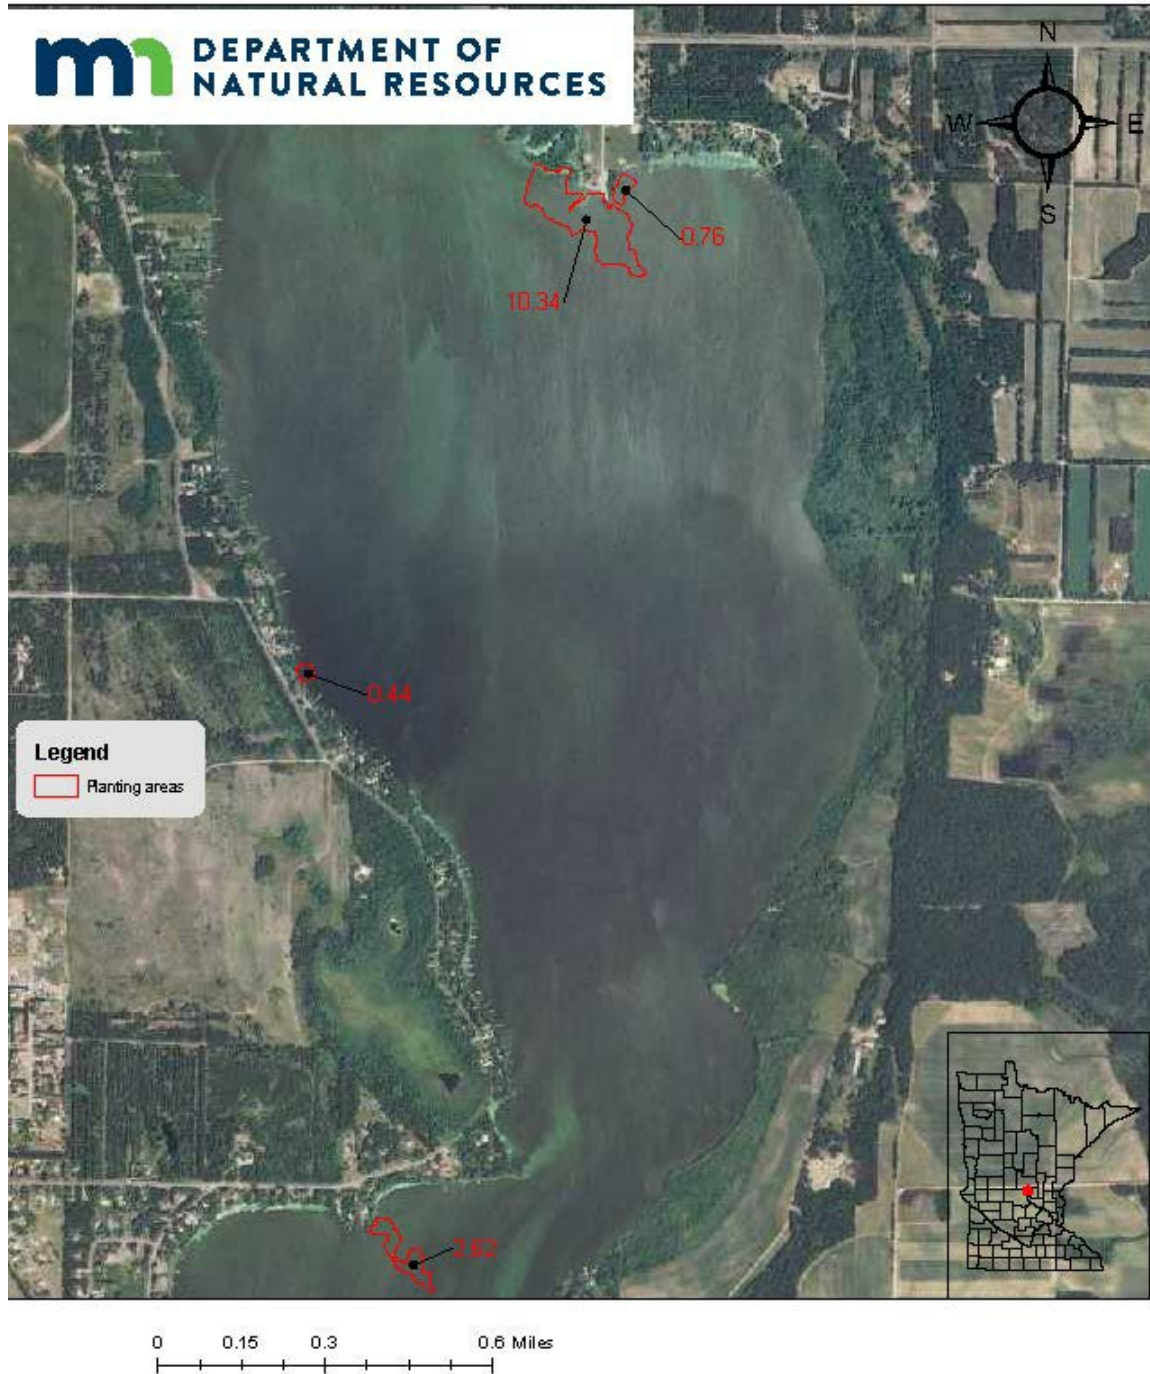
Figure 98 Aerial photo of plug planting areas in Little Rock Lake. Total acreage of 14.16 and planted with six emergent species. Map provided by Minnesota Department of Natural Resources.

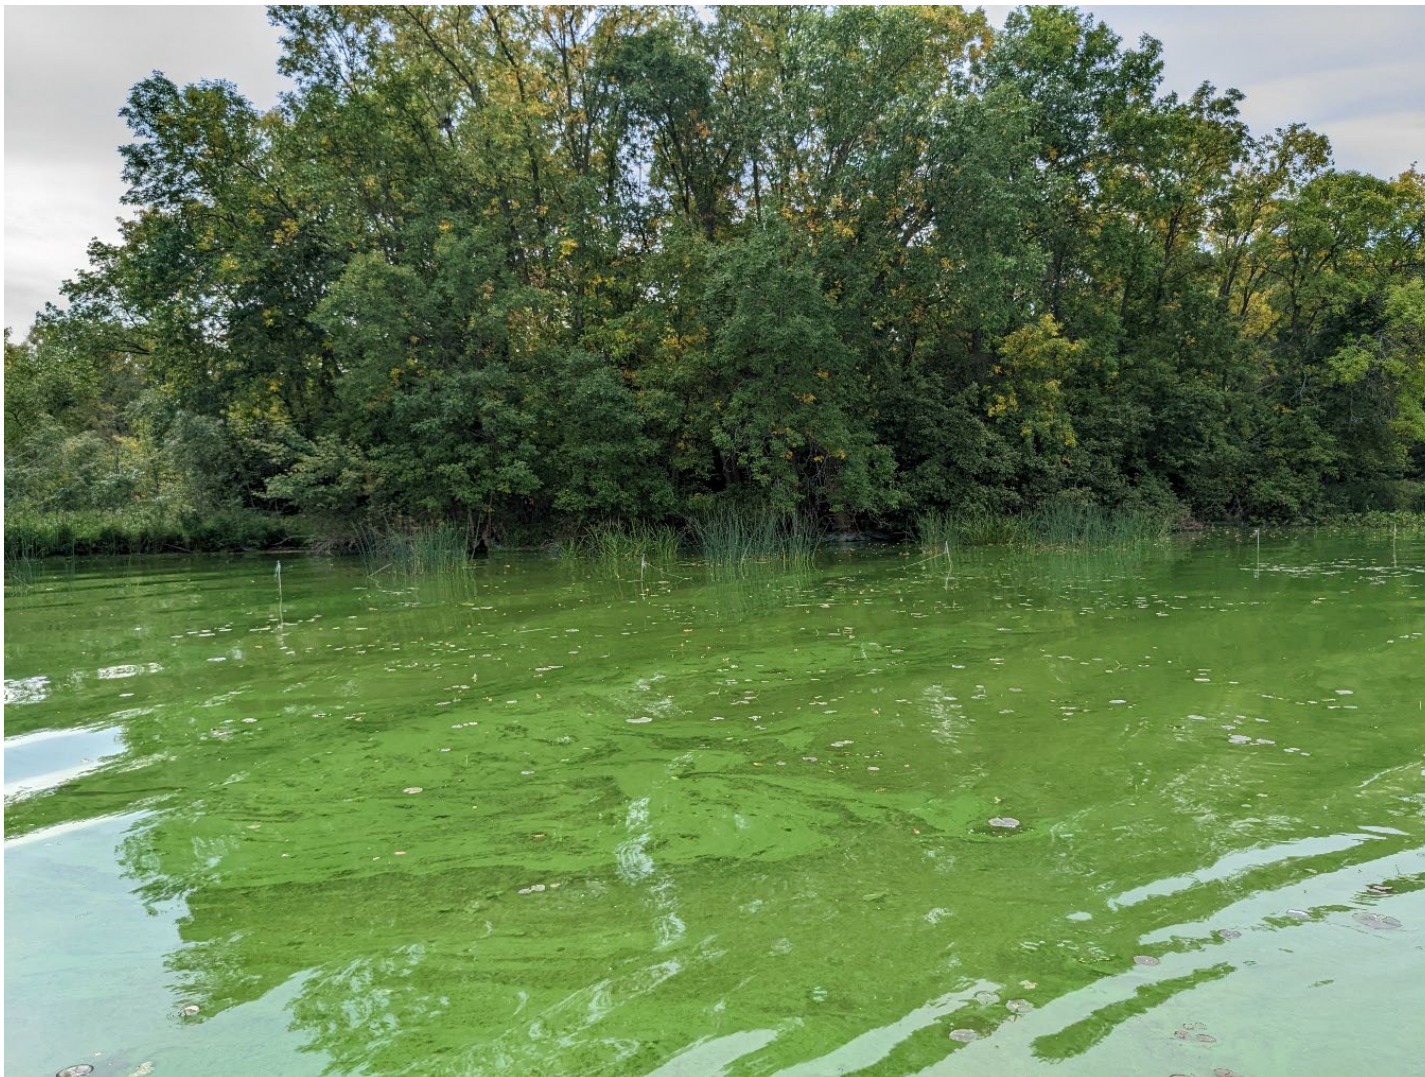
Photo 1 Taken east of the Hwy 10 bridge during the site visit on 9/15/22. The planting along this stretch had roughly 50% survival of bulrush. Note the occurrence of a severe algal bloom when the photo was taken in September.
