LEGACY FUND RESTORATION EVALUATION REPORT

Technical Panel Findings and Recommendations—2022

REPORT TO THE MINNESOTA LEGISLATURE

Date of Report: August 2023

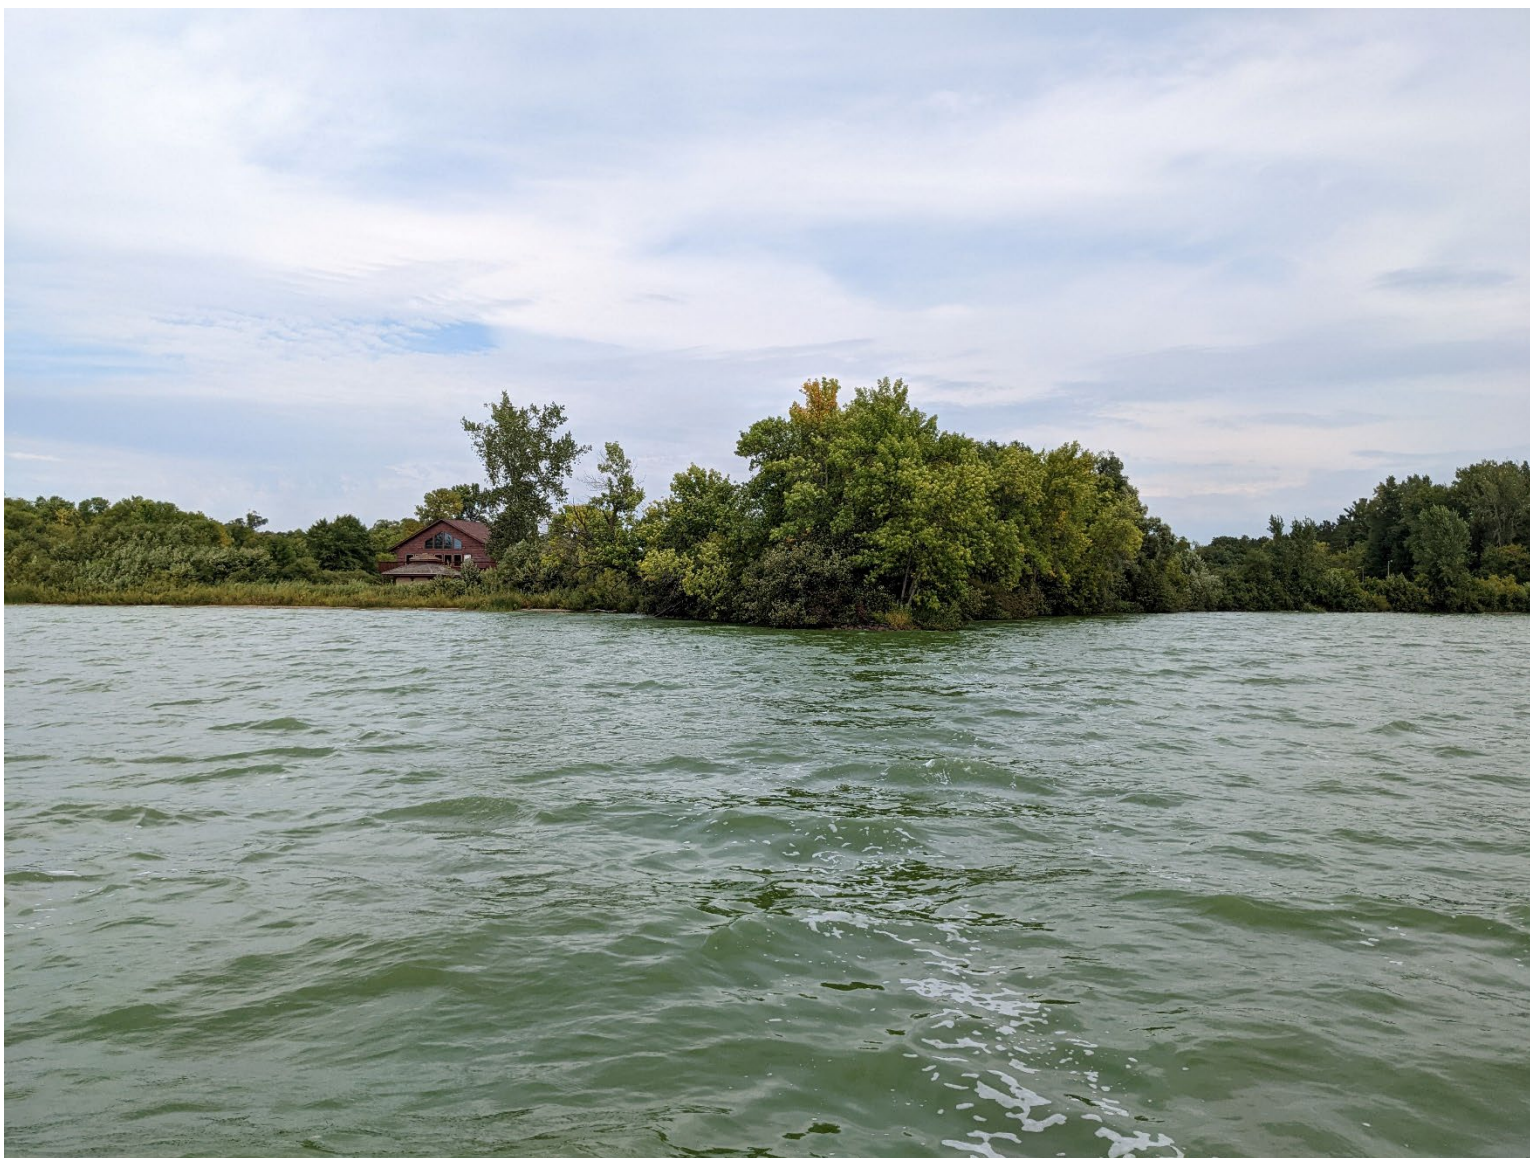
The reason the project did not meet the stated goals was likely due to the limited duration of the drawdown in addition to geese feeding on planted plugs throughout the lake. Water clarity benefits from the drawdown in 2019 showed improved clarity measurements but these were not long lasting. Overall, emergent plant survivorship was low and did not improve aquatic habitat as much as it would have if there was better protection and establishment of planted material. However, some small patches of emergent vegetation were observed and documented during the site visit.

Photo 2 The largest planting area towards the north end of the lake with low plant survival. This area was 10.34 acres in size and wrapped around the peninsula in the center of the photo. To the left of the peninsula, in front of the house, is a section of planted prairie cord grass and bulrush near shore that did survive but was limited in scale.

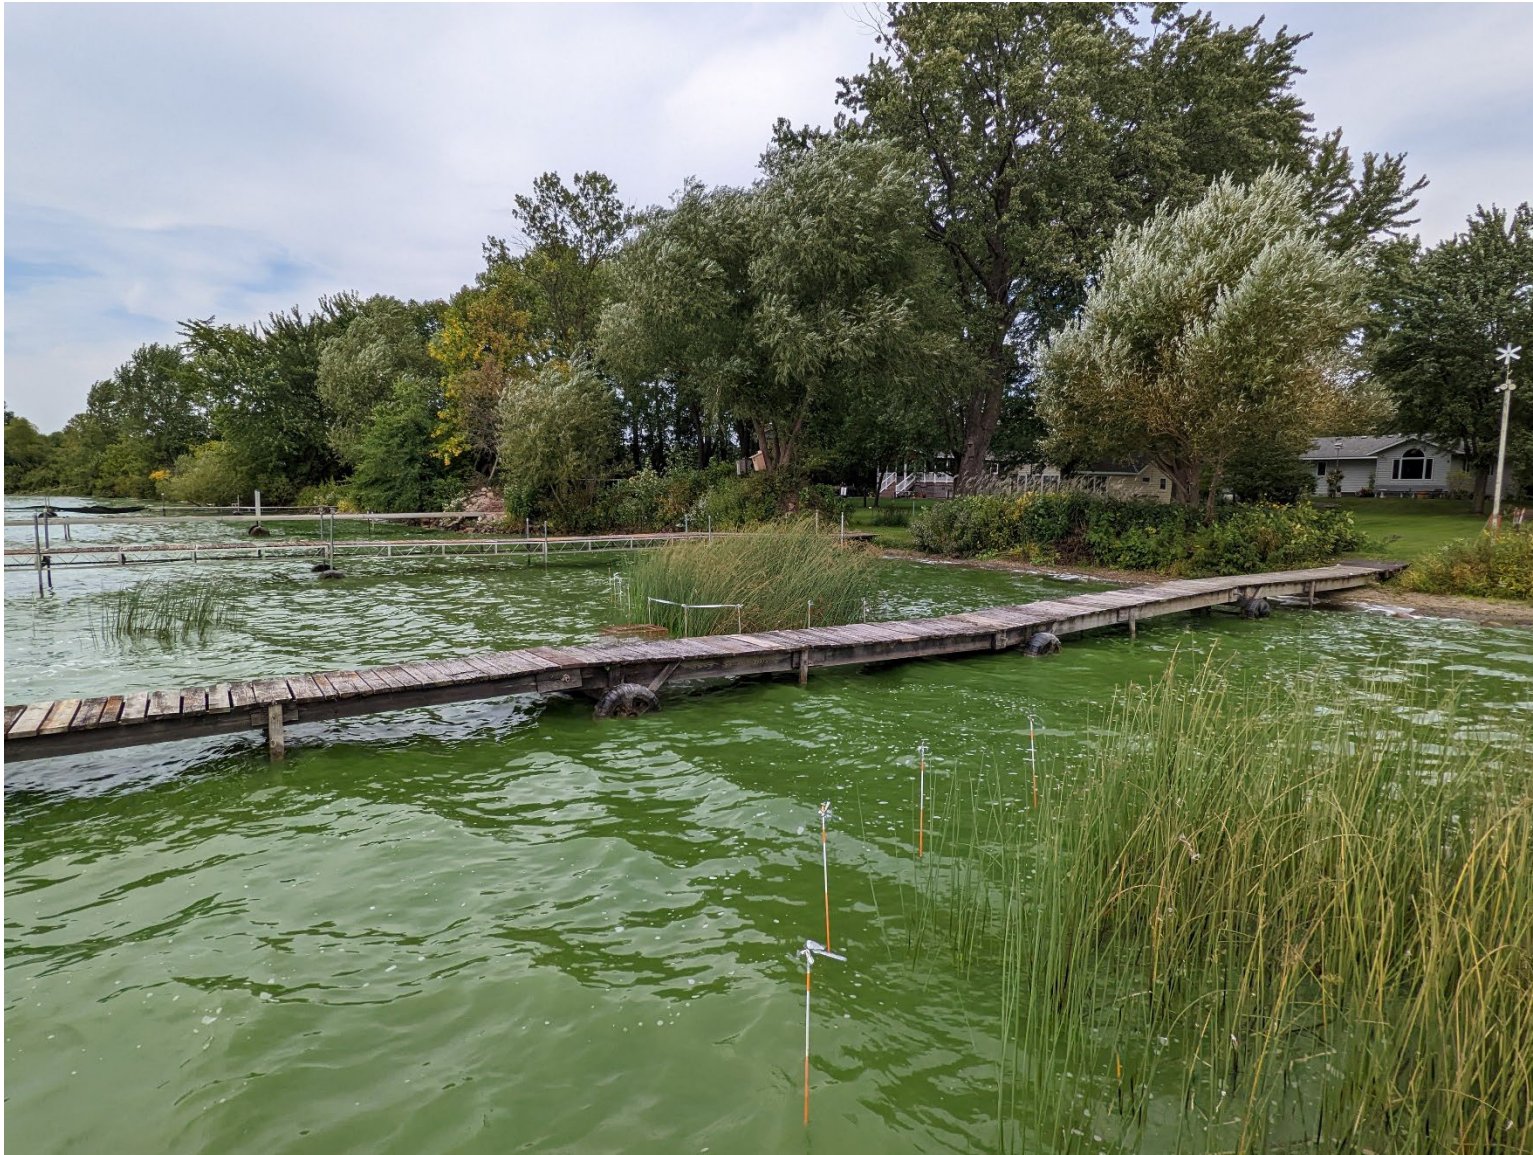
Photo 3 View of 3, small plantings installed by homeowners on the east side of the main lake basin. These plantings were not installed in the designated planting locations but were able to establish which is a positive outcome of this project.

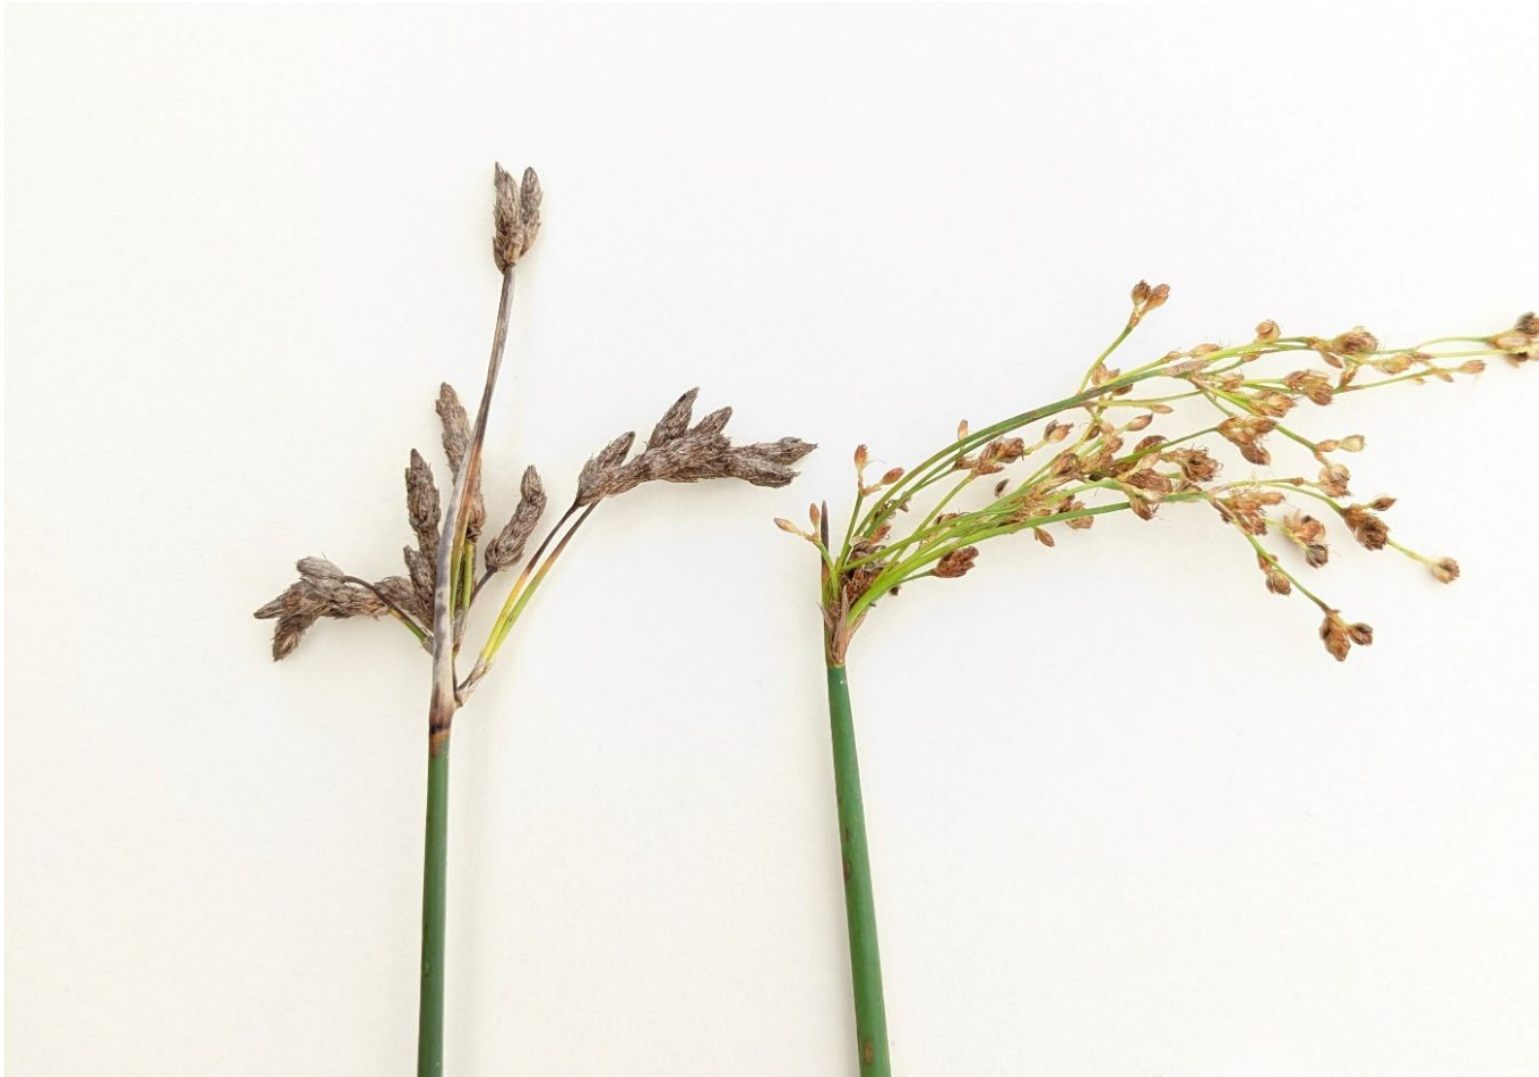
Photo 4 Hardstem and softstem bulrush collected from a planted area on the eastern shoreline of the main lake basin.
