I-35W BRIDGE OVER THE MISSISSIPPI RIVER: COLLAPSE INVESTIGATION

BRIDGE NO. 9340
MINNEAPOLIS, MINNESOTA

FINAL REPORT
NOVEMBER 2008
WJE No. 2007.3702

Prepared for:
Minnesota Department of Transportation
Bridge Office
Oakdale, Minnesota

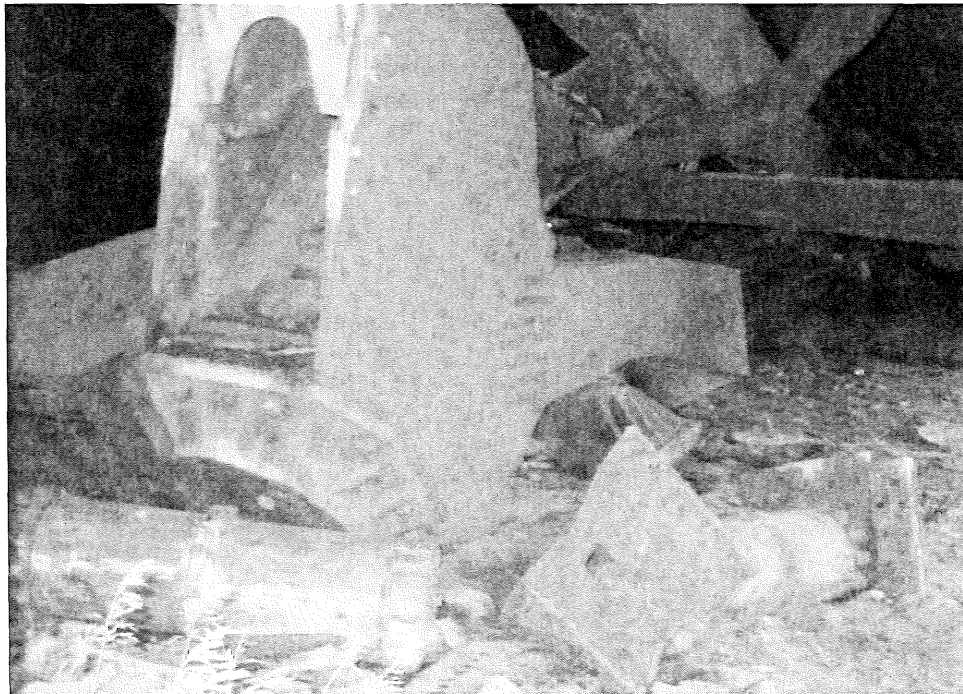
Figure 4.53. Post-collapse location of LIE, upper casting and north and center rollers.

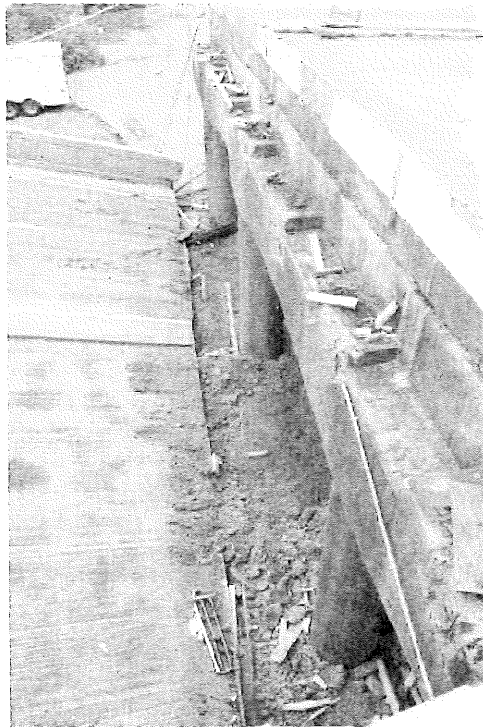
The steel superstructure for the northbound lanes remained erect in Span 11, but the southbound lanes collapsed at Pier 11 as shown in Figure 4.64. The steel girders in both structures translated at least 5 to 7 inches southward as a result of the plastic hinging of girder bottom flanges and significant upward displacement which occurred north of Pier 9. The girders supporting the southbound lanes pulled off Pier 11. The girders supporting the northbound lanes moved south 5 to 7 inches but were generally straight and did not show obvious signs of deformation or distortion and were still bearing on the south edge of Pier 11. The bottom flanges for the southbound lane girders, Girders G8 through G14 exhibited plastic hinging just north of the Pier 10 bearings with the hinges resting directly over top of the Pier 10 bearings and on the north edge of the pier cap. These girders were relatively straight north of Pier 10 and sloped downward towards Pier 11 where the bearings rested on the ground.

Figure 4.64. Collapse of the southbound lanes of Span 11 at Pier 11.

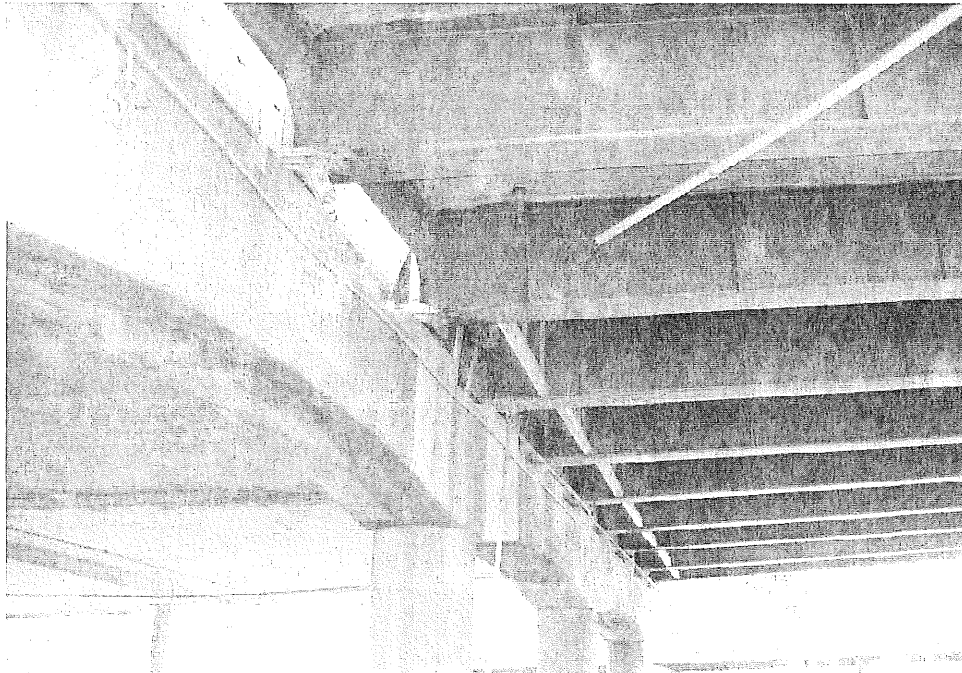
the concrete piers at Piers 12 and 13. Bearings at the north abutment were intact and nested and no distress or evidence of movement was present at the slab/pier interfaces at Piers 12 and 13. The curved plates of some voided slab bearings at Pier 11 were offset several inches either north or south of center. The fixed bearings of the southbound lane girders at Pier 9 dislodged and translated west due to the collapse. Southward movement of the superstructure also dislodged the expansion (sliding) bearings at Piers 10 and 11. The girders supporting both the southbound and northbound roadways lifted and shifted off of the expansion bearings at Pier 10 following plastic hinging in the girder bottom flanges north of Piers 10 and/or 9. The upper bearing plates of the Pier 10 bearings remained connected to the girder sole plates but these components translated approximately one to two feet south and up to one foot west of the lower bearing plates and were either suspended above, or minimally supported on, the south edge of the pier as shown in Figure 4.65. The northbound lane girders remained suspended above the pier following the collapse such that they effectively spanned between Piers 9 and 11. The southward movement of the southbound roadway was significant enough to pull the upper bearing assemblies off of Pier 11, leading to the partial collapse of this span. Southward movement of the northbound roadway occurred, but the Pier 11 bearings still partially rested on the pier as shown in Figure 4.66.

Figure 4.66. Southward displacement of bearings of the northbound lanes at Pier 11.
