# Testing of Alternative Asphalt Trail Surfaces for Resistance to Damage from Snowmobiles With Carbide Studs

*Minnesota Department of Natural Resources  
in cooperation with the Minnesota Asphalt Pavement Association and  
the Minnesota Department of Transportation Office of Materials and  
Road Research*

*December 15, 1998*

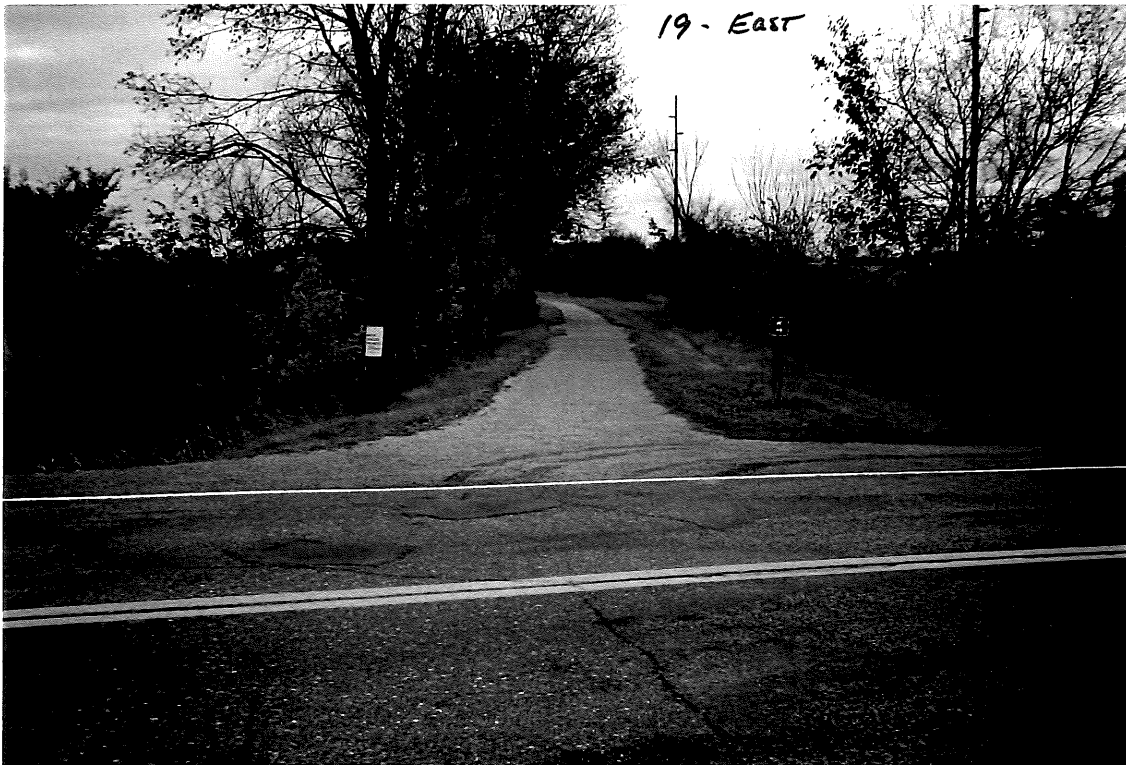
Segment 1 prior to placing test material

**Segment 1:** Luce Line State Trail & Hennepin County 19, East Approach

**Mix Used:** Mn/DOT Specification 2331, Type 41 Wear Course, Size A (1/2" maximum)  
55% crushed aggregate, Asphalt Cement (AC) Grade PG58-28, AC 6.1% minimum

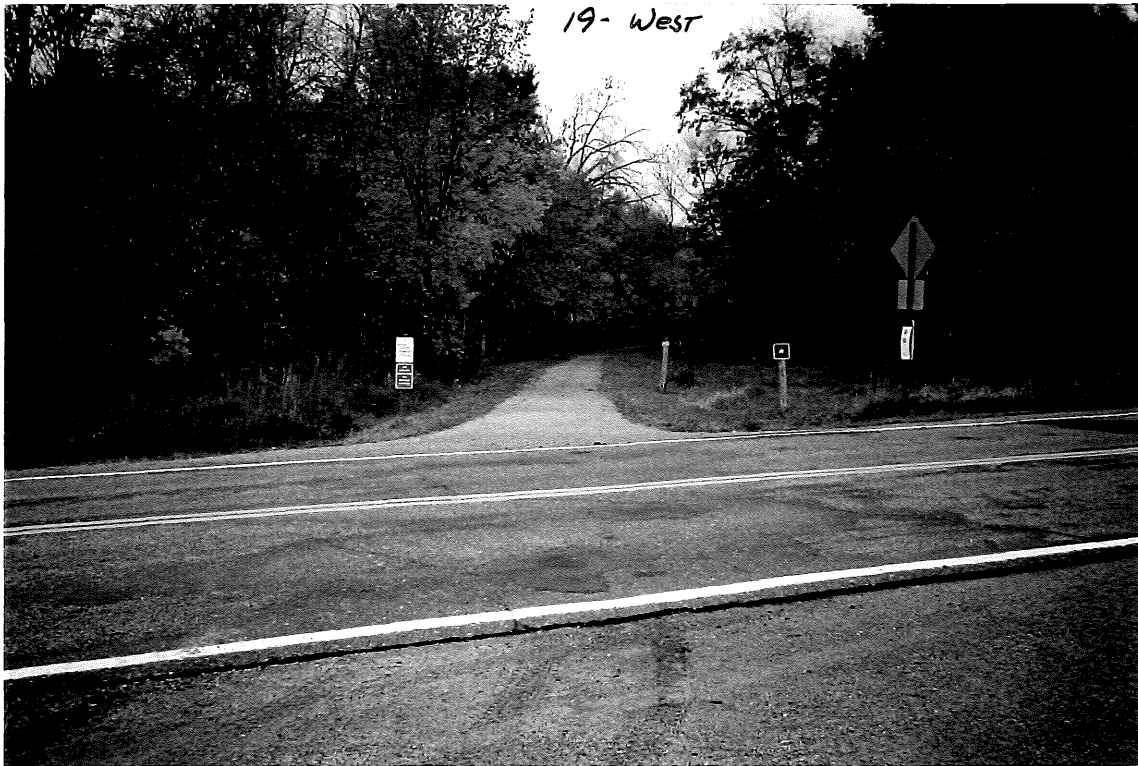
**Segment 2:** Luce Line State Trail & Hennepin County 19, West Approach

**Mix Used:** Mn/DOT Specification 2331, Type 41 Wear Course, Size B (3/4" maximum)  
55% crushed aggregate, AC Grade PG58-28, AC 5.8% minimum

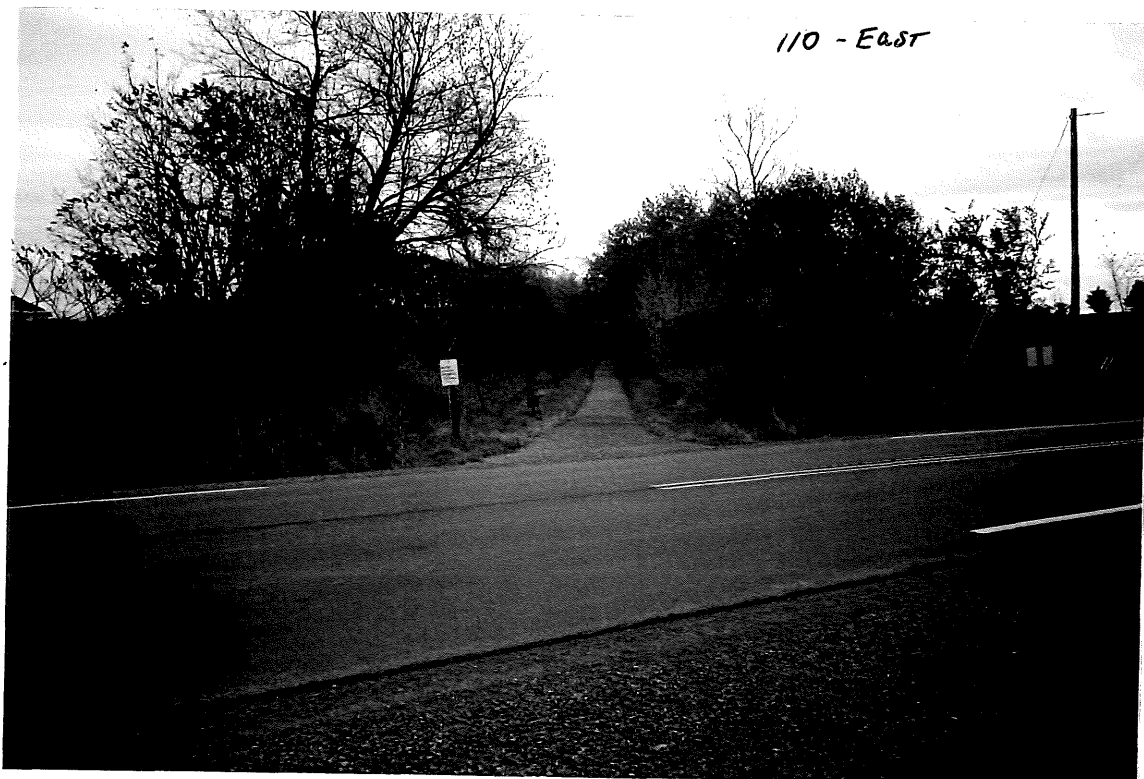
**Segment 3:** Luce Line State Trail & Hennepin County 110, East Approach

**Mix Used:** Mn/DOT Specification 2331, Type 61 Wear Course, Size A (1/2" maximum)  
100% crushed granite aggregate, AC Grade PG58-22, AC 6.1% minimum

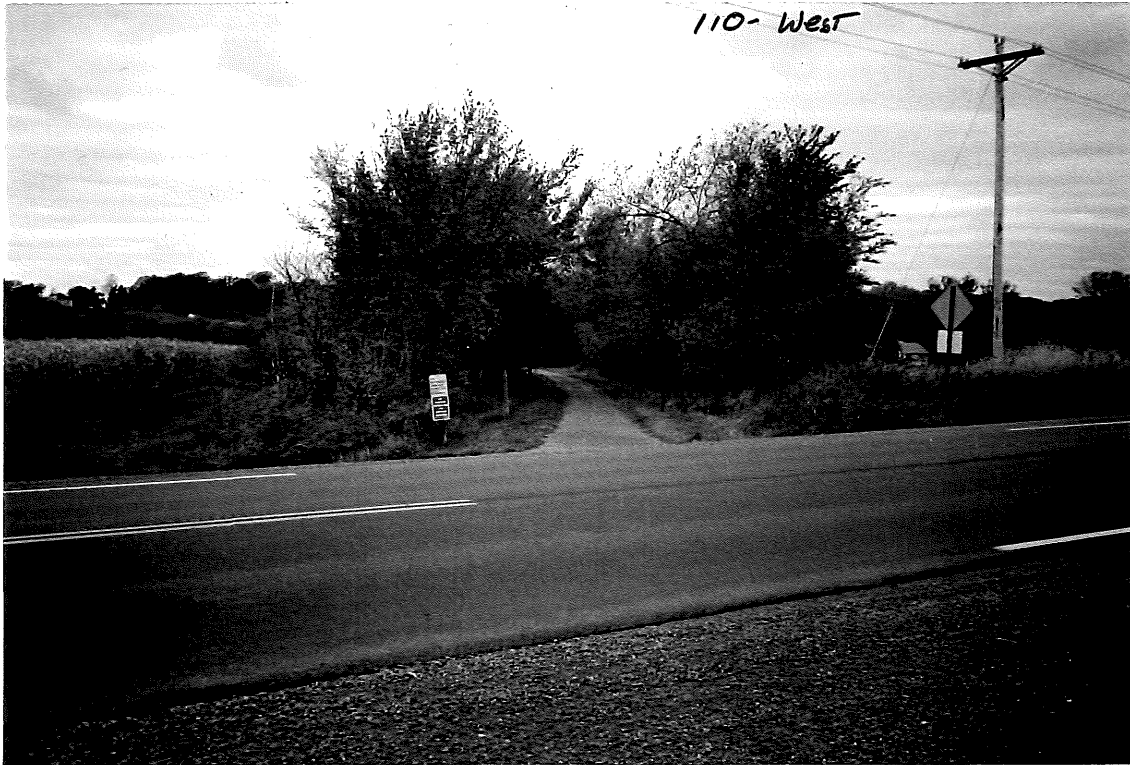
**Segment 4:** Luce Line State Trail & Hennepin County 110, West Approach

**Mix Used:** Mn/DOT Specification 2331, Type 61 Wear Course, Size B (3/4" maximum)  
100% crushed granite aggregate, AC Grade PG58-22, AC 5.8% minimum

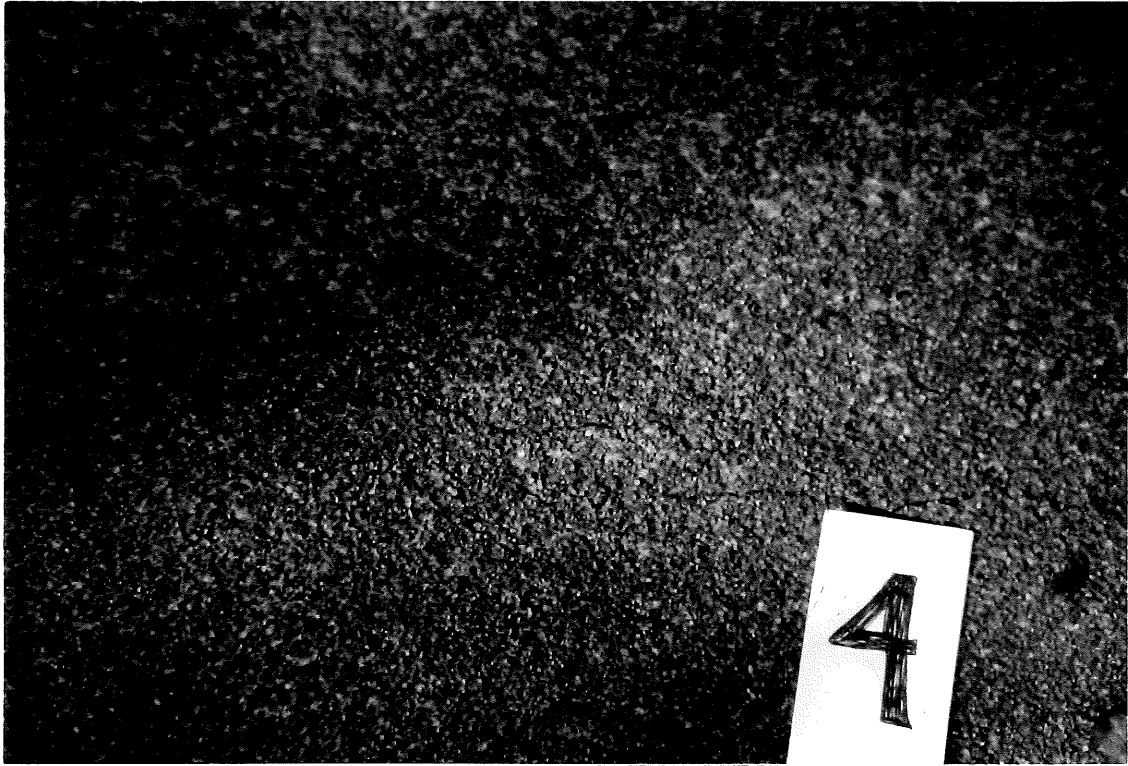
**Segment E4 (Flexogrid):** No penetration or grooving, little abrasion. However some longitudinal cracking is present, separating from the asphalt and pulling the asphalt surface apart. As in the previous segments, cracking seems to be due to epoxy expanding and contracting at a different rate than asphalt during temperature changes.

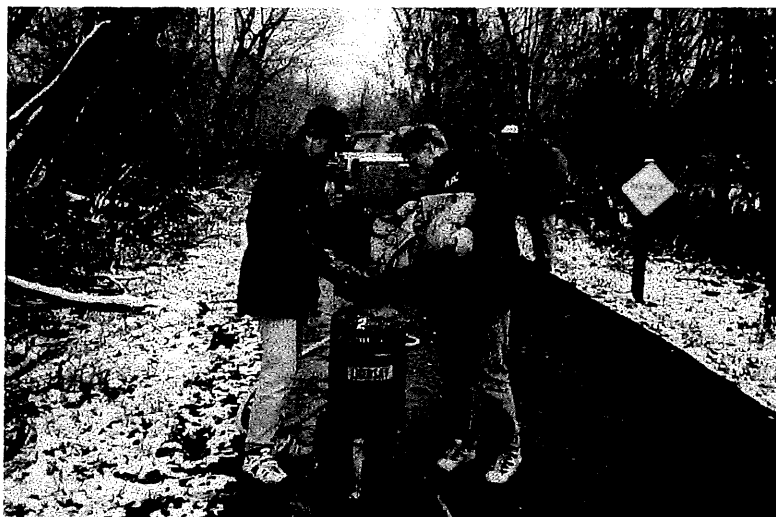
**Figure 3.** Sandblasting the surface.

The test sections were laid out on November 3, 1997. Using a MINNDNR sandblasting unit, the pavement surface was cleaned and roughened in preparation for the application of the coatings. All excess sand was swept from the surface. There was light snow covering the sections at this time and this was also cleared. Figure 3 shows the sandblasting work.

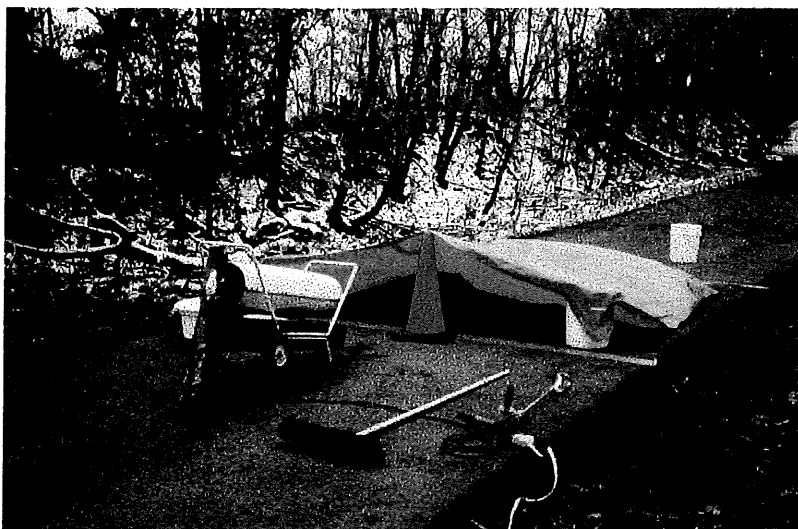
**Figure 4.** Pavement drying and heating.

The coatings were applied on November 4, 1997. Tom Miller of MDOT traveled to St. Paul to assist with the applications. He is the engineer in charge of the tests being performed in Michigan by MDOT. The ambient air temperature during the application was in the low 30's. This necessitated heating the pavement surface before application of chemicals was started. Since the pavement surface was also wet, this was also a means to dry it. This was achieved by covering the sections with a tarp and blowing hot air over the surface from a salamander as in Figure 4.

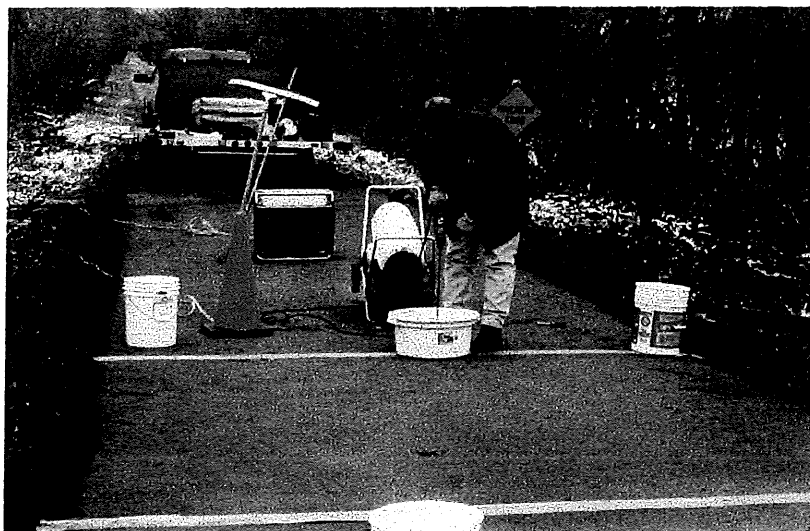
**Figure 5.** Mixing of epoxies.

The four elastomeric coatings were applied as each section was completely dry and warm. Each test pad was 10 ft. long along the trail and covered the width of the pavement, about 10 ft. The chemicals were kept warm inside a vehicle and were also warmed as they were mixed. The epoxies were mixed in batches of six gallons. The mix ratio prescribed by the manufacturers for 3 of the coatings, not including Flexogrid, is 1:1 (Resin : Hardener). Flexogrid is mixed at 2:1 (Resin : Hardener). The six gallon batch size was chosen as an estimate to cover 100 ft<sup>2</sup>. This amount was fairly close to the right amount in all cases. Mixing was accomplished using a power mixer as in Figure 5.

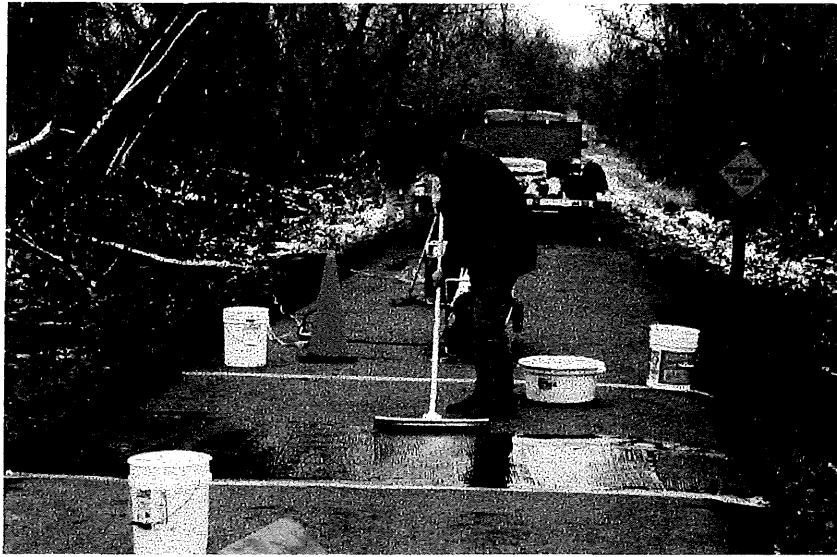
**Figure 6.** Coating application.

The mixtures were applied on the surface using a notched rubber squeegee and thinned to approximately 1/8" thick. Figure 6 is a photo of the application of liquid epoxy.

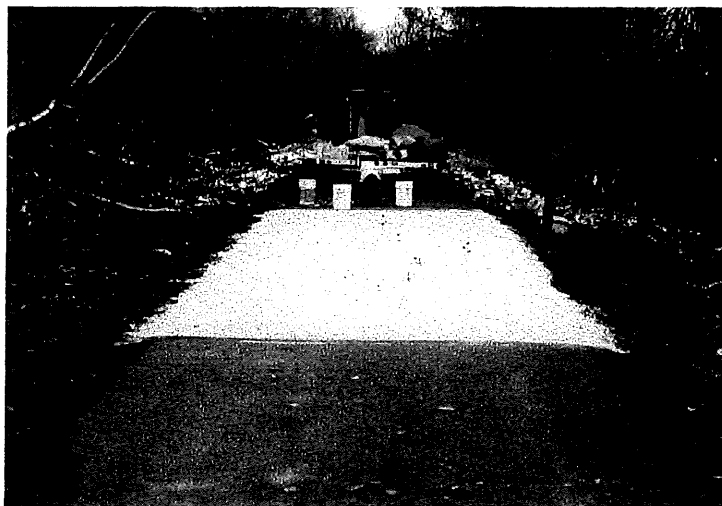
**Figure 7.** Completed test sections.

The test sections were applied in order from west to east along the trail as #1 - ProPoxy, #2 - CB 700, #3 - Sikadur, and #4 - Flexogrid. After all of the chemicals were applied, the entire test area was covered with a plastic tent and the salamander was used to keep the surface warm in order to speed up the set-up process. Figure 7 is a photo of the end product.

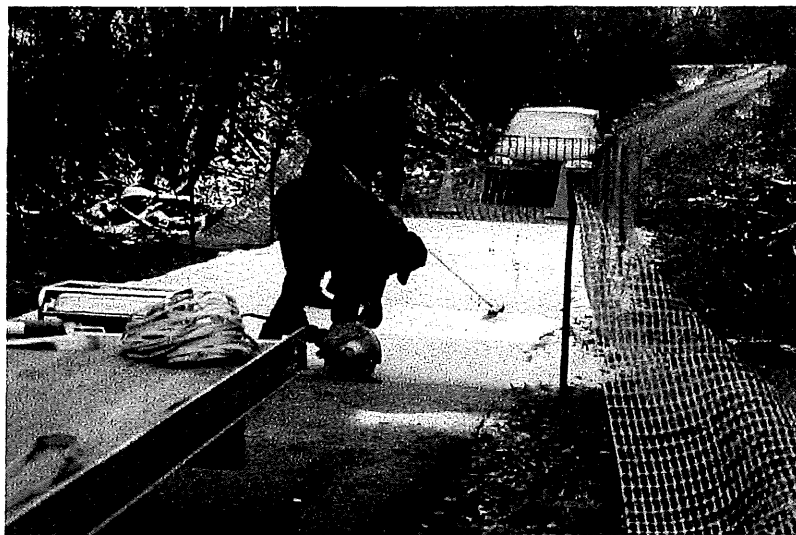
**Figure 8.** Saw cutting of boundaries.

The final step in the application process was to sweep the excess sand off of the surface and a saw cut was made along the far west and far east end of the sections where the epoxies met the bare pavement perpendicular to the direction of travel. This is done to keep differential shrinkage of the surface from causing cracks within the test section. Figure 8 shows one of these cuts being made.
