Minnesota State Capitol

A Preservation & Planning Study for Public & Ceremonial Areas

Prepared for The Capitol Area Architectural Planning Board

October 1984

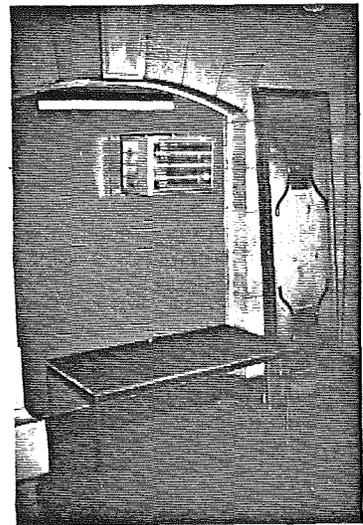
Examples of Intrusive HVAC Elements

interior. Inappropriate grilles of modern design, exposed wiring, modern light fixtures, emergency lighting, surface mounted wire mold and junction boxes, electrical cords taped to marble walls, exposed plumbing piping, surface-mounted public address speakers, public telephone booths and altered light fixtures are common occurrences throughout the building.

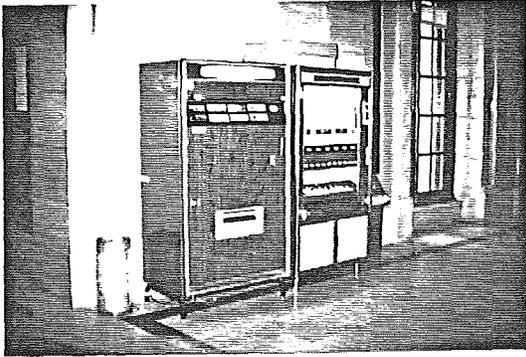
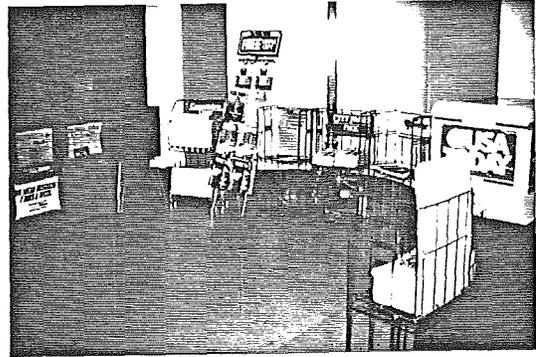
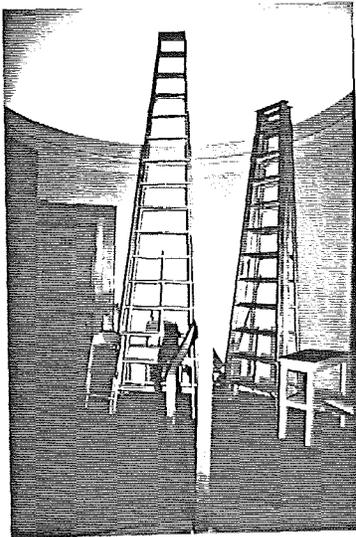
Examples of Other Intrusive Elements

receptacles be selected for use in the building that is in character with the historic interior.
