A Watershed Management Procedure

Forest Service
Northern Region

STREAM REACH INVENTORY AND CHANNEL STABILITY EVALUATION

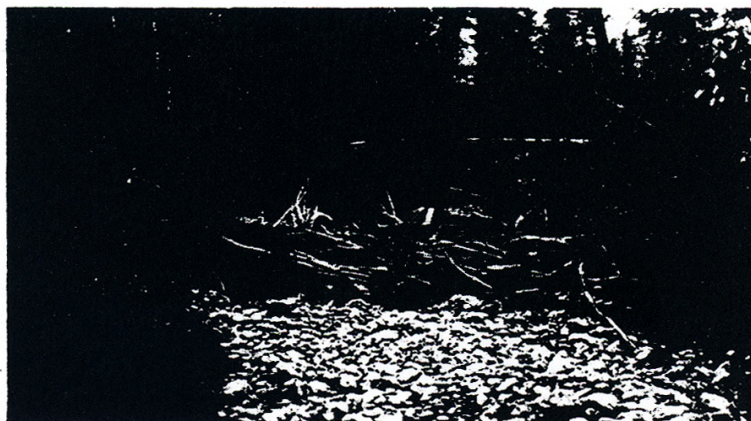
A series of debris jams of small size materials like the one shown in the center of this photo cause this item to be rated "Poor".

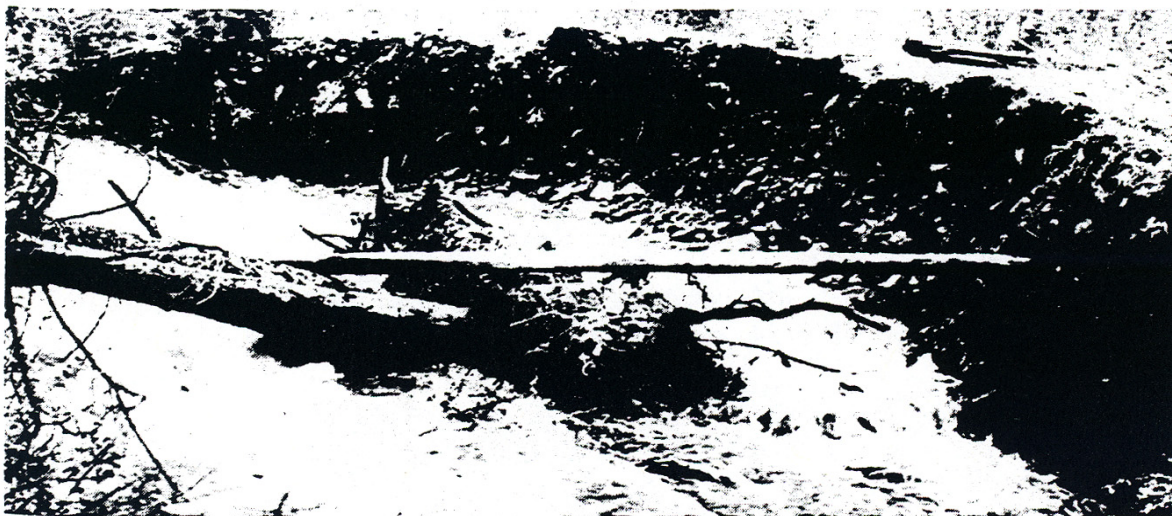
*Same location as shown on page 14, but looking upstream.
Obstruction like this could become the nucleus of a debris jam.*

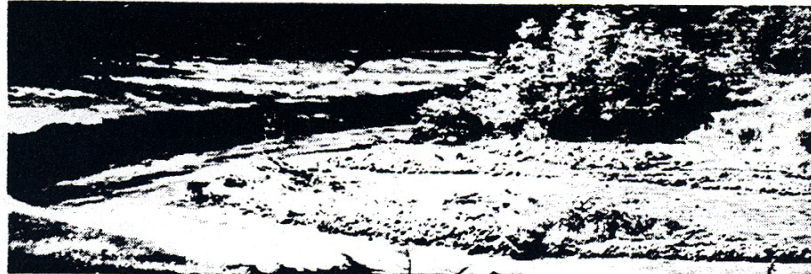
Poor bank conditions at this bend are evident.

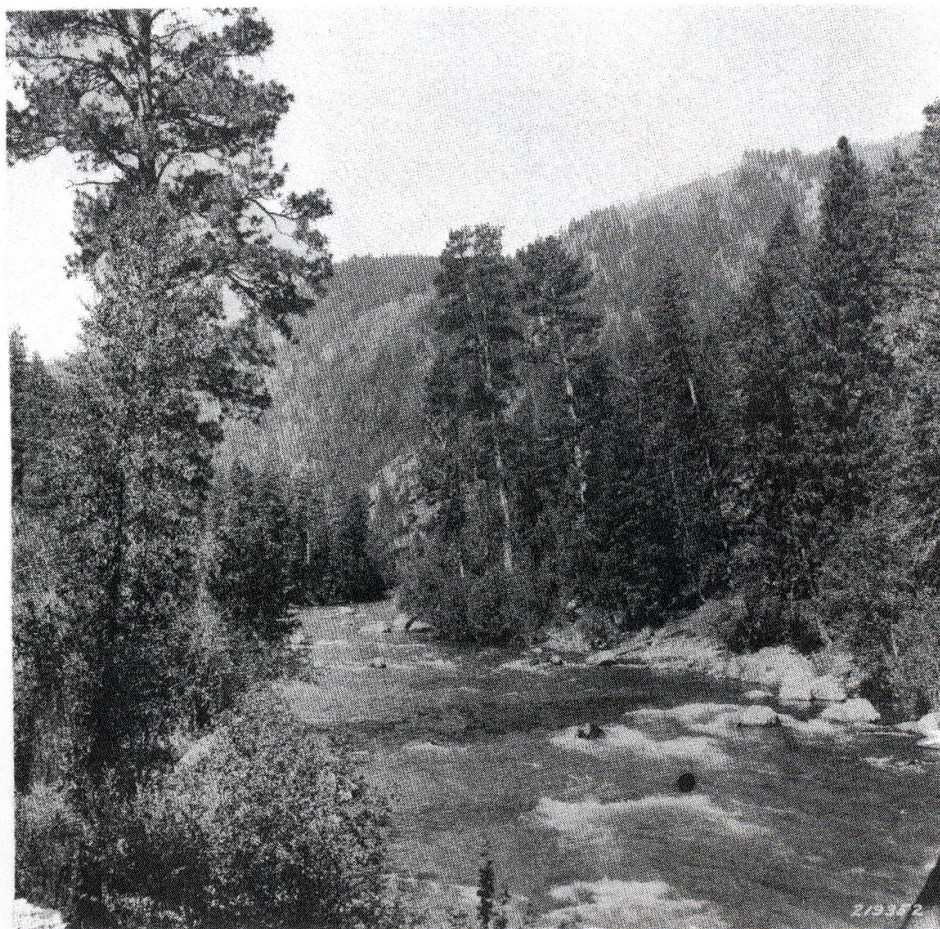
*This large stream channel reach
would be rated "excellent" overall.*
