NorthMet Project

Geotechnical Data Package

Volume 2 - Hydrometallurgical Residue Facility

Version 5

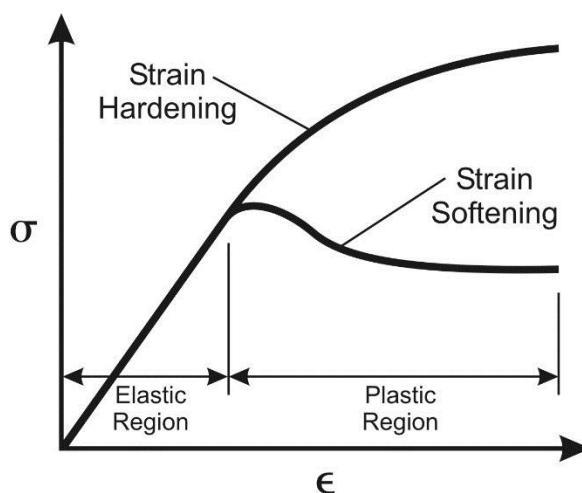
Figure 4-2 Modified Cam-Clay (MCC) Stress-Strain Diagram

The MCC constitutive model is an elasto-plastic strain hardening/softening model. The MCC constitutive model is most appropriately applied to saturated normally to slightly over-consolidated soils, which experience significant non-reversible volume changes when compressed (Reference (18)). Residue, LTVSMC fine tailings, LTVSMC slimes, LTVSMC slimes - wick, compressed peat, and compressed peat - wick were assigned MCC parameters. Figure 4-2 illustrates the stress (σ) strain (ϵ) relationship in a MCC material model.

There are two distinct regions of the MCC constitutive model: (1) an elastic region at lower strains and (2) a plastic region at higher strains. The term elastic relates to non-permanent deformation; a material will spring back to its initial shape. The plastic region of the stress-strain curve is the range of higher strain values that will cause permanent deformation in a material. The transition between these regions is termed the yield point. Moving to the right of the yield point, the additional strain will cause an increase in stress (strain hardening) or a decrease in

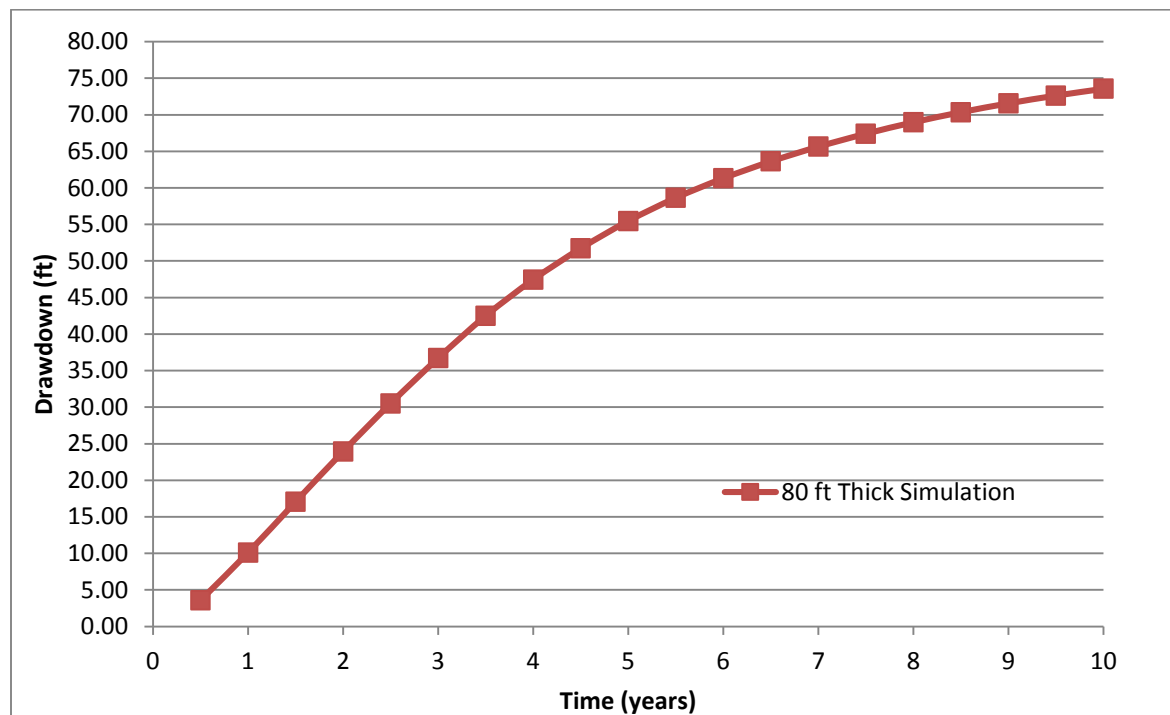
Figure 6-1 HRF Dewatering: Hydraulic Head Drawdown vs. Time at 125 Foot Drain Spacing

With this configuration and based on a maximum Residue depth of approximately 80 feet, the cells should be effectively dewatered within approximately 10 years of the cessation of Residue discharge into the HRF. A check of this time estimate can be made using Darcy's Law for velocity using Equation 4-1. Based on a permeability of 5.5×10^{-6} cm/sec (Table 4-1) and an 80 foot flow path, the estimated time for drainage to occur through the 80 foot column of residue is approximately 14 years (5113 days); a value commensurate with the 10 year (3652 day) estimate from the MODFLOW model. These dewatering calculations assume drainage only through the geocomposite drainage collection layer. The calculations ignore drainage through the overlying layer of LTVSMC Coarse Tailings. This means that drawdown may be more rapid than modeled for an 80-foot column of residue.

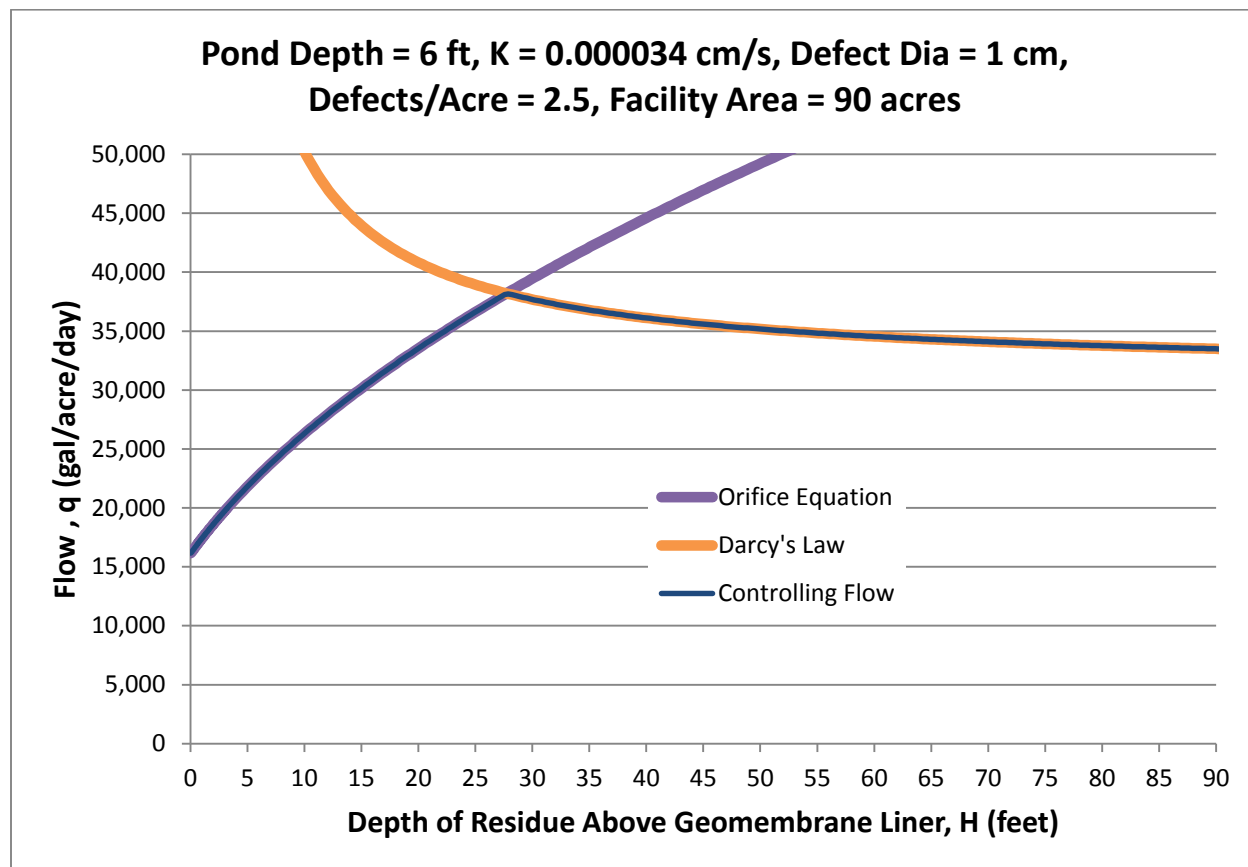
Figure 6-2 HRF Dewatering: Hydraulic Head Drawdown vs. Time

Leakage flow is constrained by the limitations on flow through liner defects (the orifice equation) and by the hydraulic conductivity of the Residue (Darcy's law). Figure 6-2 is an example plot of leakage flow based on the orifice equation and Darcy's Law at different Residue depths. When Residue is shallower, flow is constrained by the inability of liner defects to transmit an unlimited amount of flow, so the controlling flow line (the dark blue line) follows the orifice equation (purple line). However, as the Residue depth increases, a point is reached where flow becomes constrained by the hydraulic conductivity of the Residue, which controls the rate at which liquid can move through and drain from the Residue (the orange line). From that point, the controlling flow line follows Darcy's Law (the orange line). The Drainage Collection System is designed to collect the leakage flow as shown by the dark blue controlling flow line.

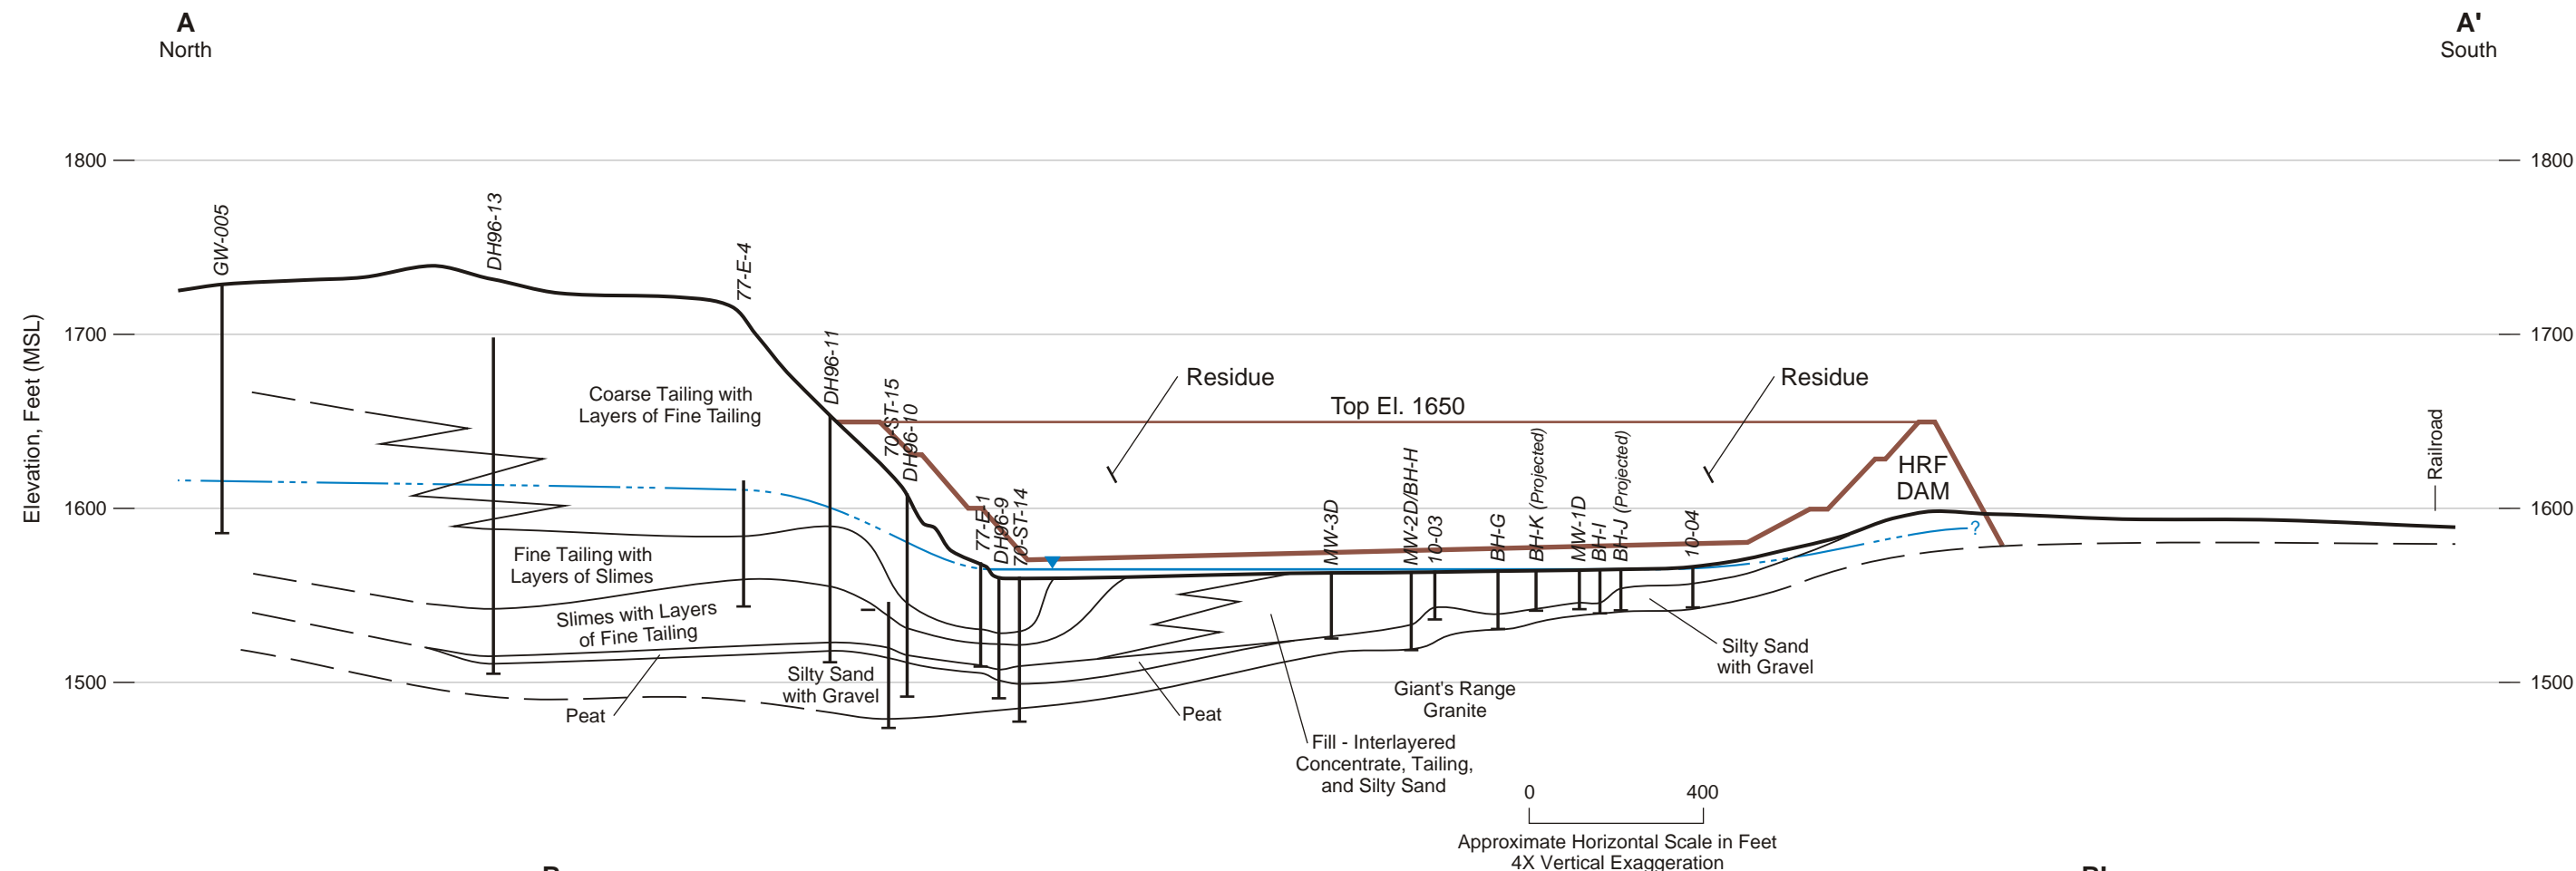
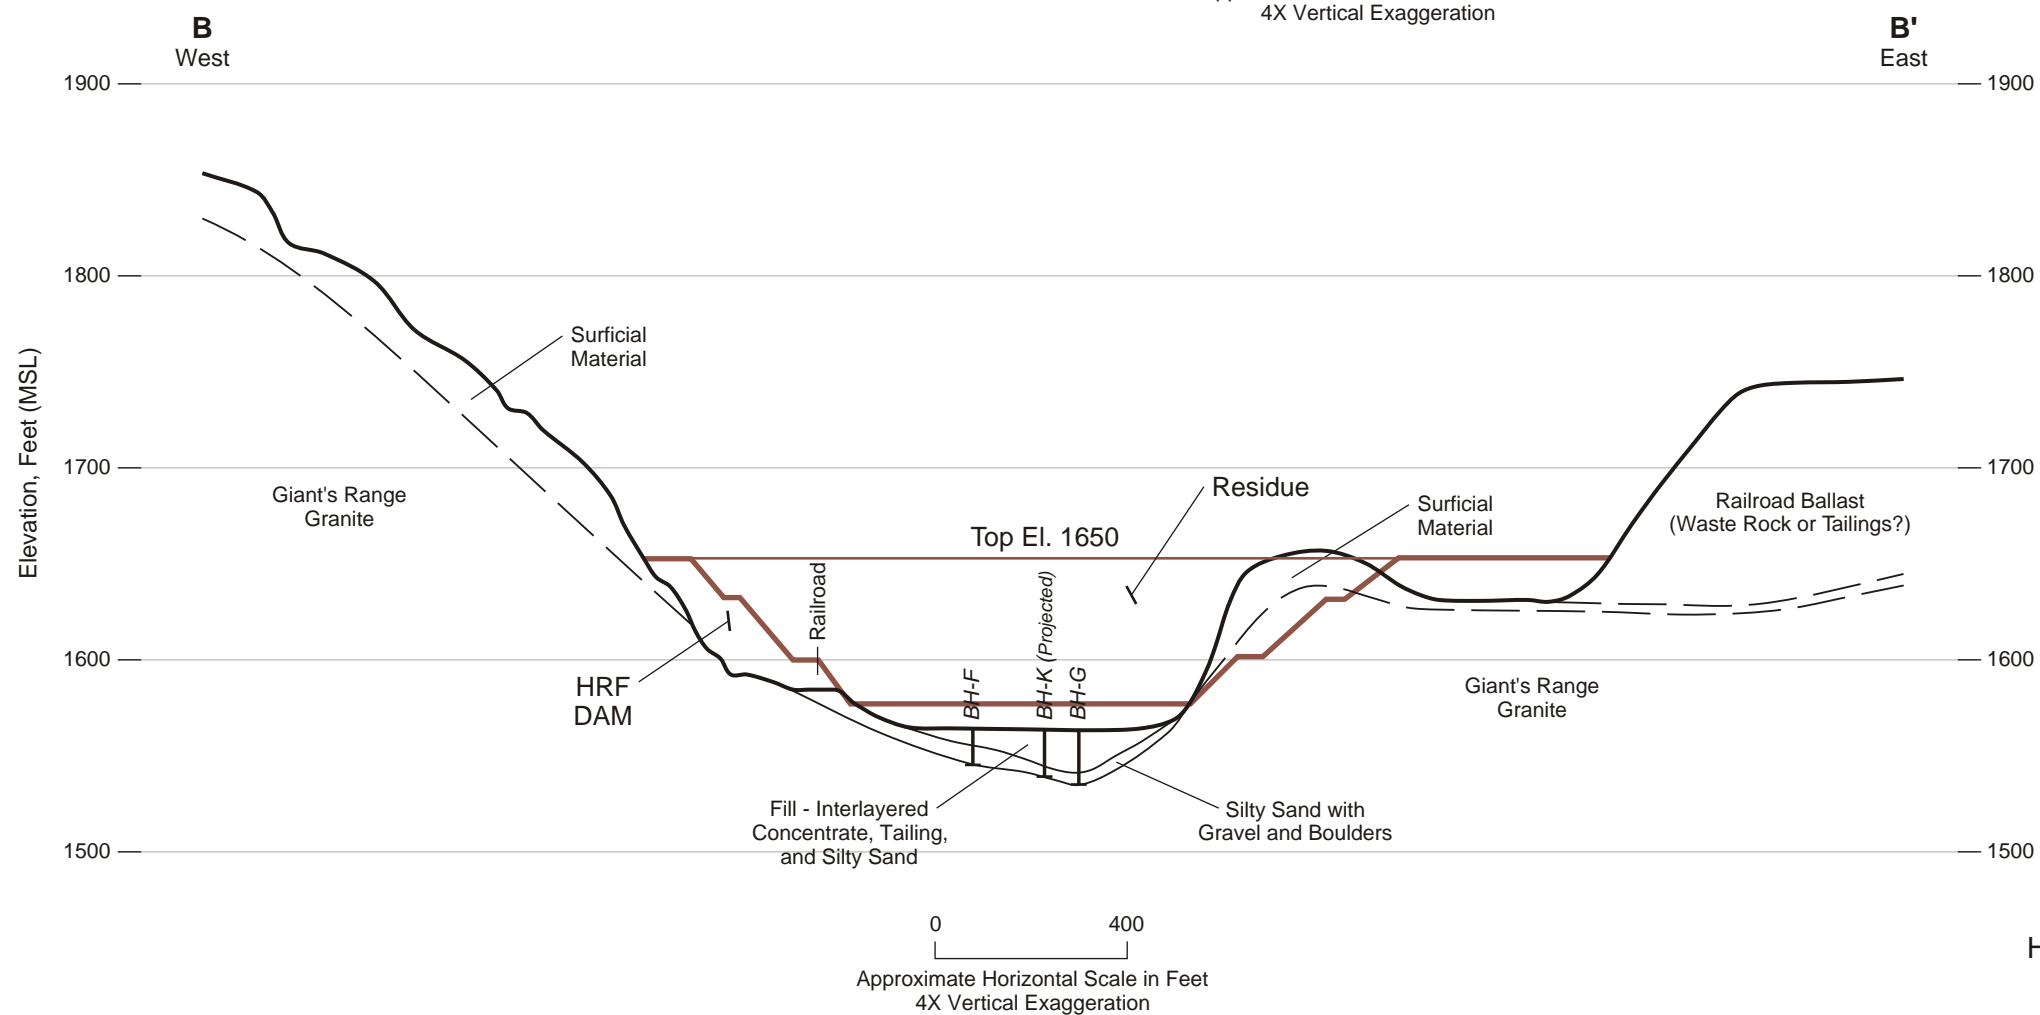
Large Figure 6

HRF GEOLOGIC CROSS SECTIONS
A-A' AND B-B'

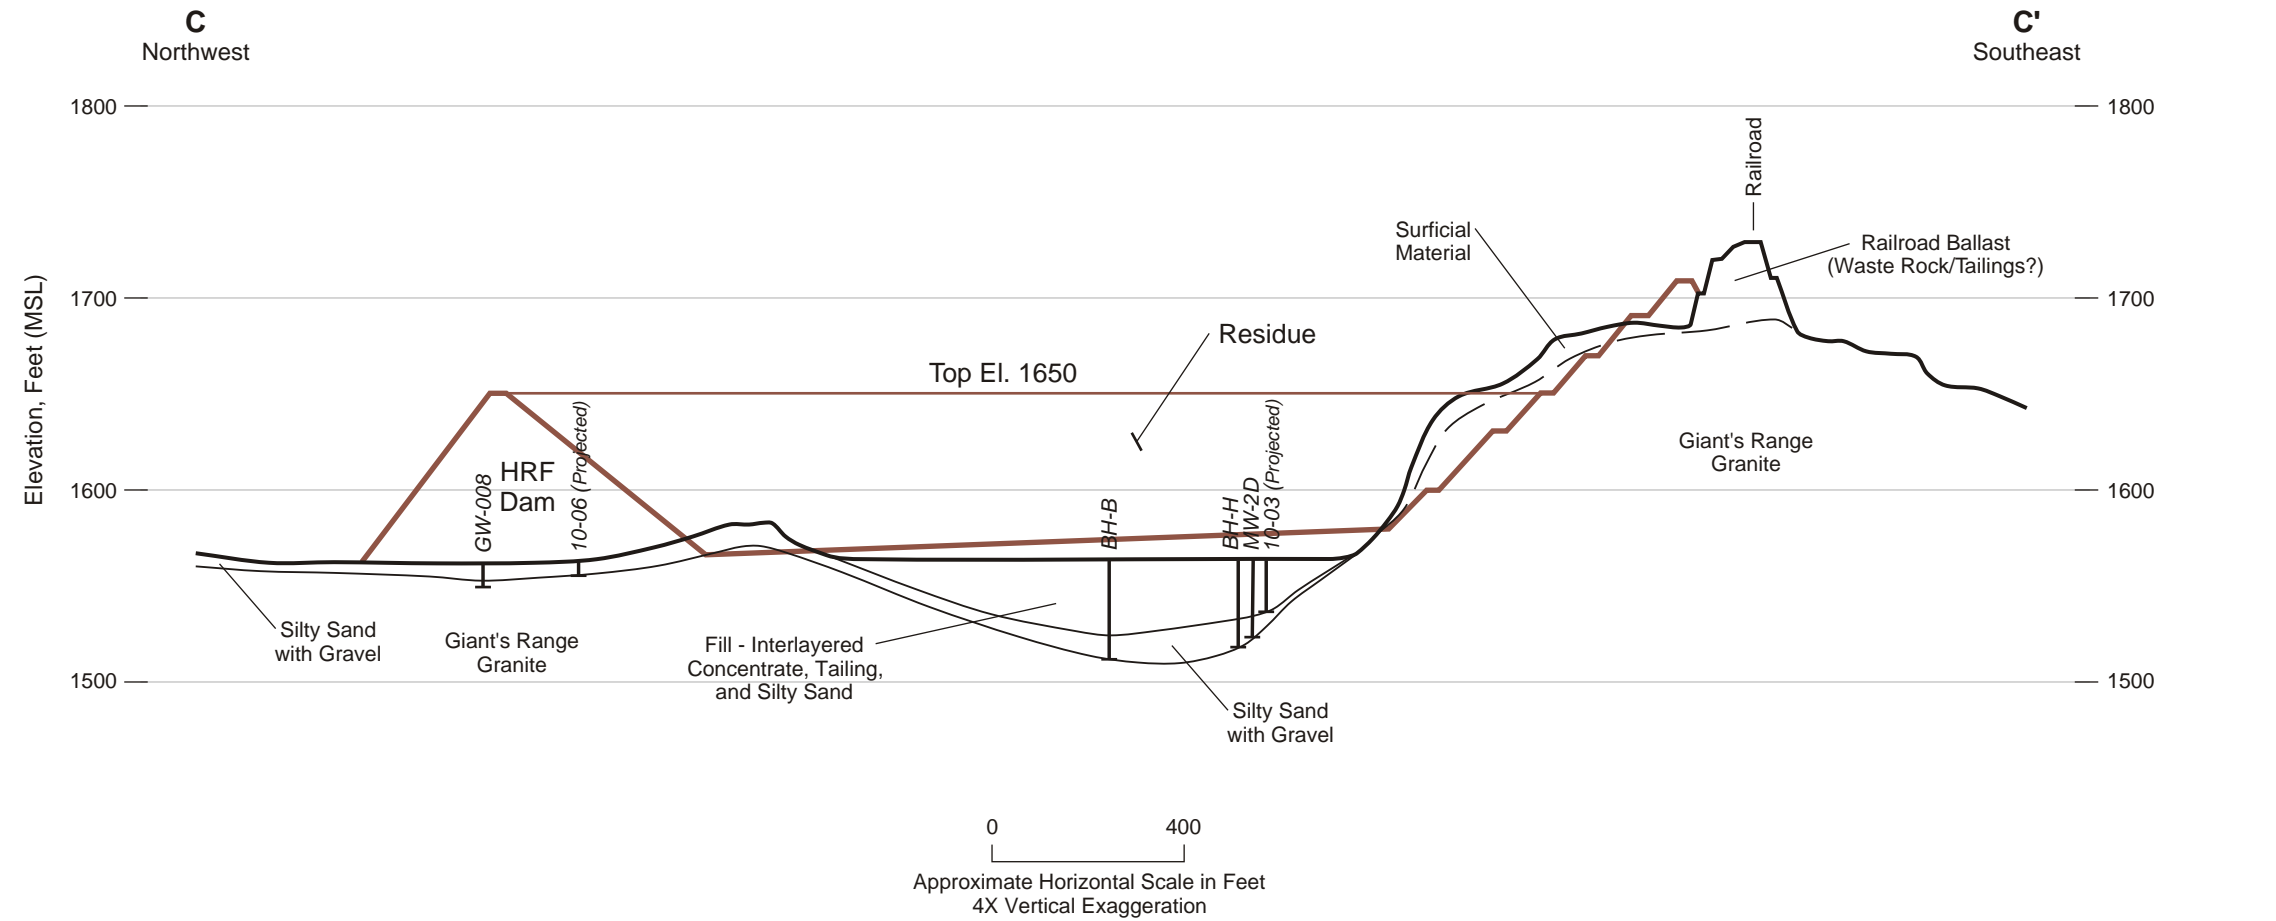
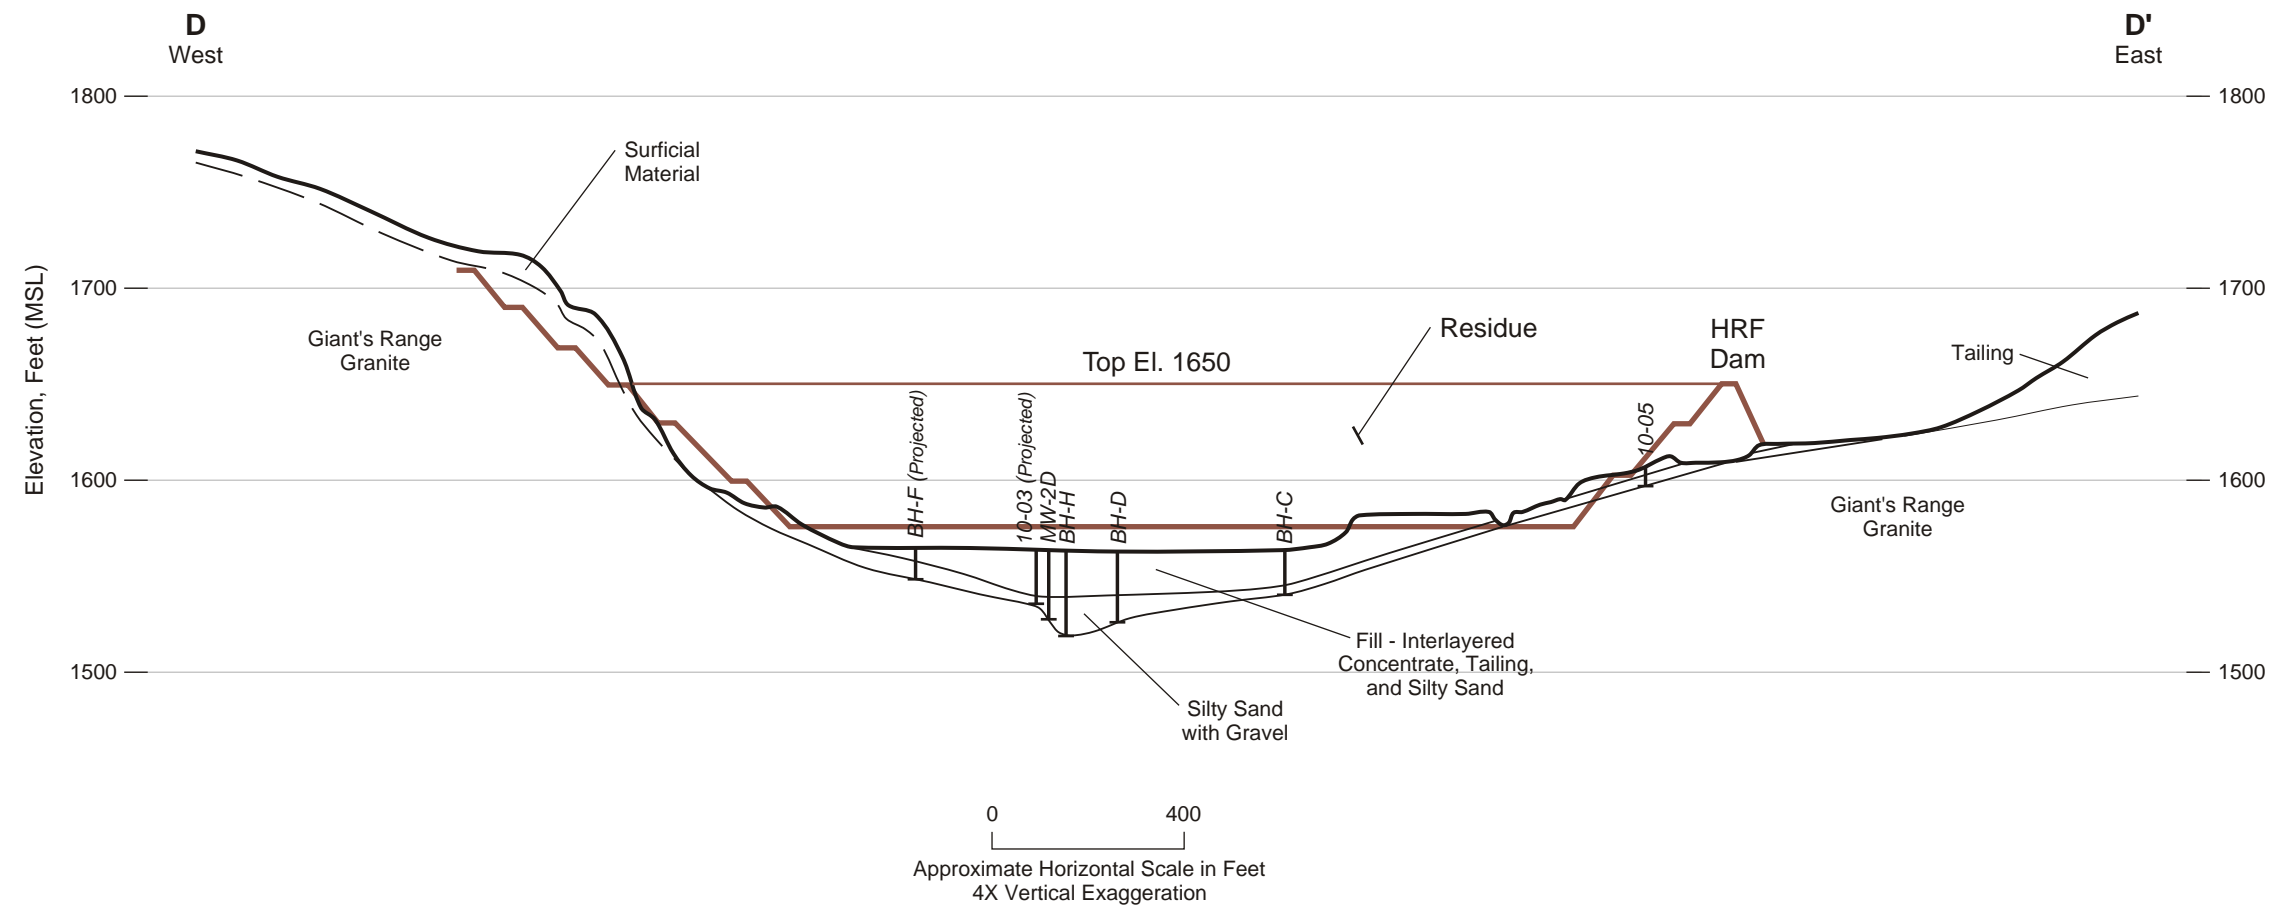
Large Figure 7
HRF GEOLOGIC CROSS SECTIONS
C-C' AND D-D'

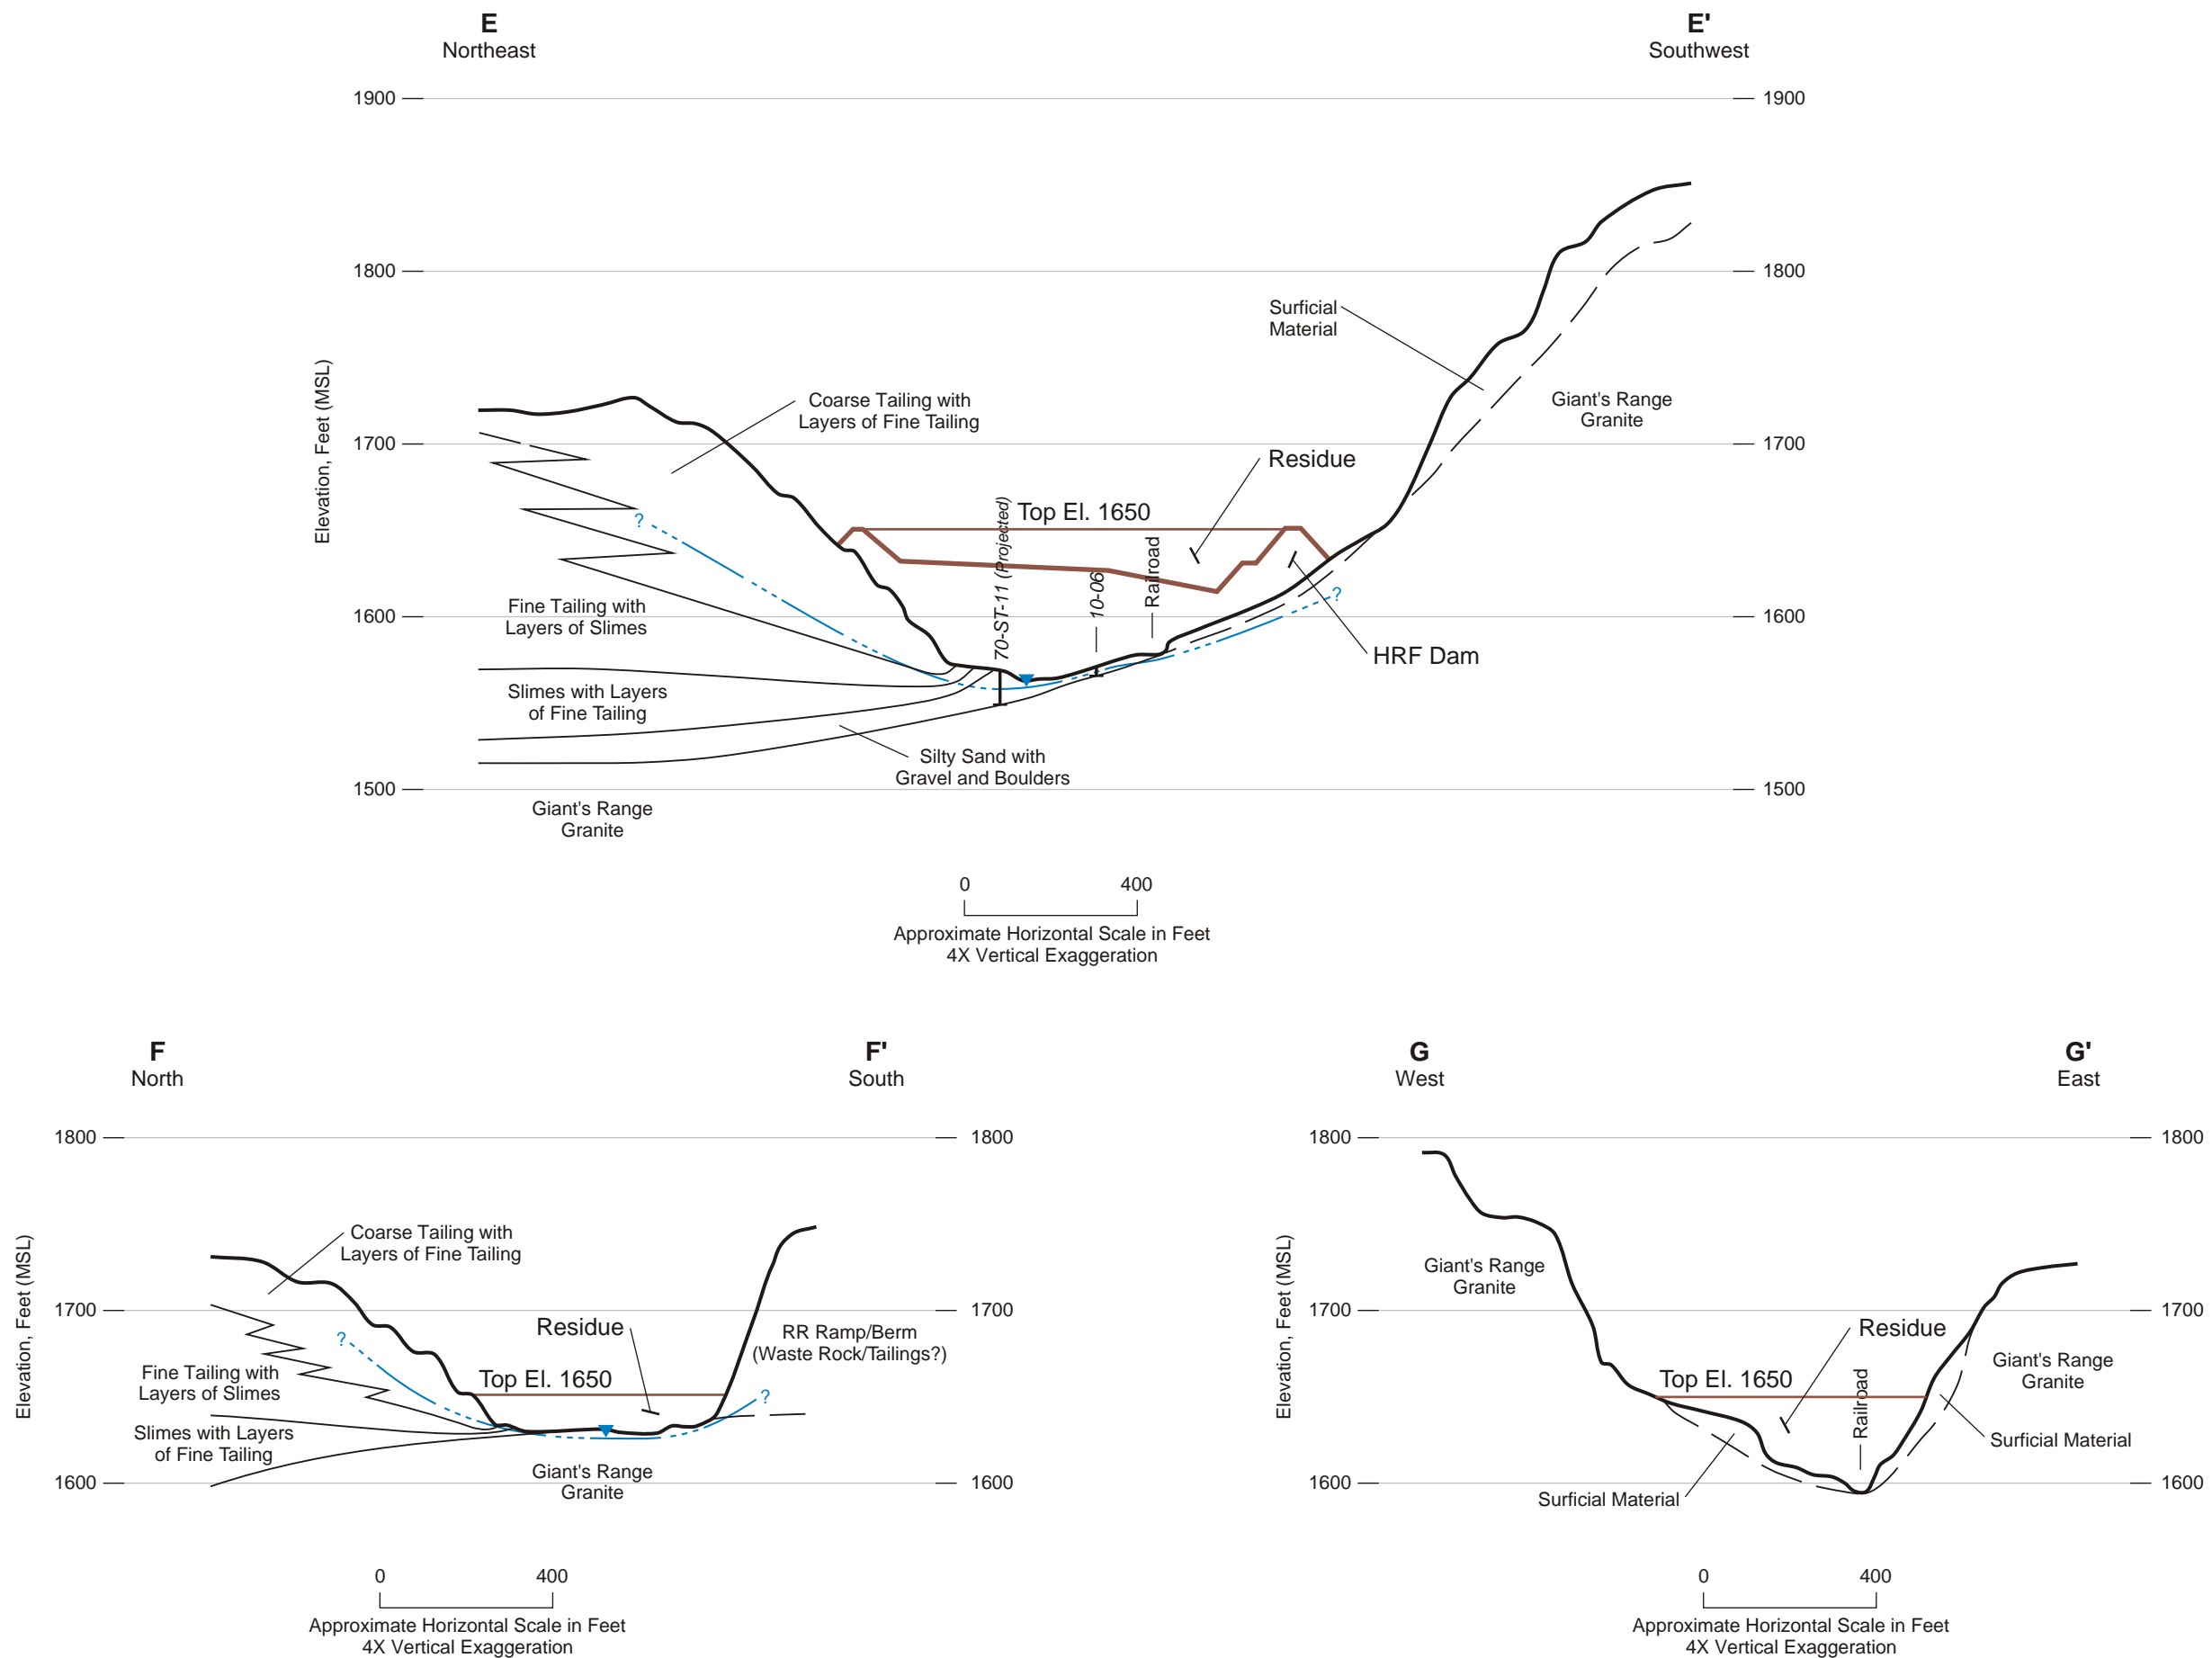
Large Figure 8
HRF GEOLOGIC CROSS SECTIONS
E-E', F-F' AND G-G'

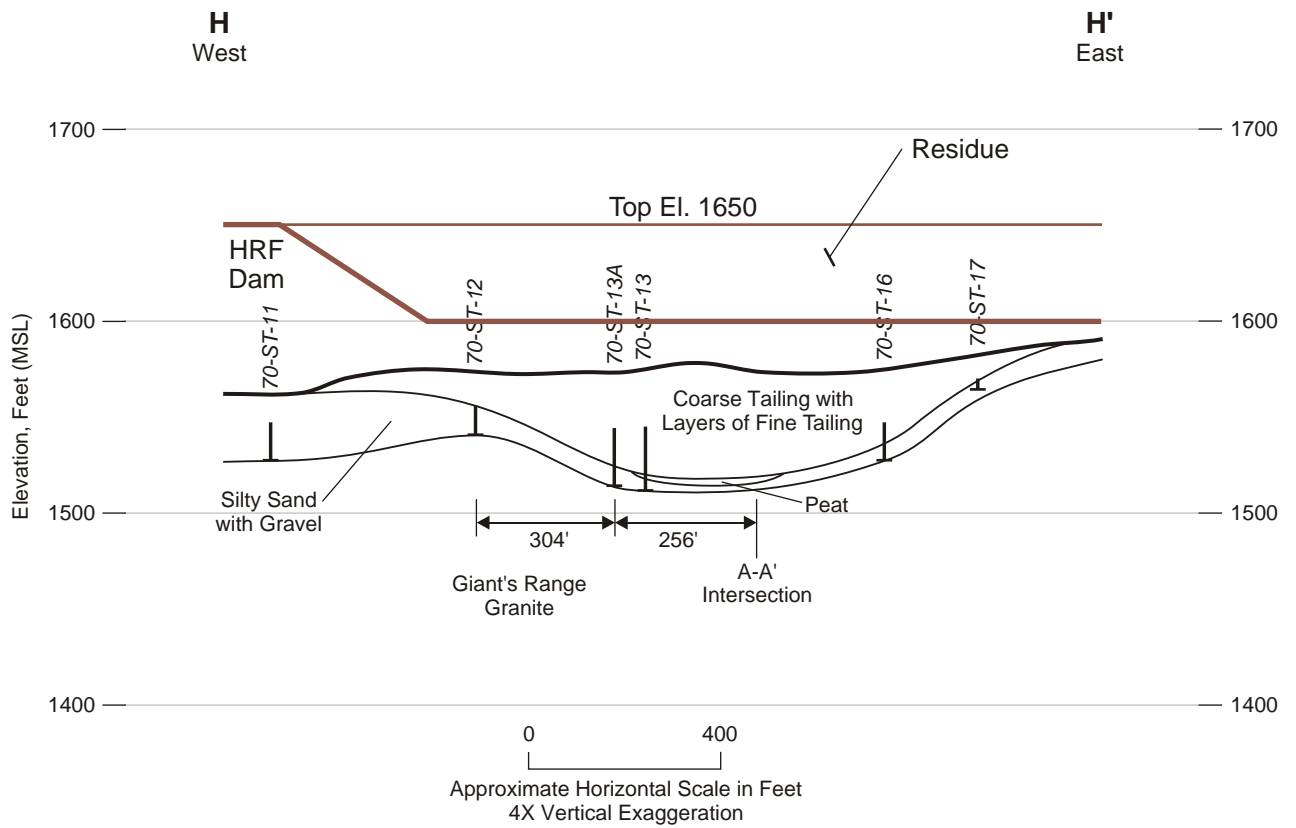
Large Figure 9

HRF GEOLOGIC CROSS SECTION H-H'

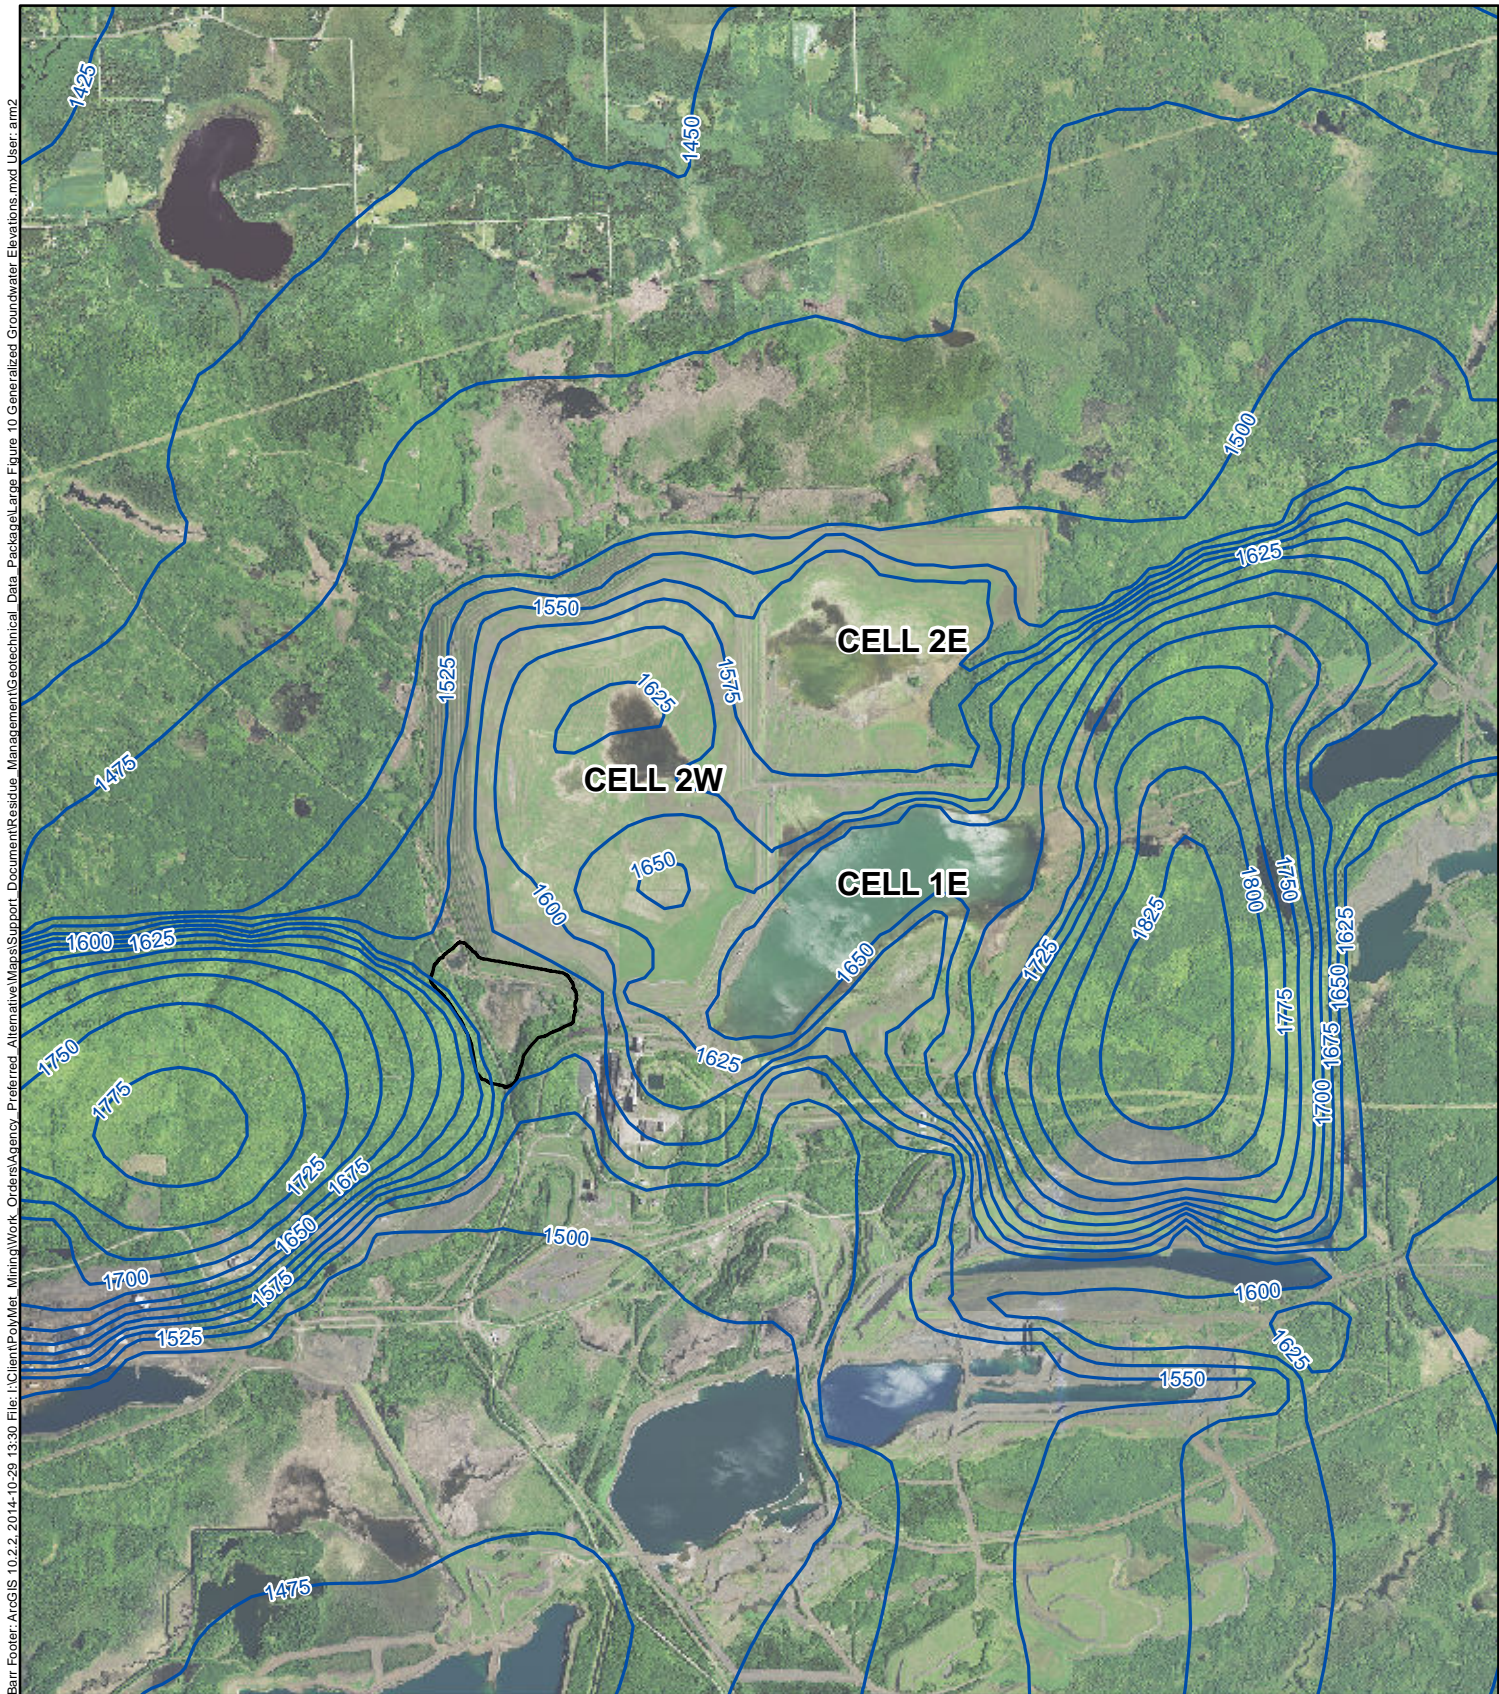
Large Figure 10
 HRF AREA GENERALIZED
 GROUNDWATER ELEVATIONS
 NorthMet Project
 PolyMet Mining Inc.
 Hoyt Lakes, MN

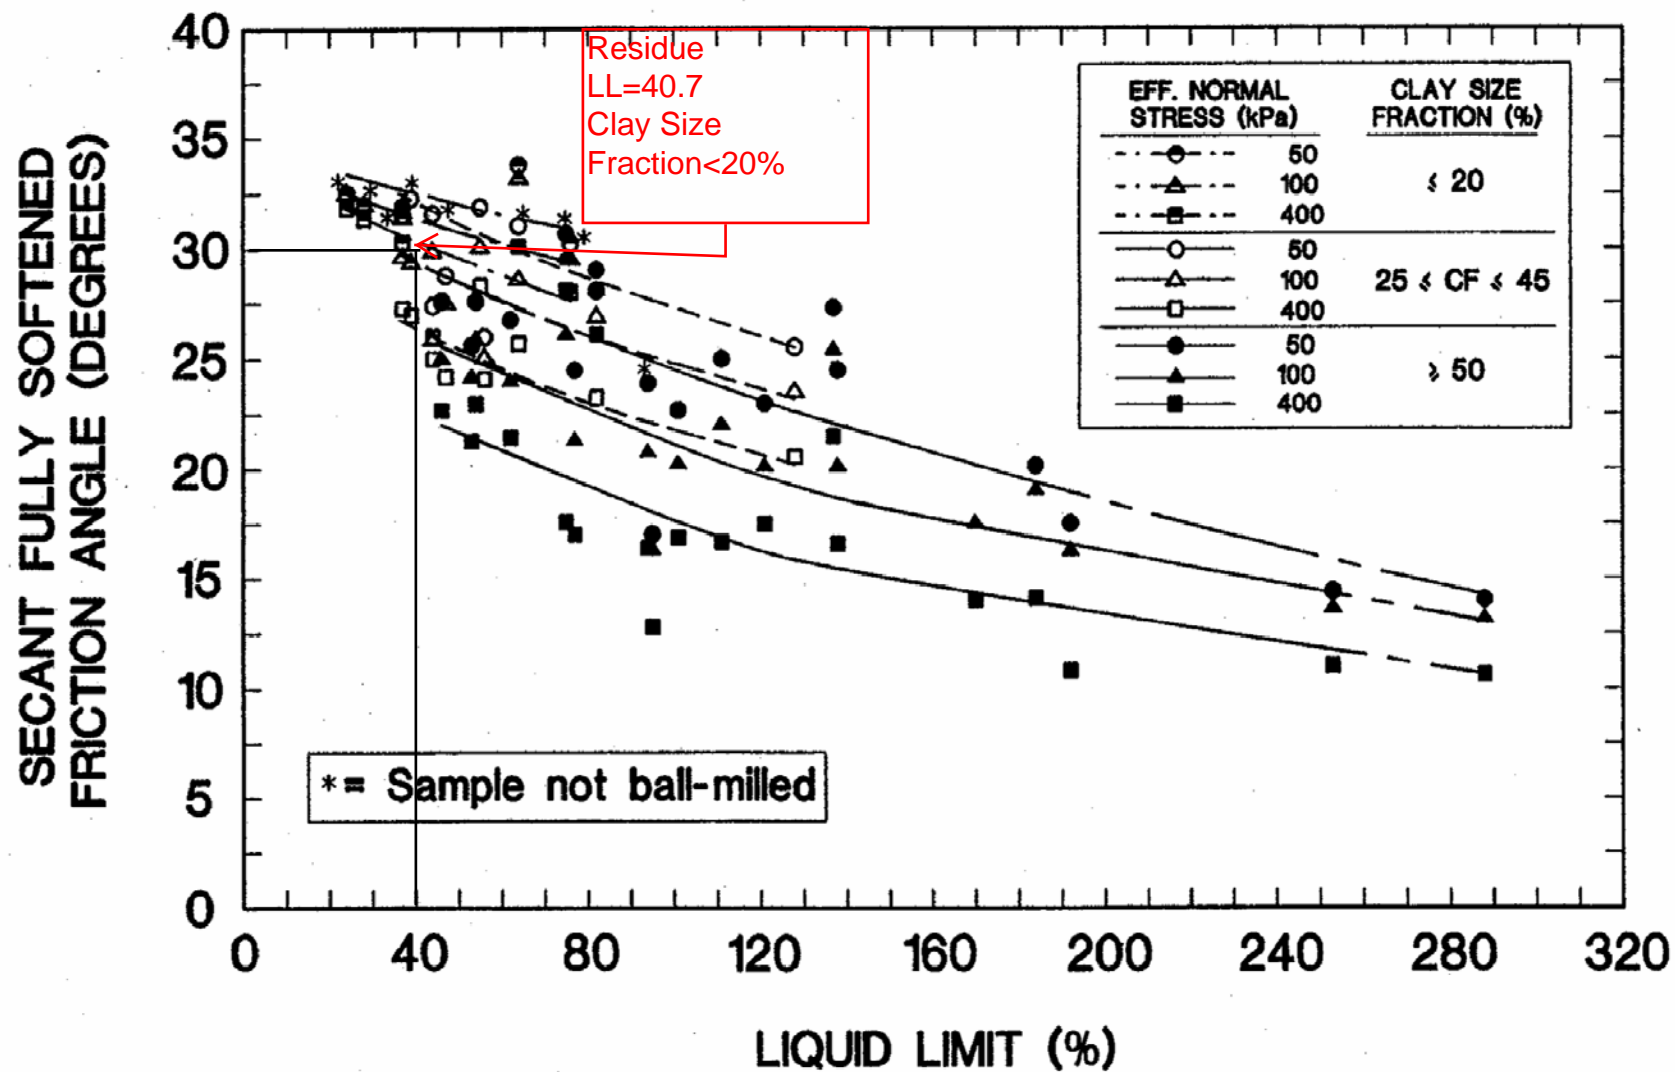
Large Figure 11. Revised Fully Softened Friction Angle Relationships with Liquid Limit, Clay-Size Fraction, and Effective Normal Stress (Stark and Eid, 1997).
