NorthMet Project

Geotechnical Data Package

Volume 2 - Hydrometallurgical Residue Facility

Version 5

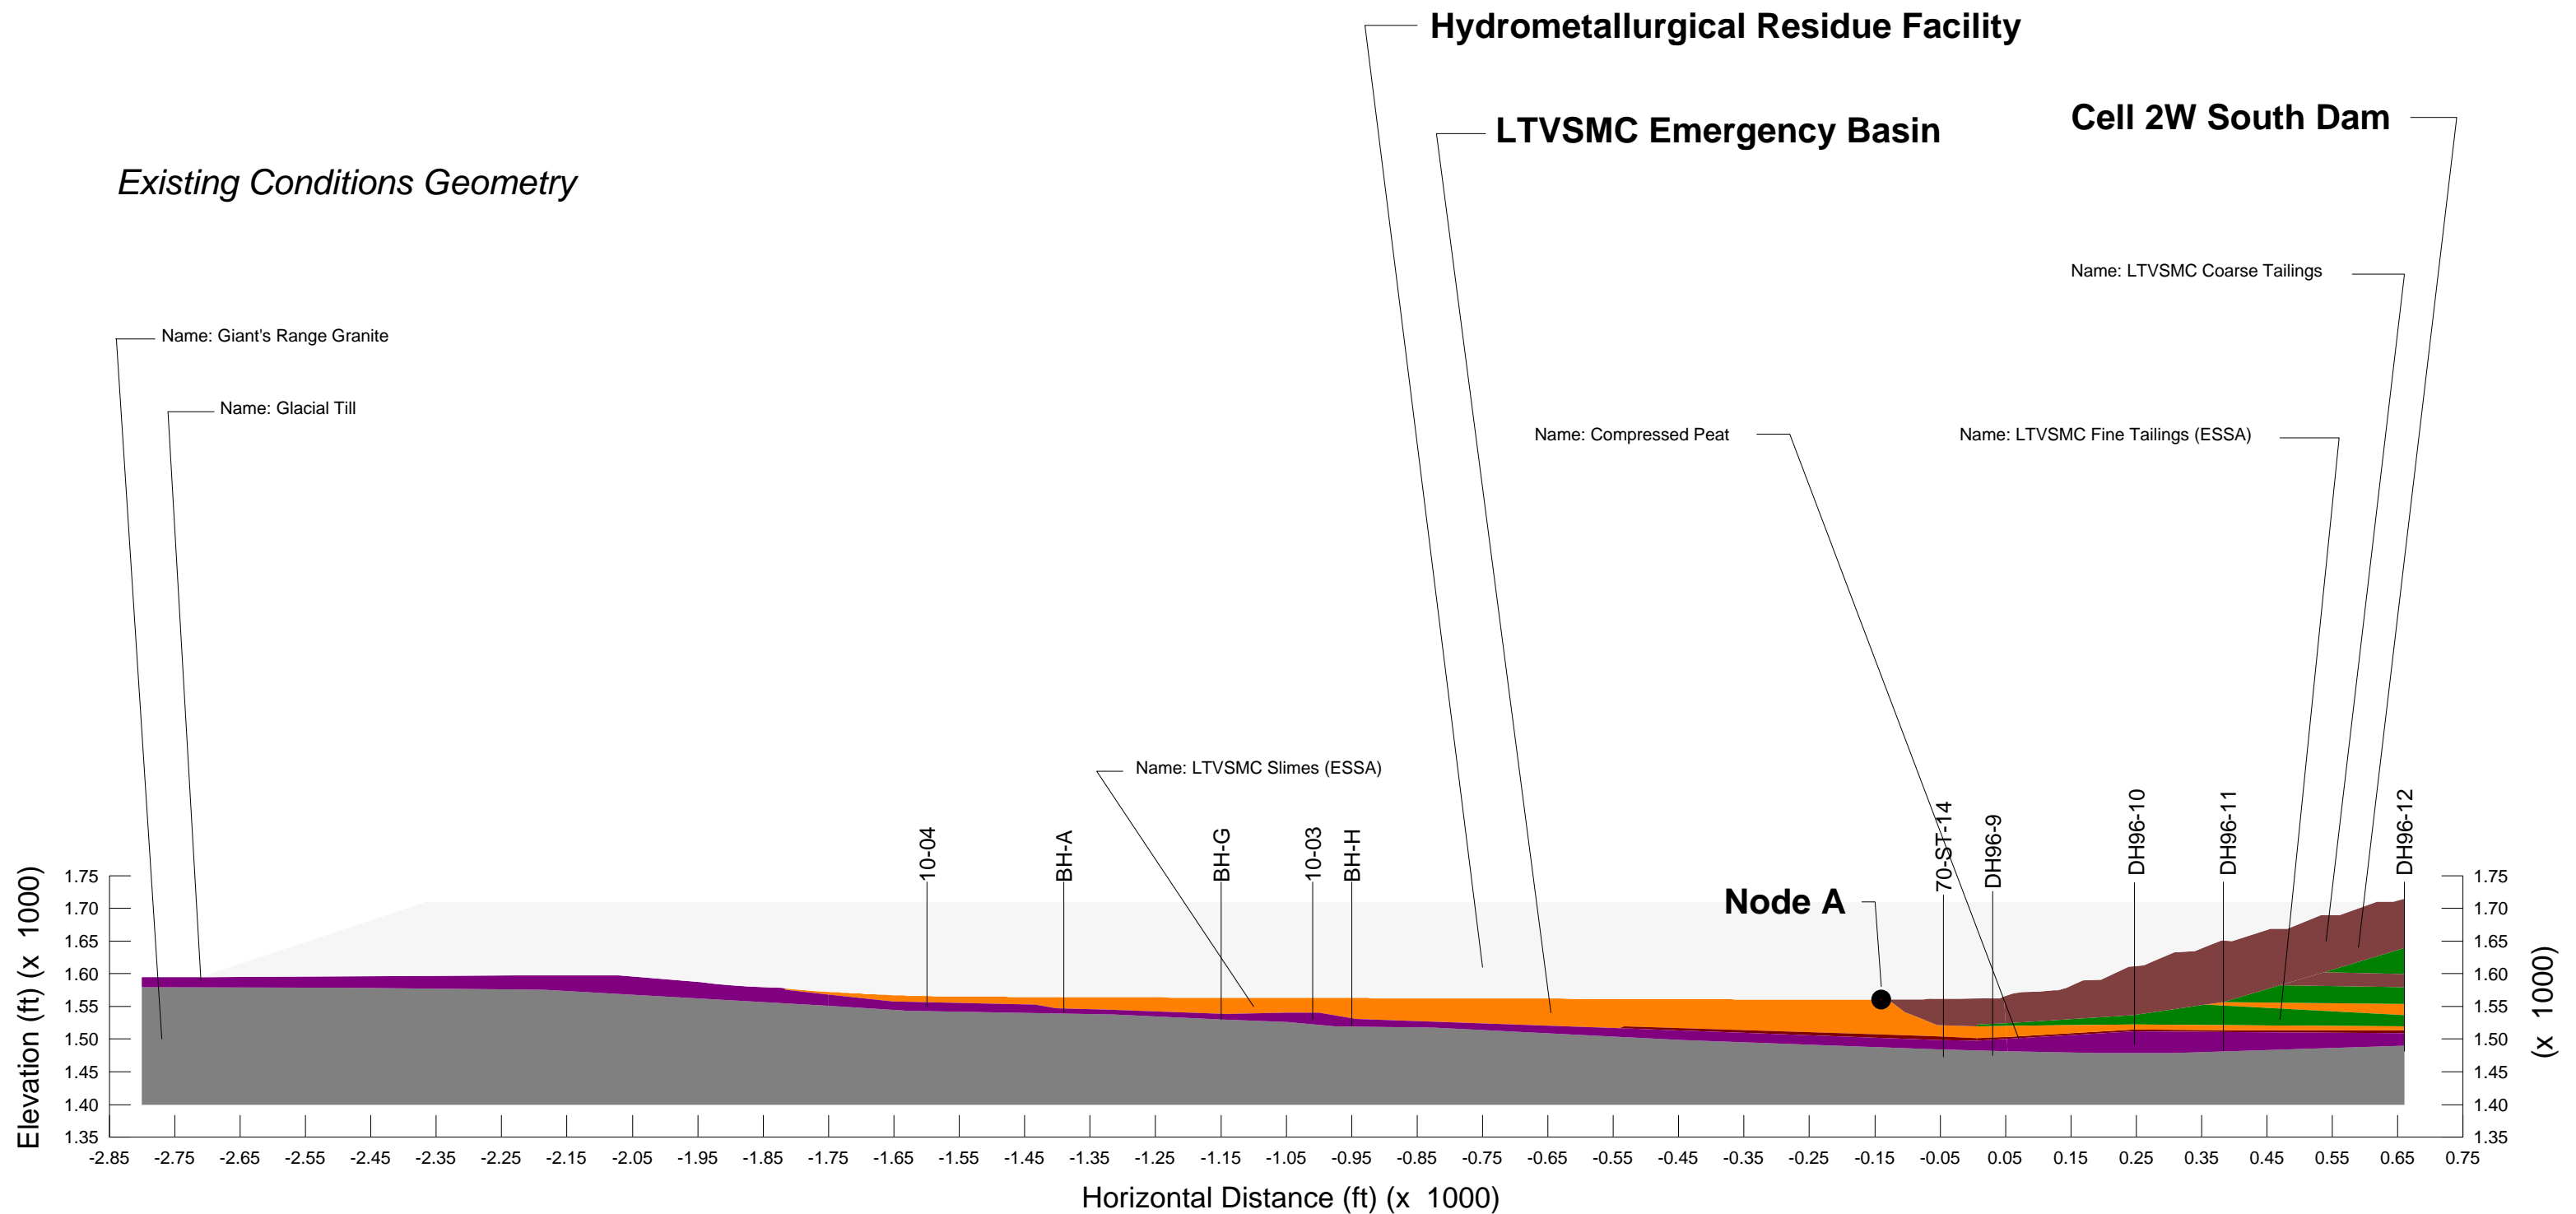
Large Figure 13
HRF End of Operation (Year 20)
Geometry A-A'

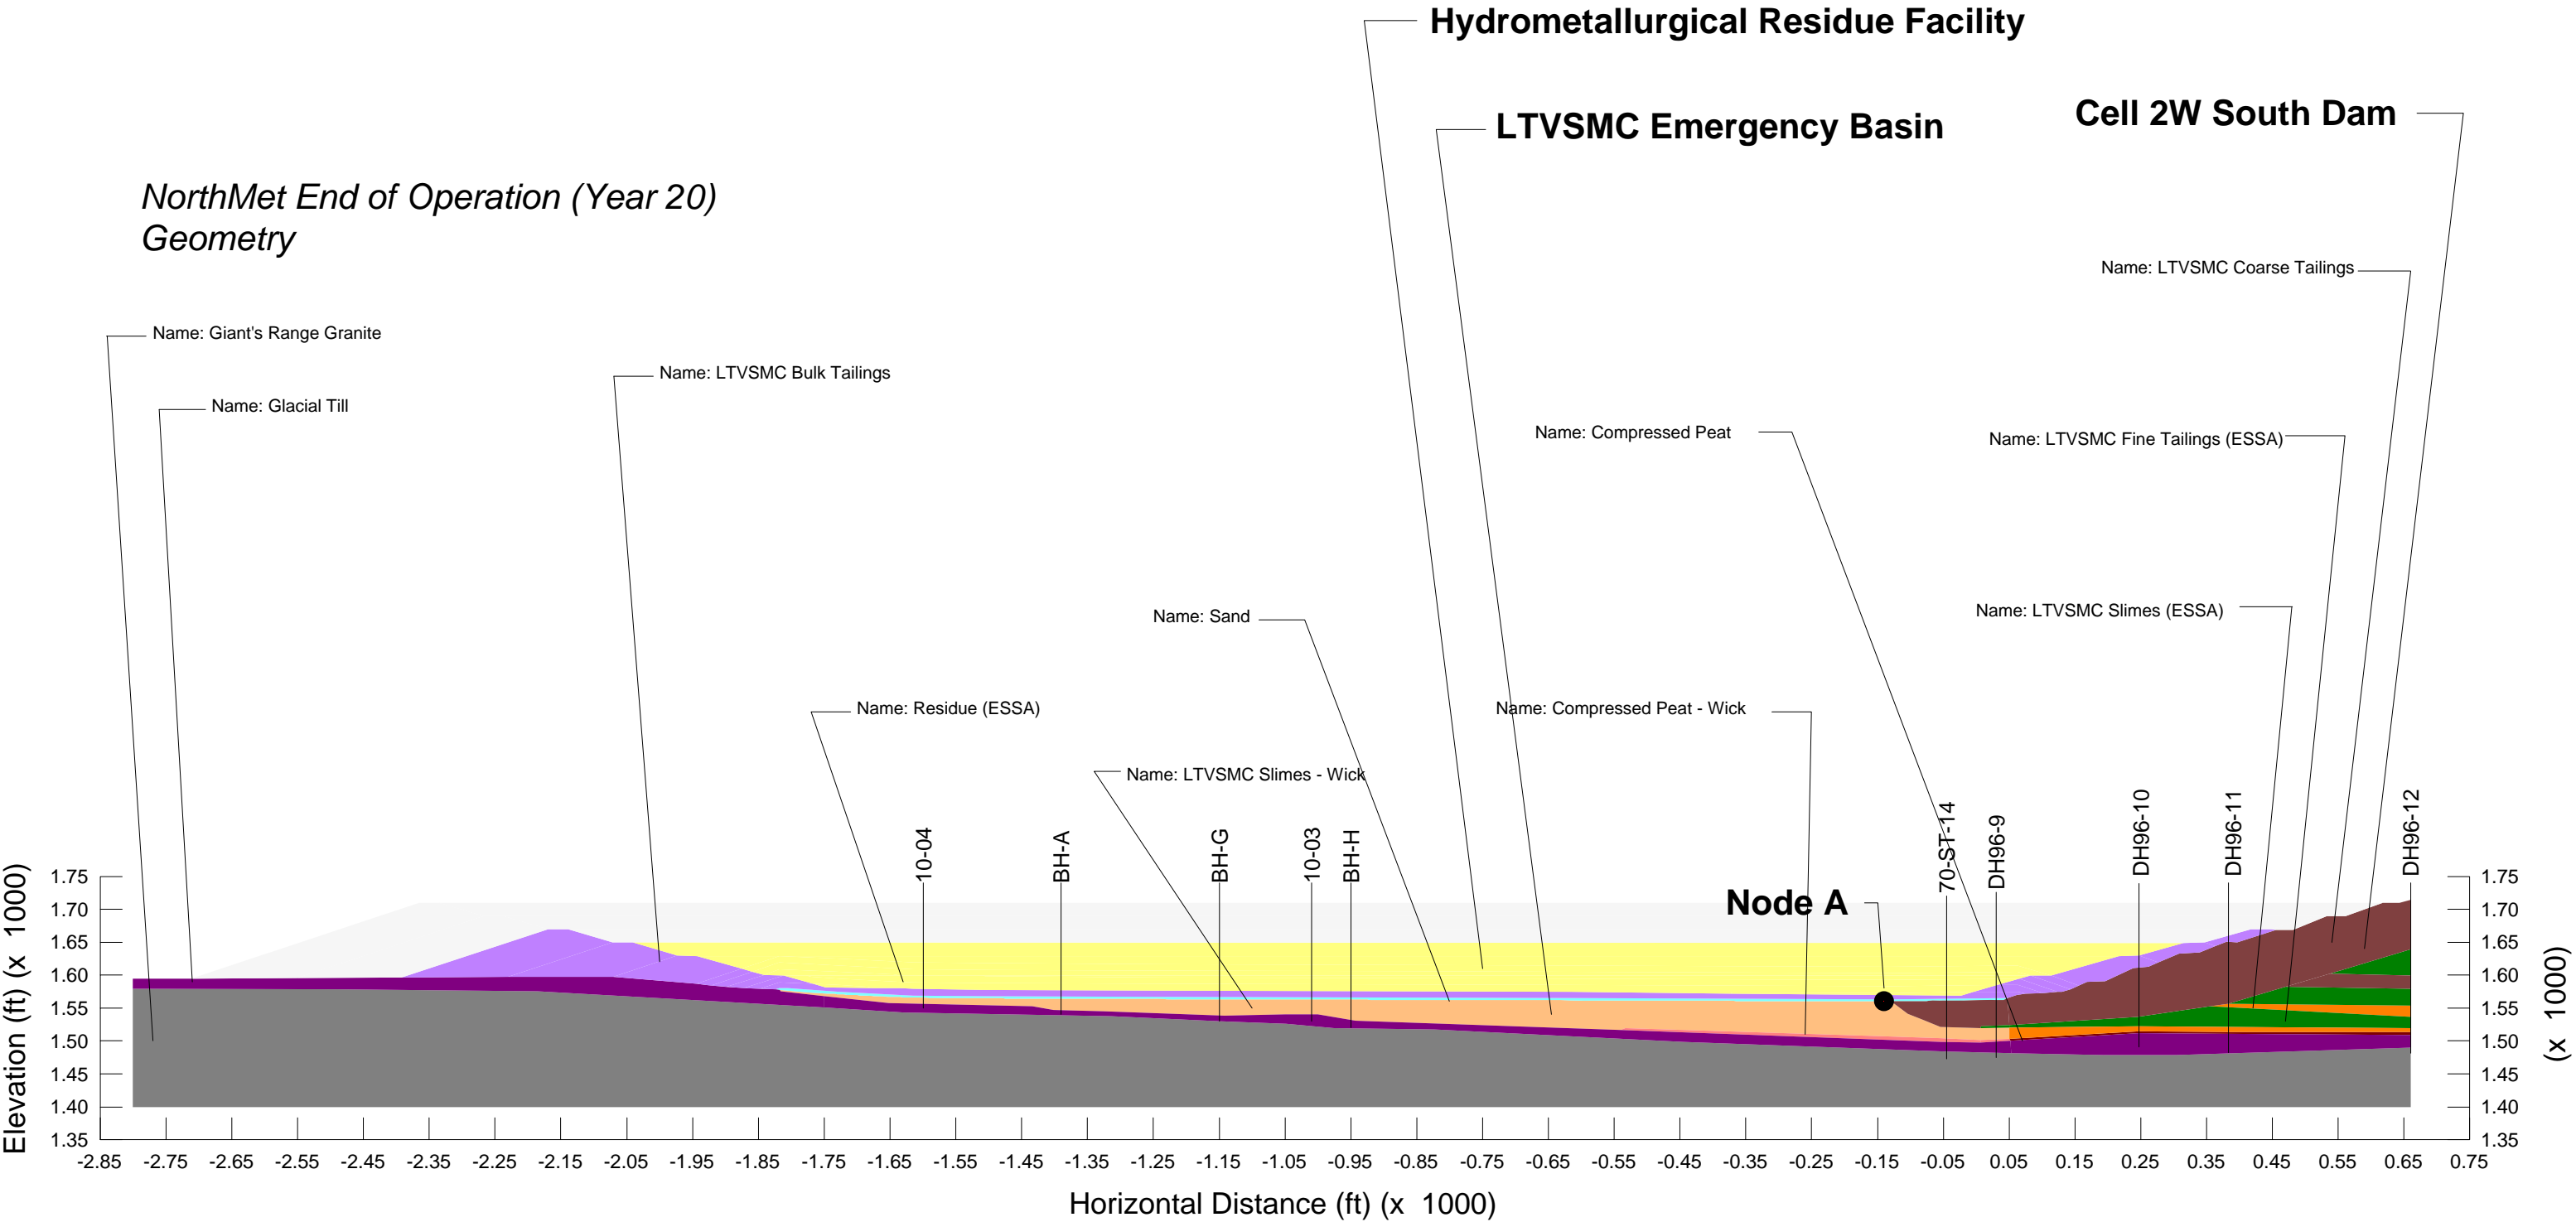
Large Figure 14
HRF End of Operation (Year 20)
Finite Element Mesh A-A'

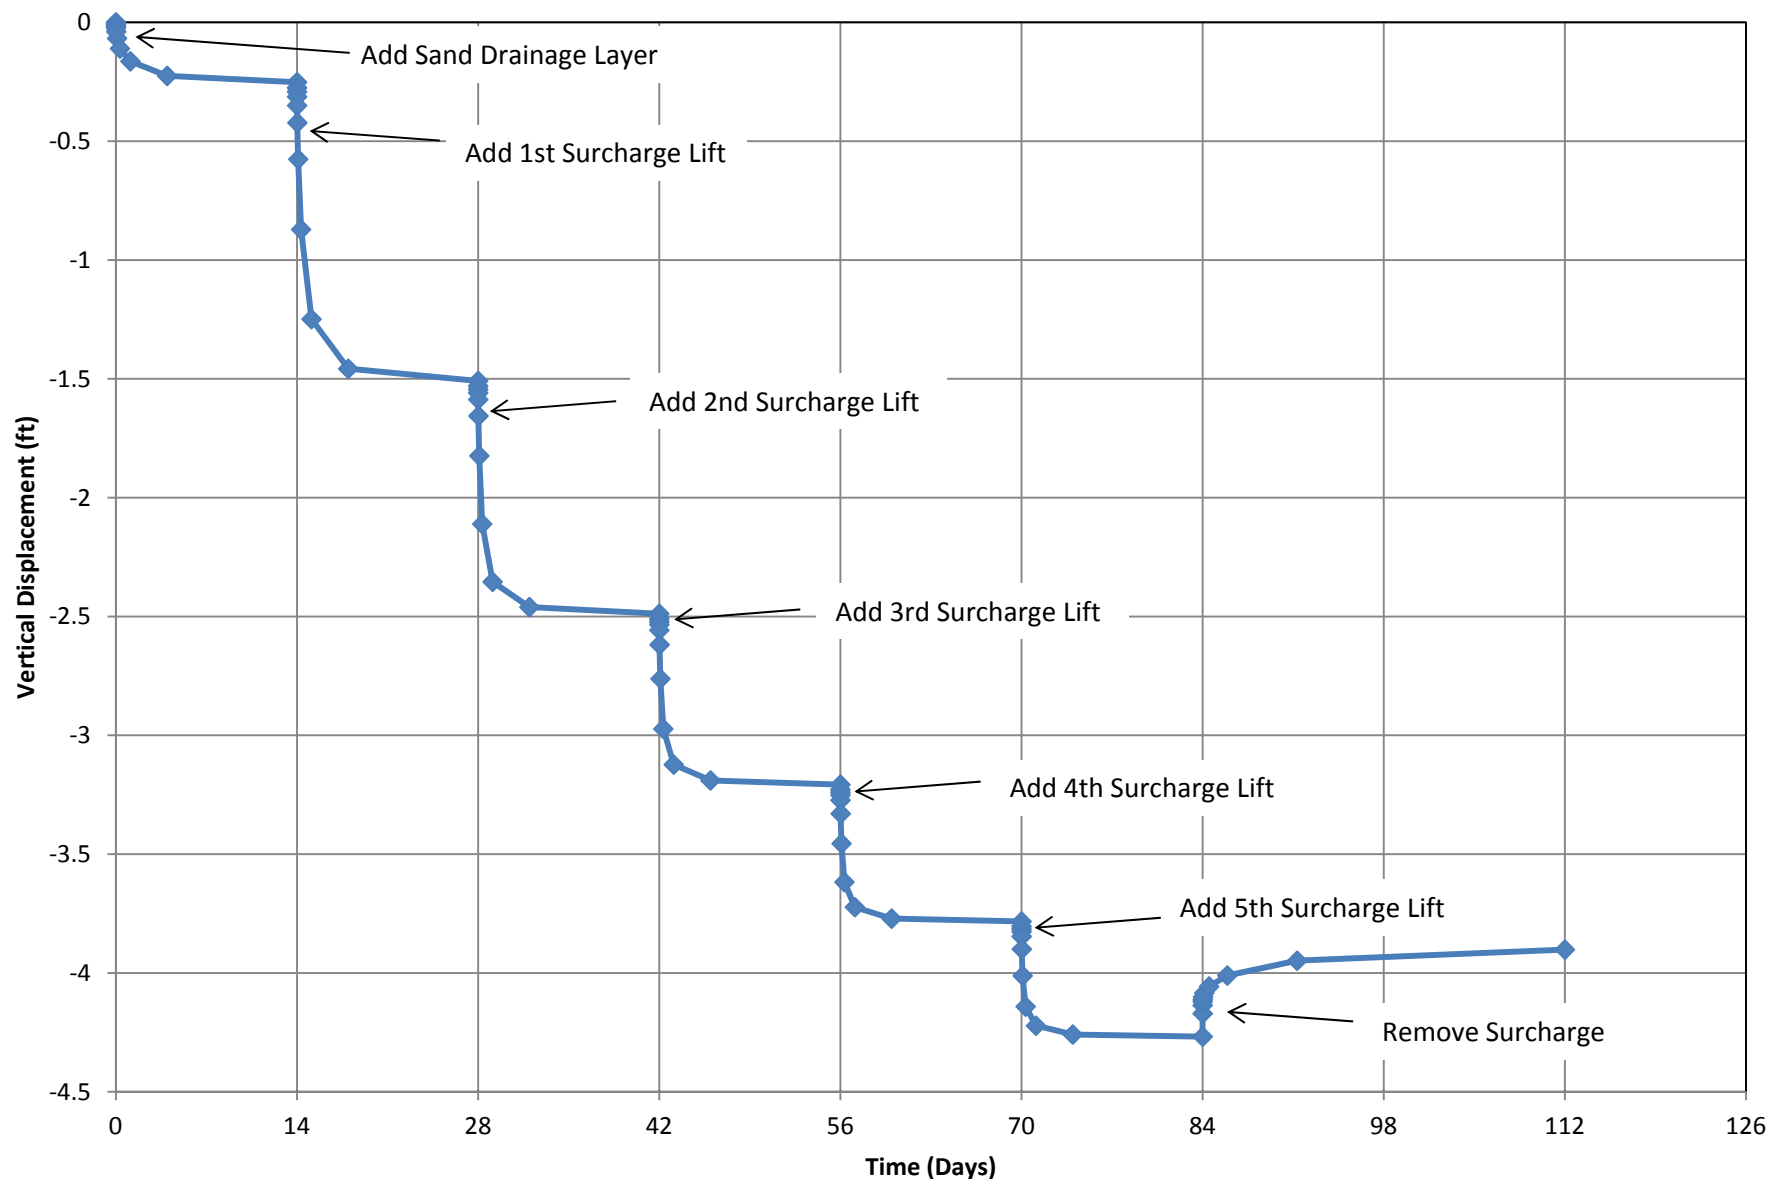
**Large Figure 21. Vertical Displacement at Node A after Removal of Surcharge
NorthMet Hydrometallurgical Residue Facility**

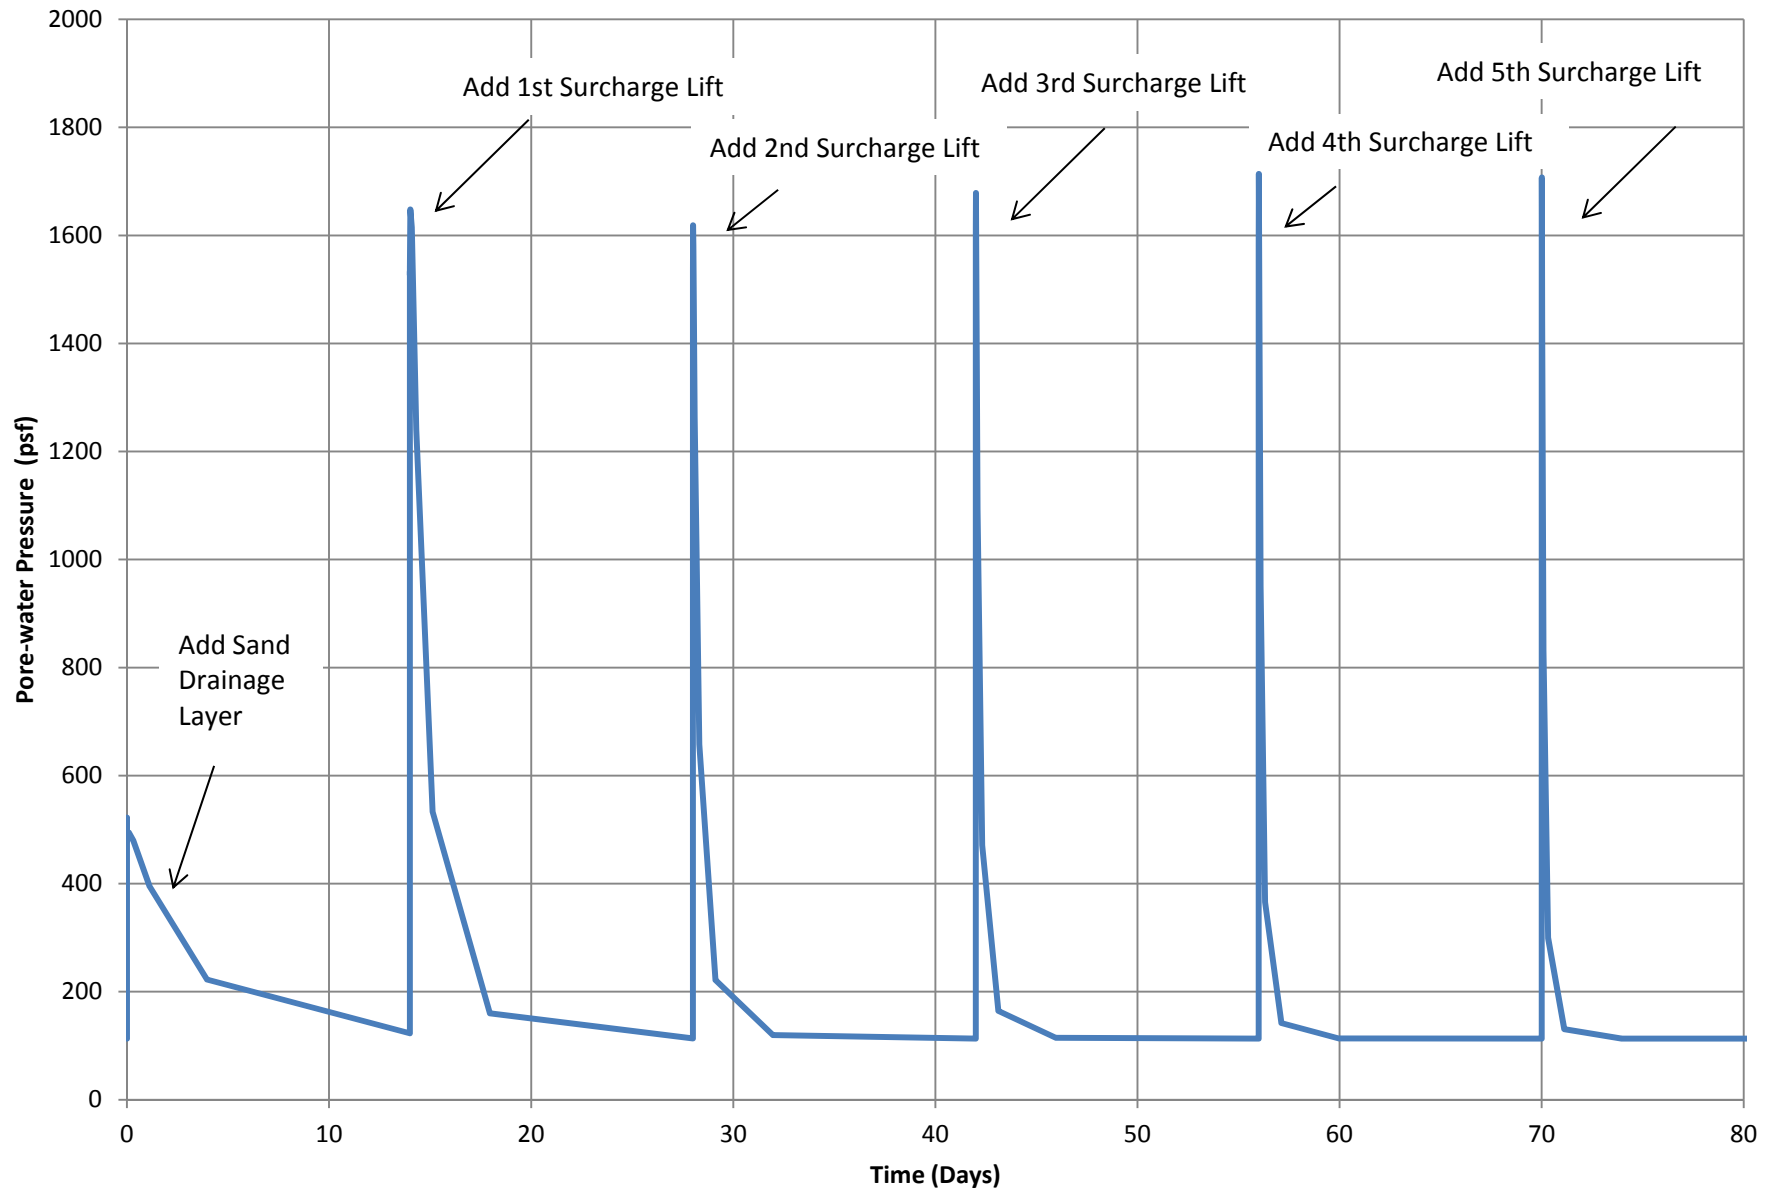
**Large Figure 22. Pore-Water Pressure at Node A after Removal of Surcharge
NorthMet Hydrometallurgical Residue Facility**

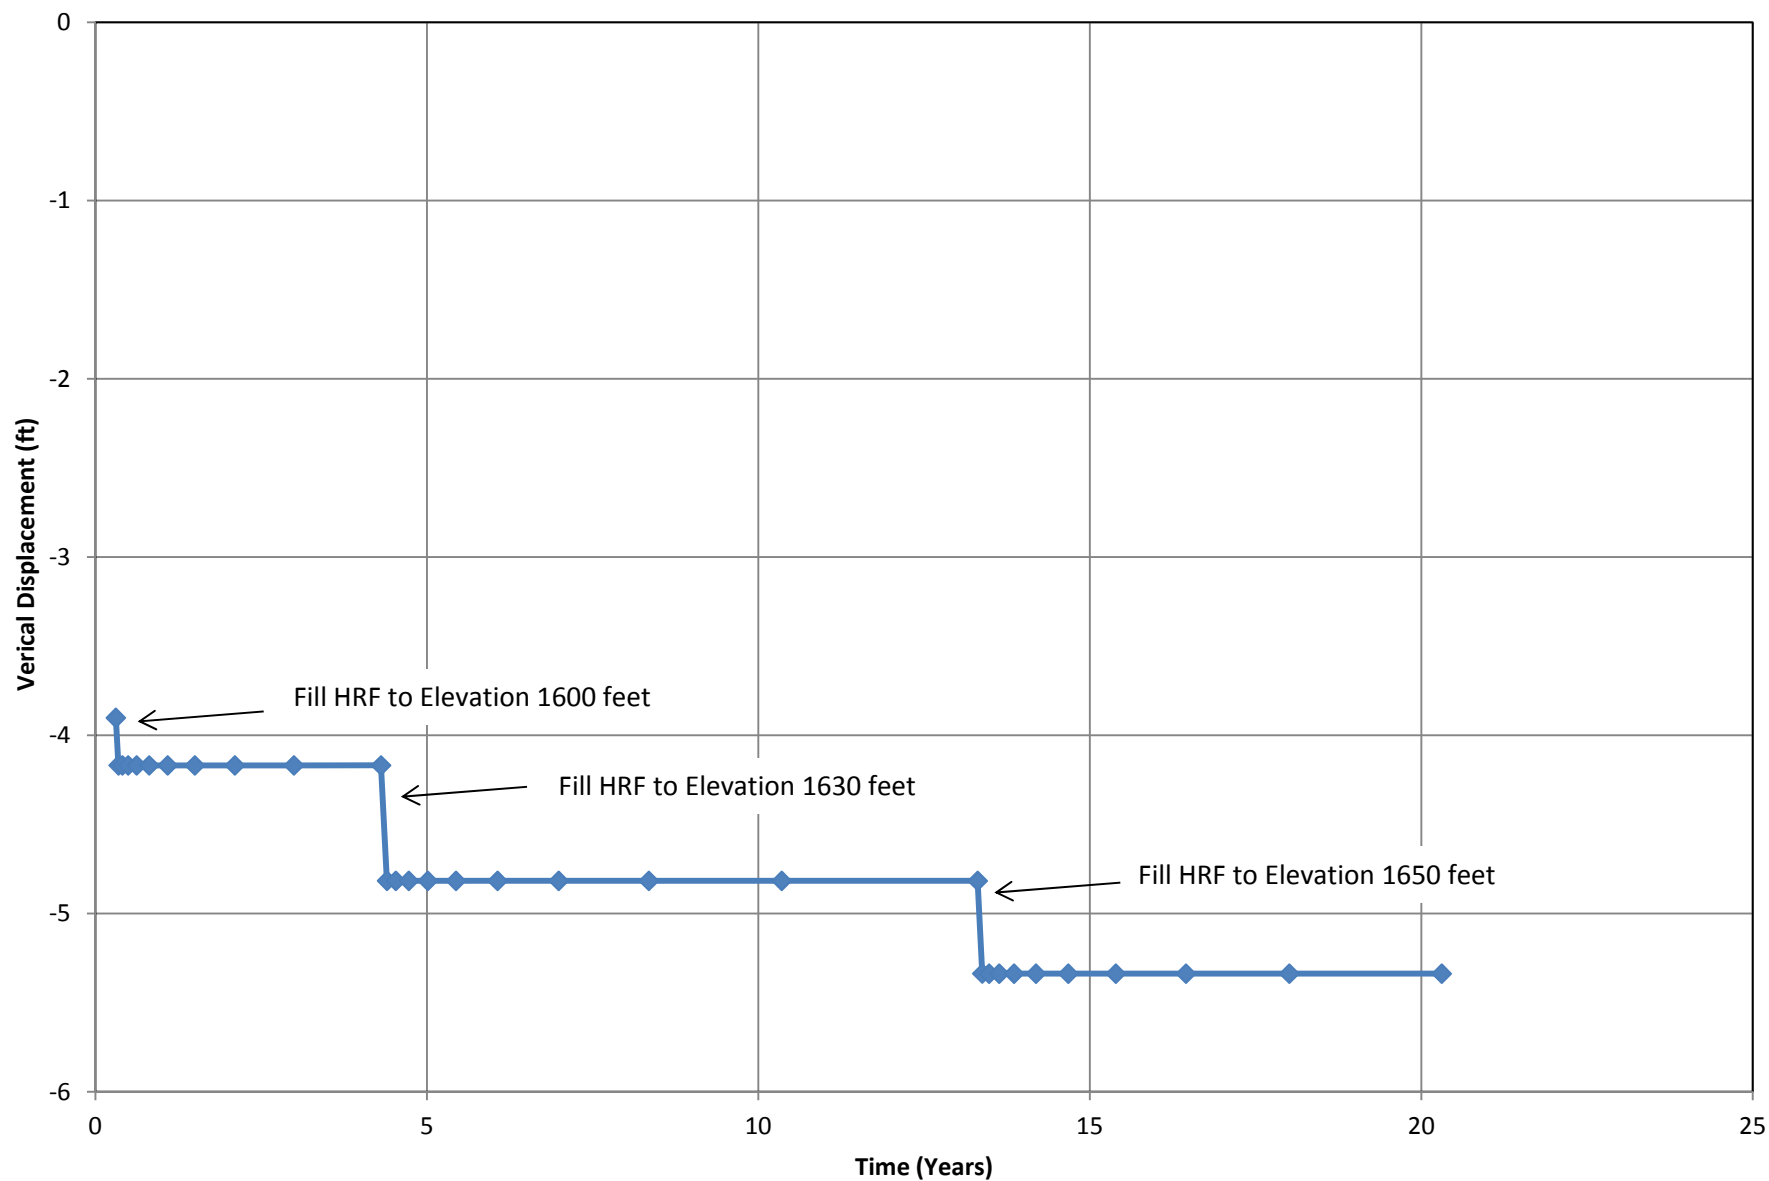
Large Figure 28. Vertical Displacement at Node A at End of Operation (Year 20)
NorthMet Hydrometallurgical Residue Facility

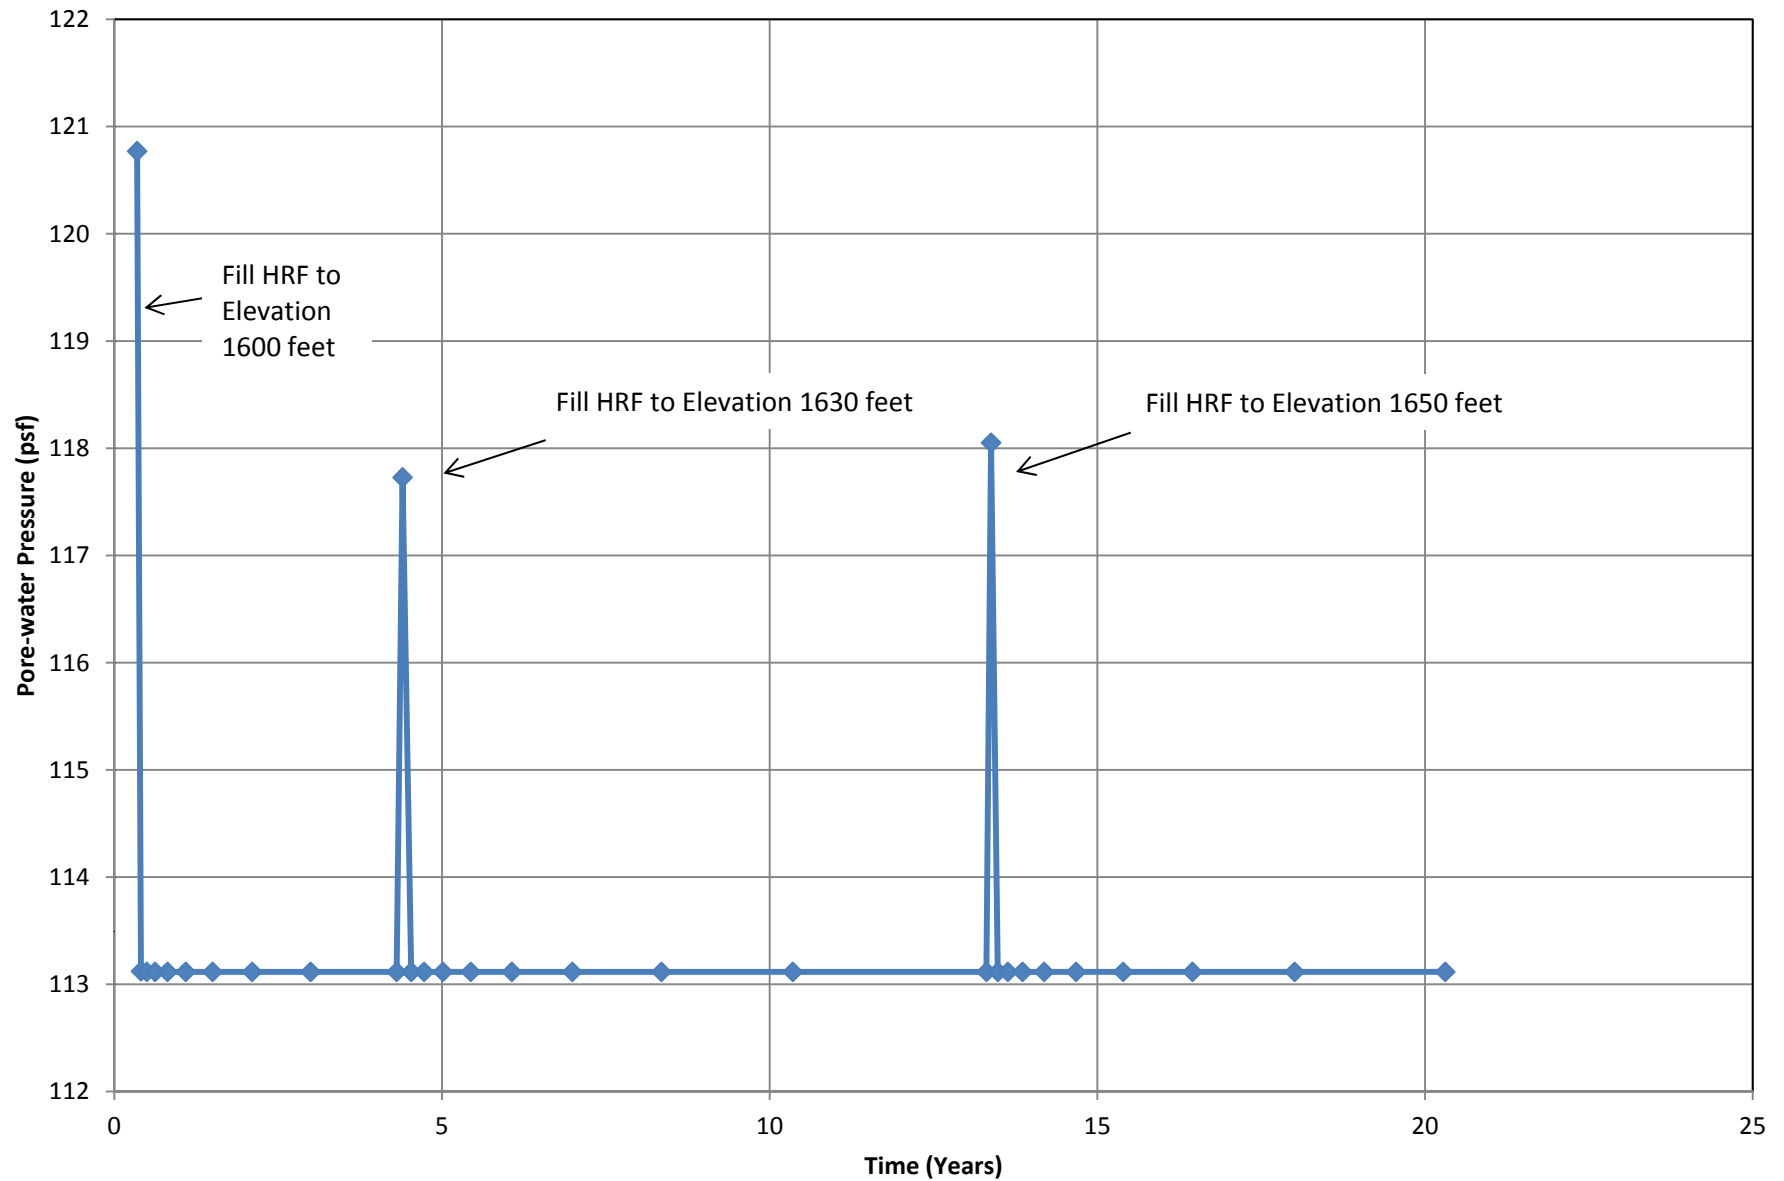
Large Figure 29. Pore-Water Pressure at Node A at End of Operation (Year 20)
NorthMet Hydrometallurgical Residue Facility

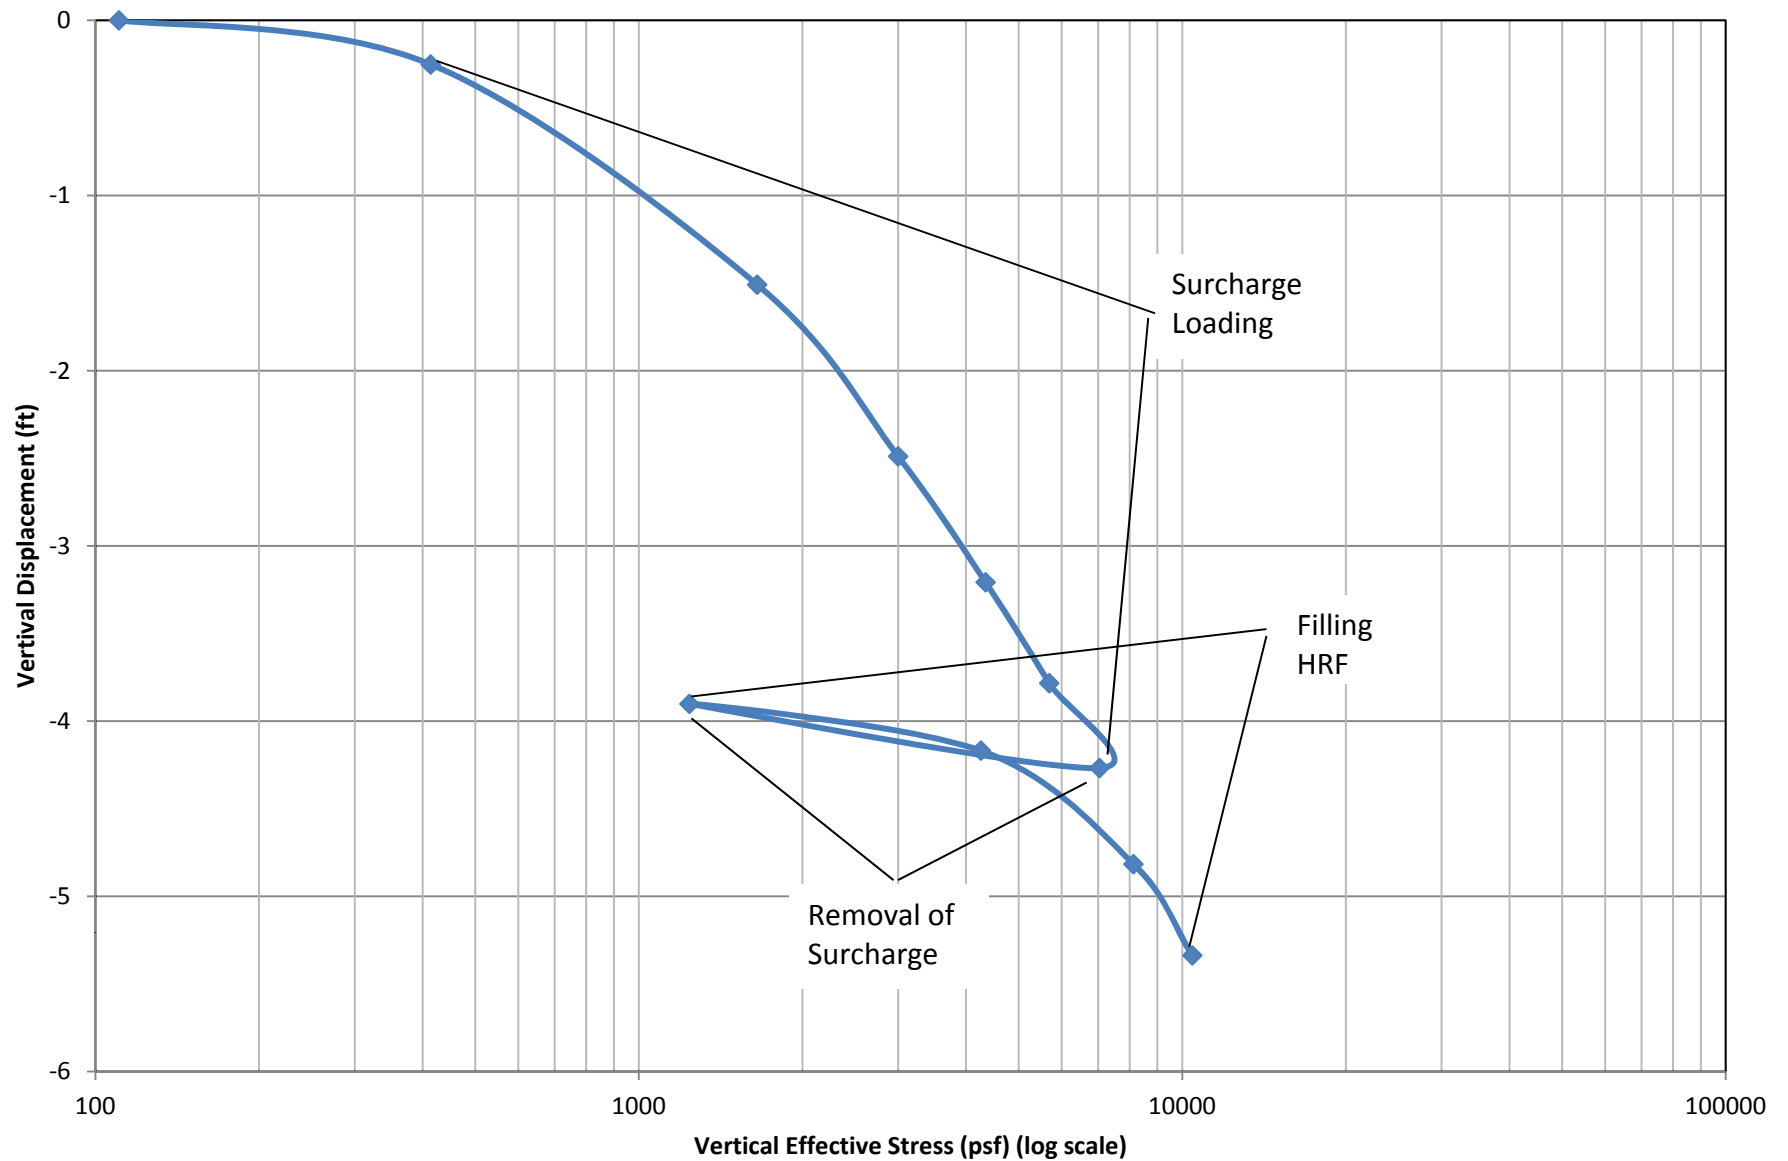
**Large Figure 30. Displacement due to Effective Stress at Node A
NorthMet Hydrometallurgical Residue Facility**

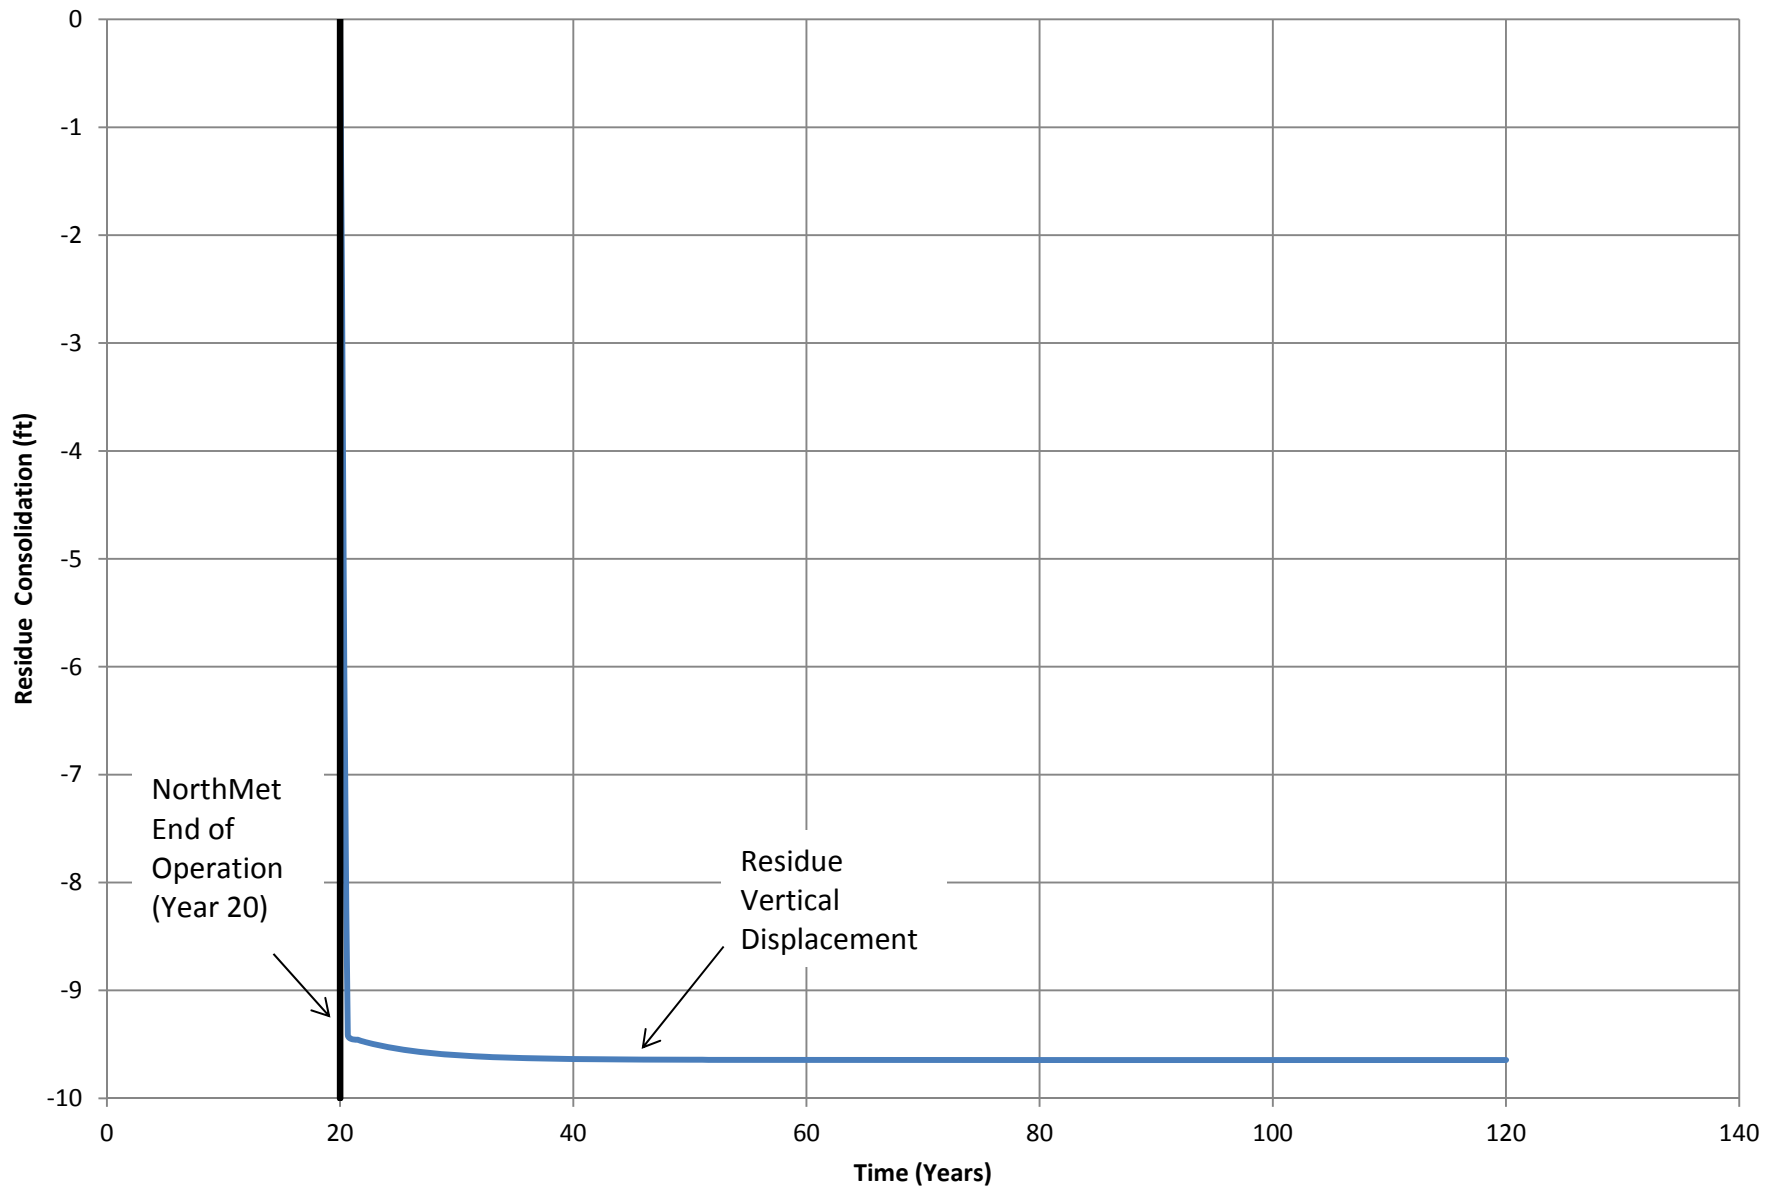
**Large Figure 31. Residue Consolidation at Node A
NorthMet Hydrometallurgical Residue Facility**

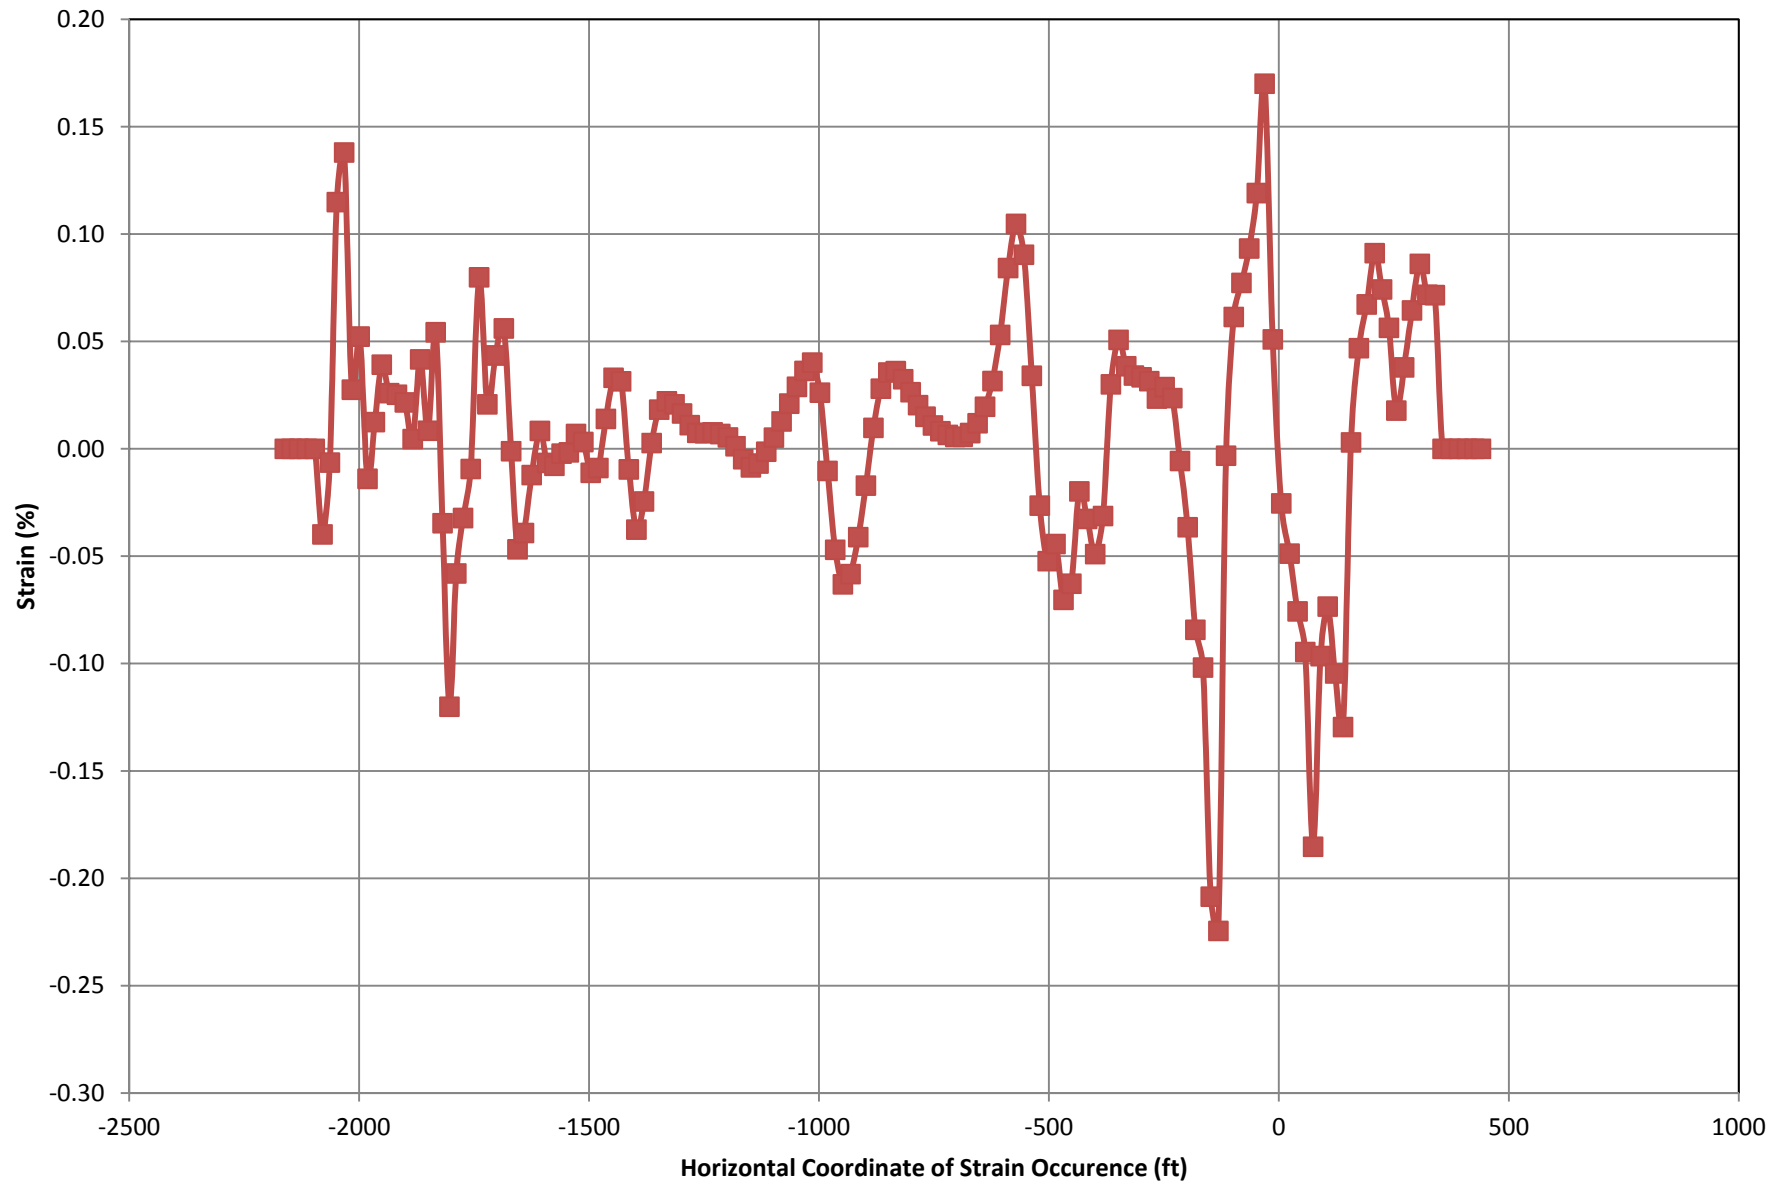
Large Figure 32. Strain in Geosynthetic Liner at NorthMet End of Operation (Year 20)
NorthMet Hydrometallurgical Residue Facility
