NorthMet Project

Geotechnical Data Package

Volume 2 - Hydrometallurgical Residue Facility

Version 5

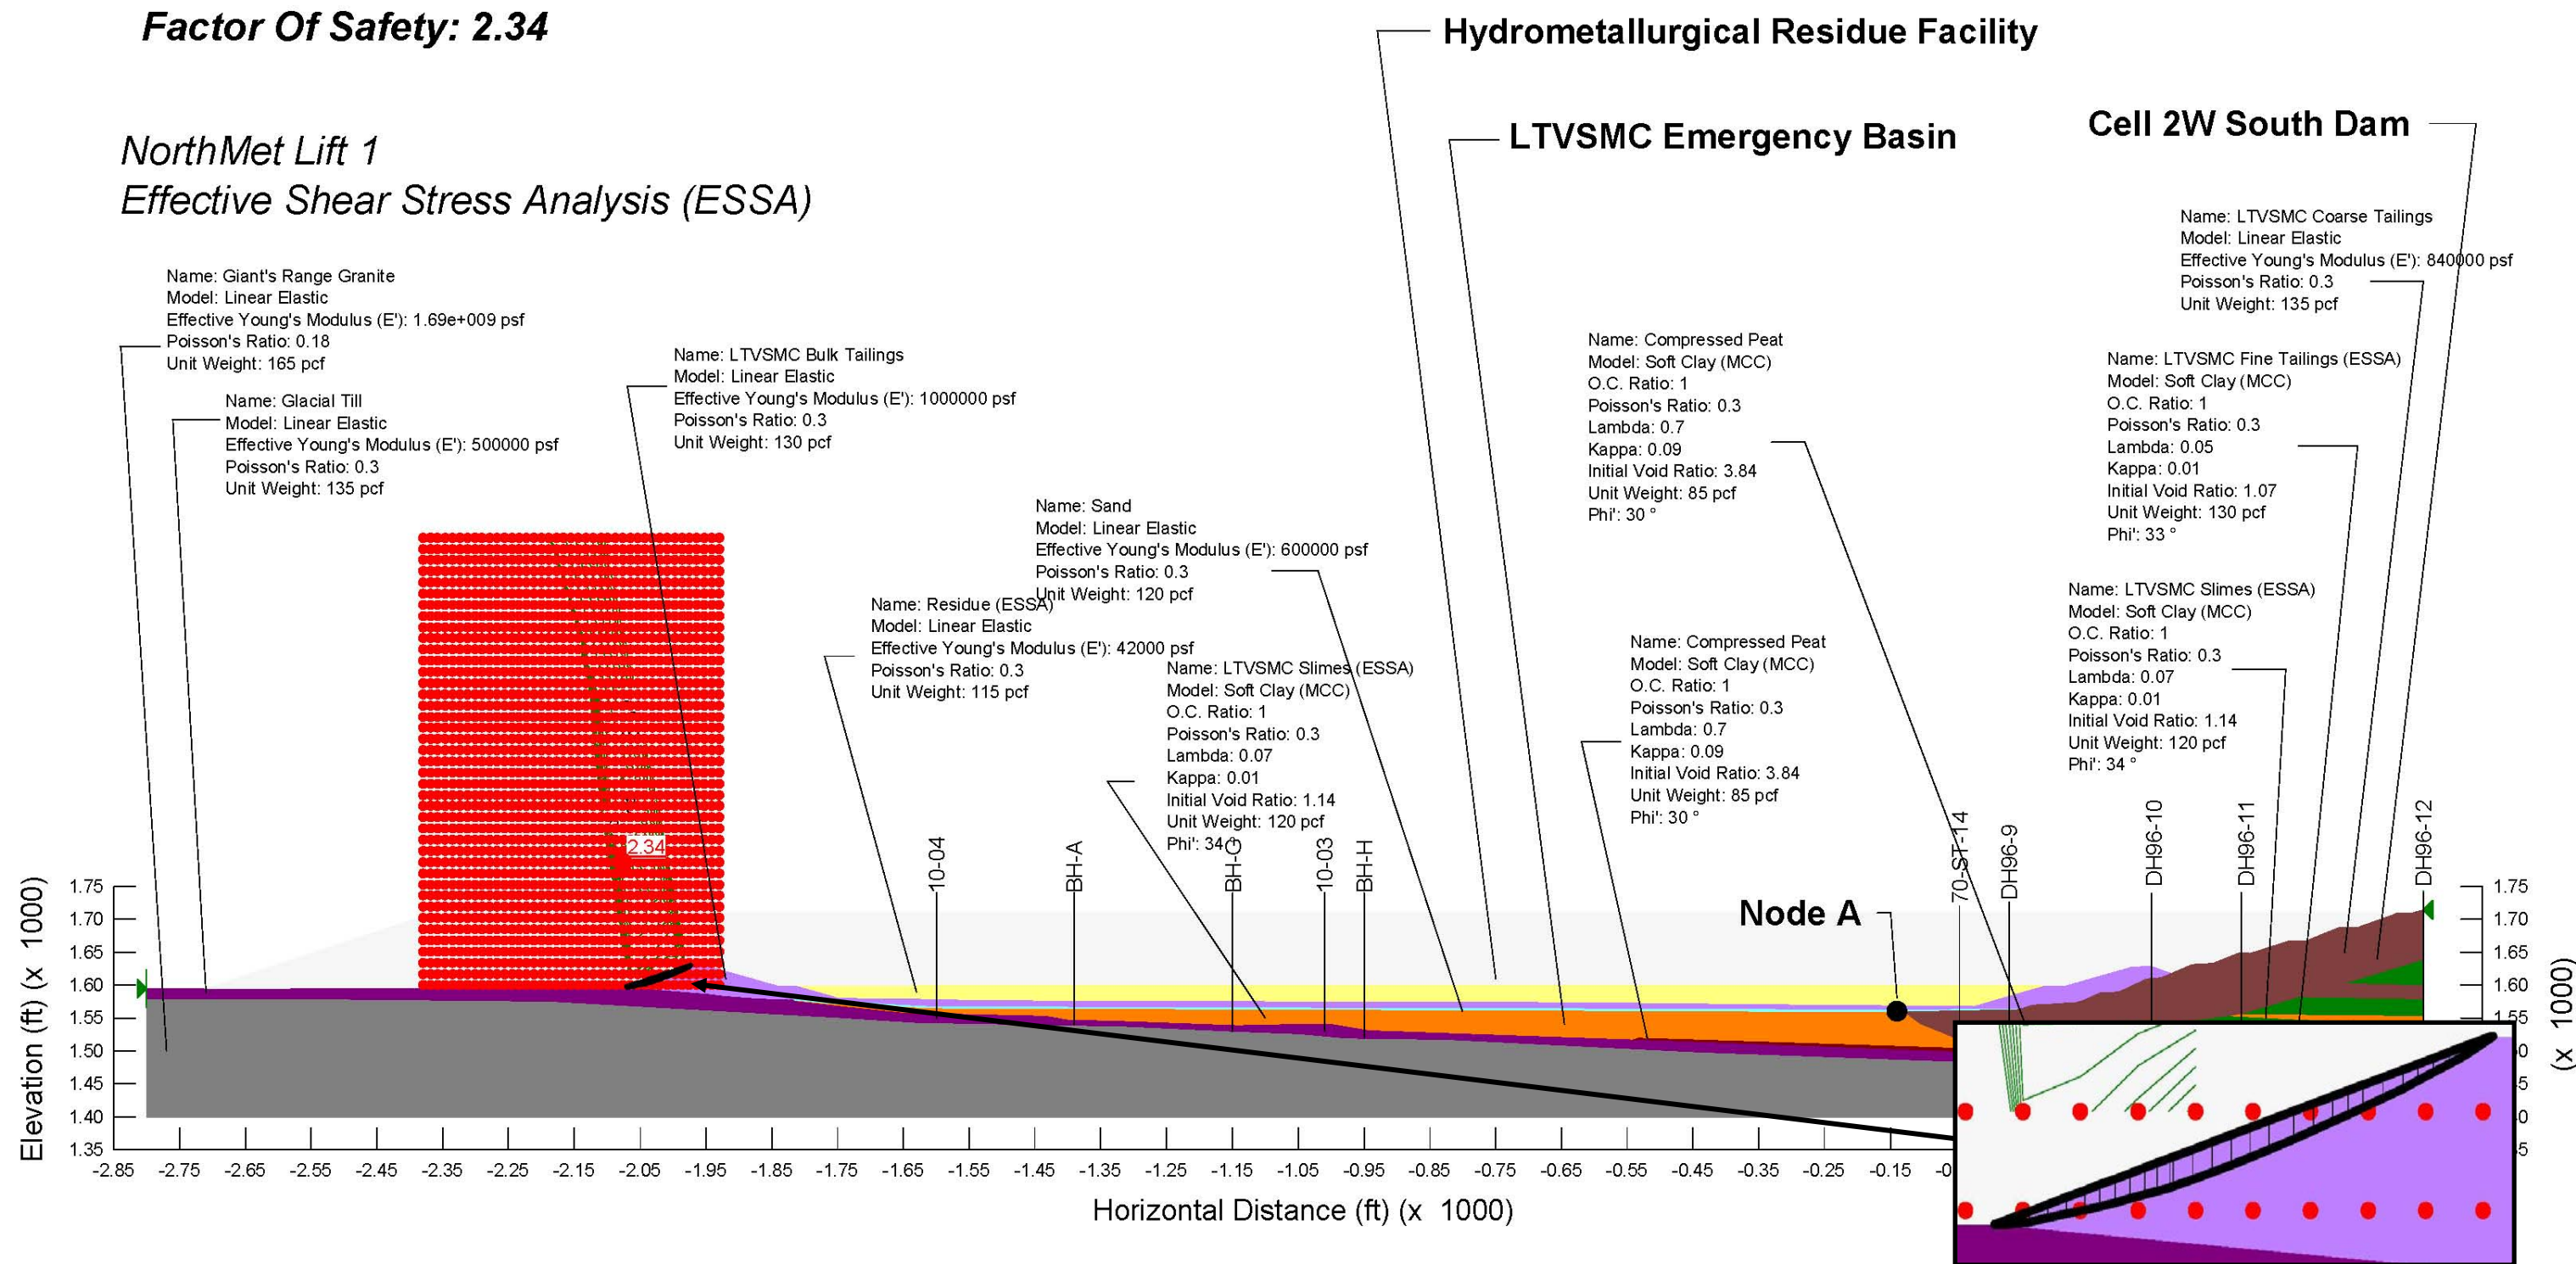
NorthMet Lift 1
Effective Shear Stress Analysis (ESSA)

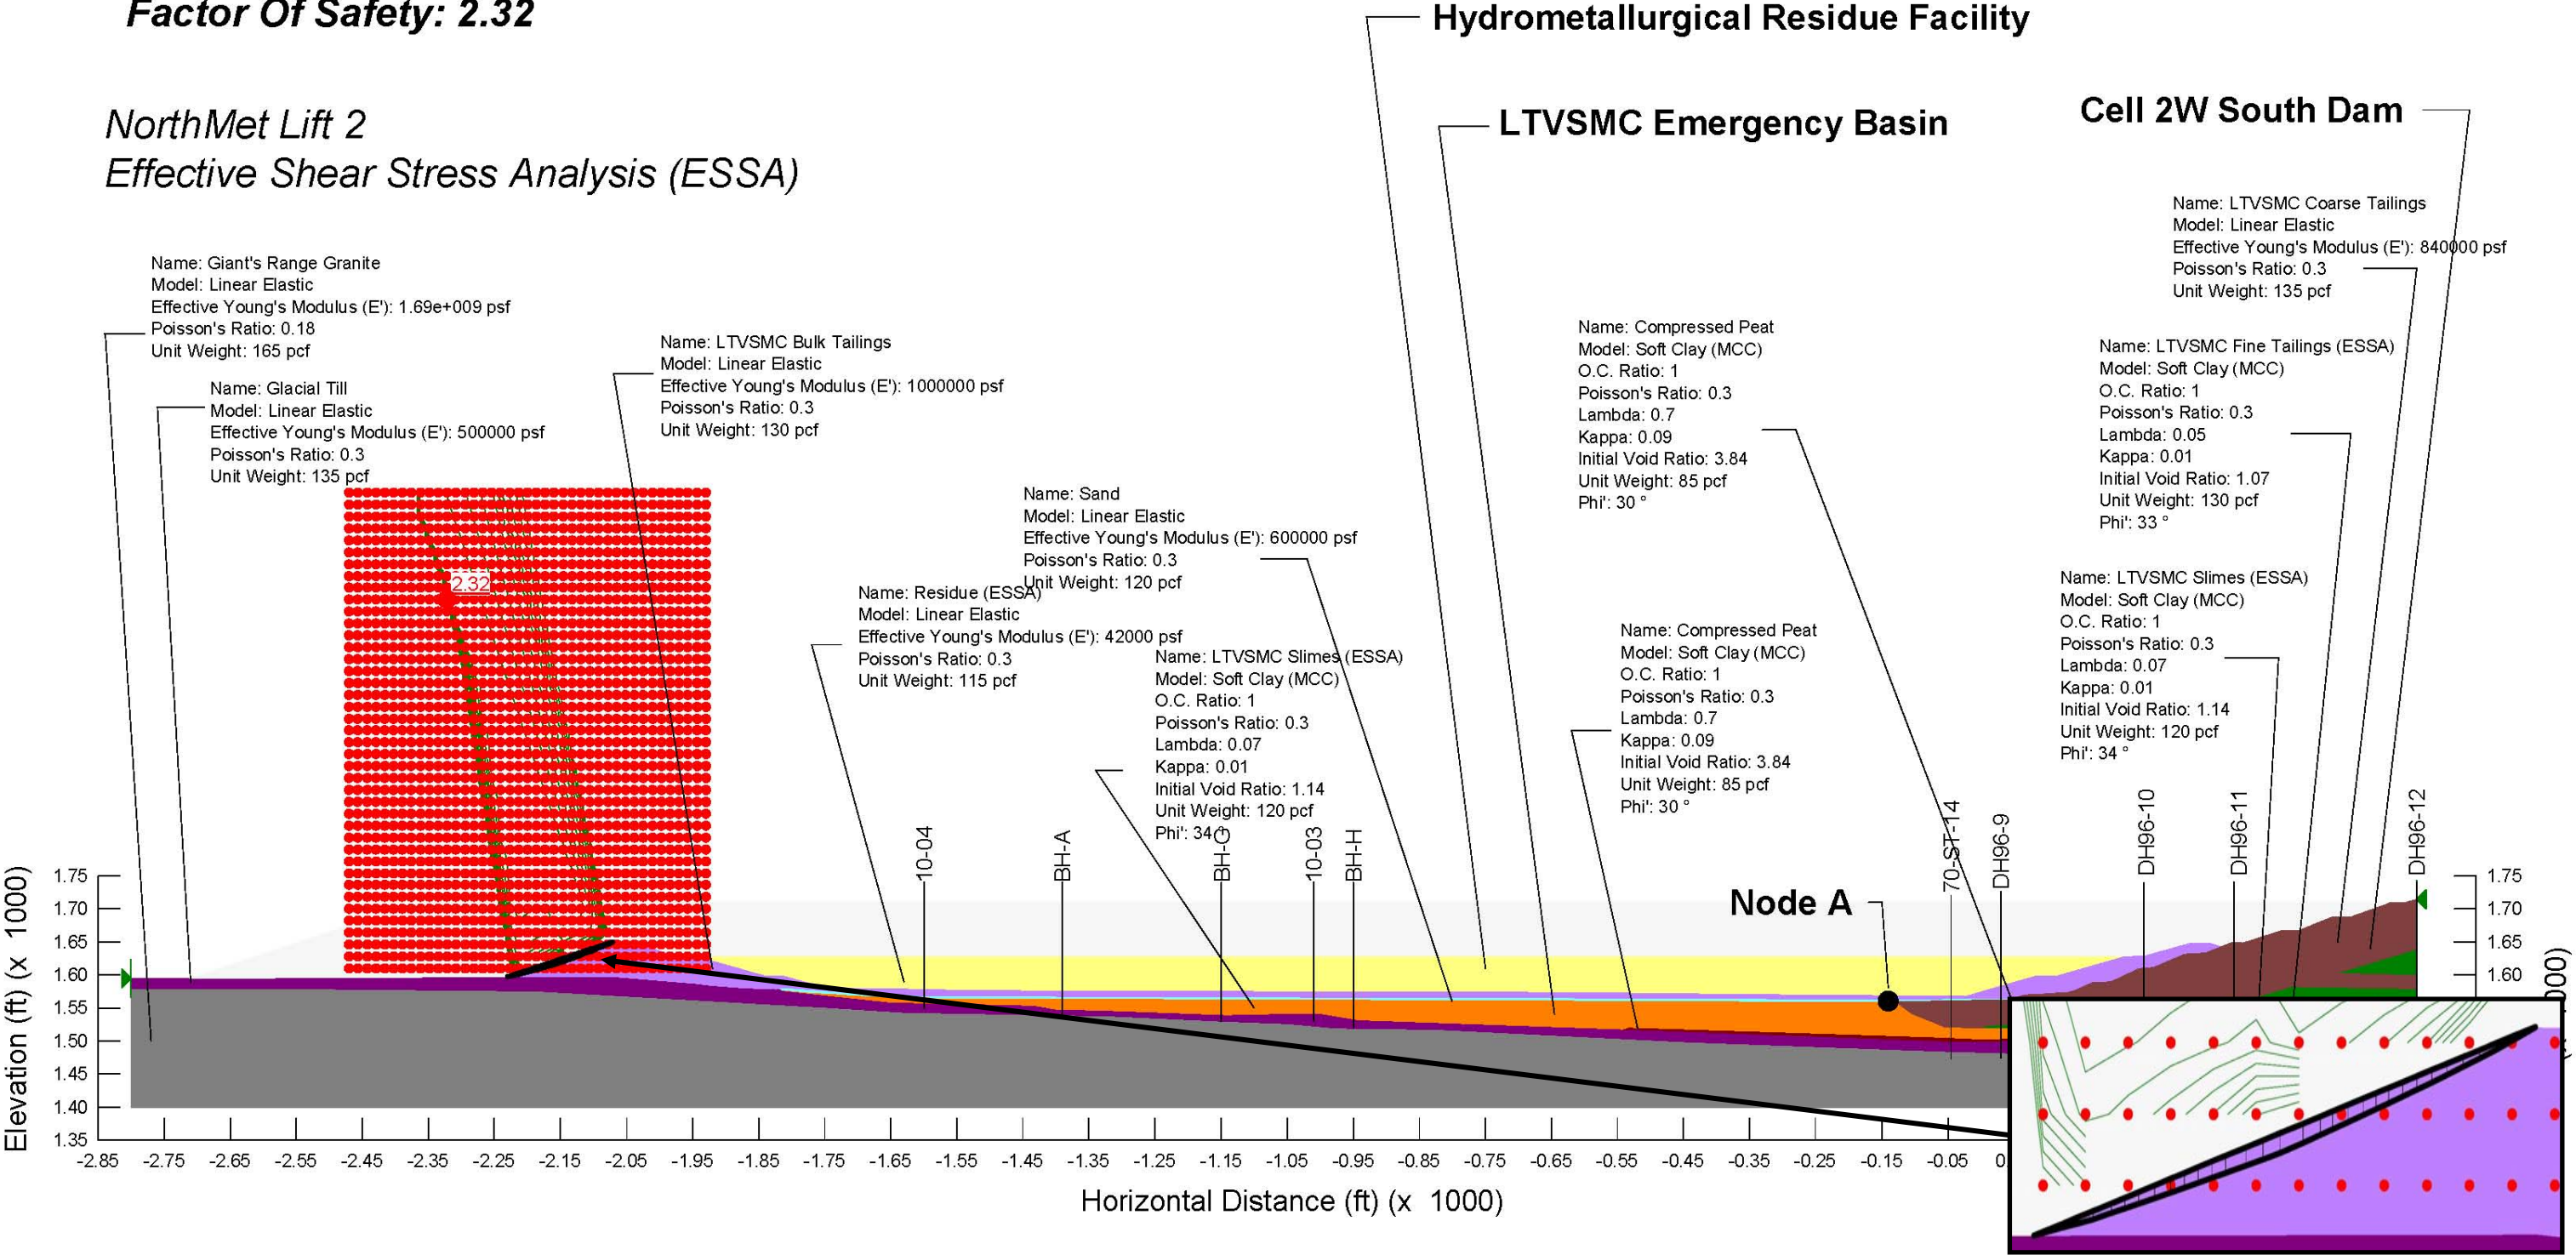
NorthMet Lift 2
Effective Shear Stress Analysis (ESSA)

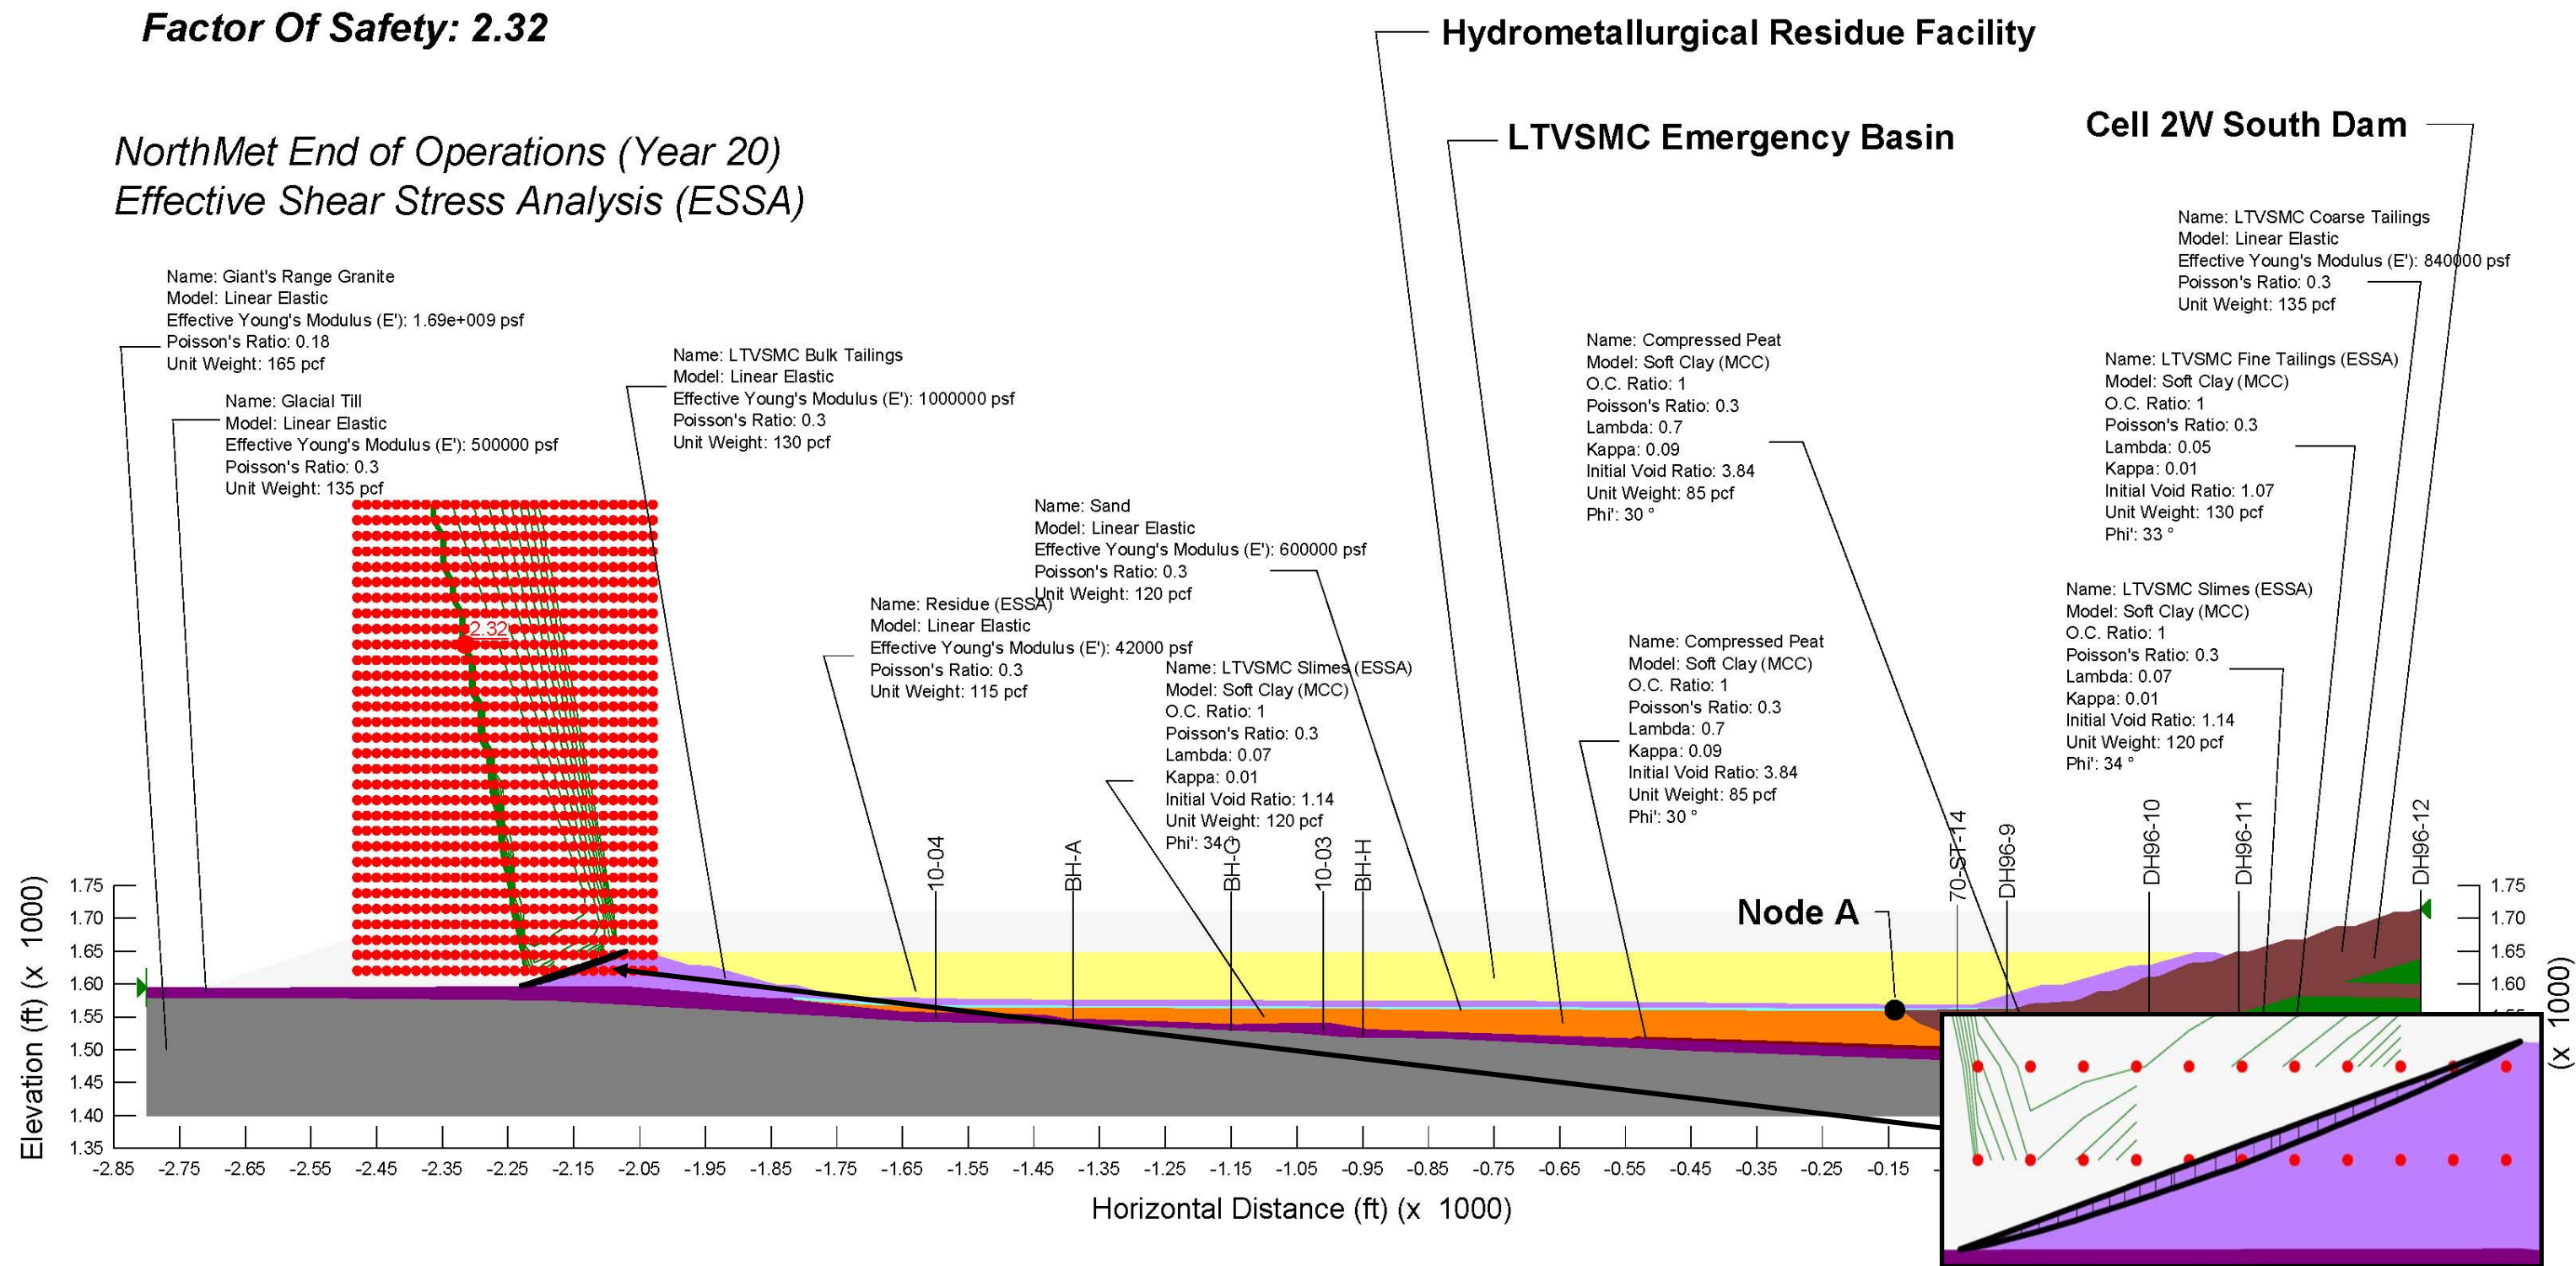
Large Figure 36
ESSA Slope Stability HRF Northwest Dam End of Operation (Year 20)
