A Citizen-Based Approach to Stormwater Management:

Raingardens to Improve Impaired Waters

Final Report

Powderhorn Lake
Minneapolis, Minnesota

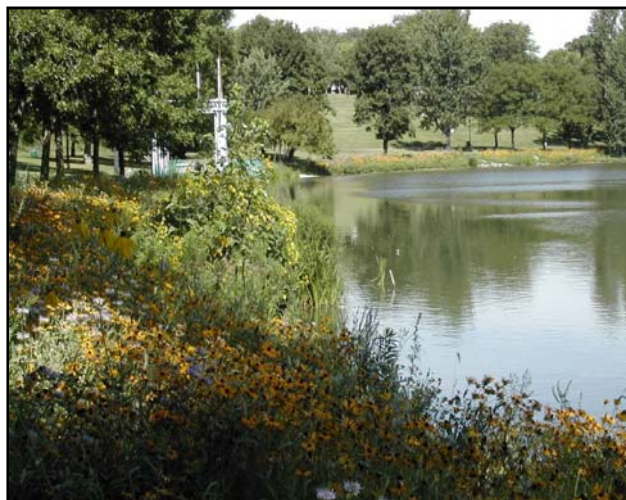
Figure 4 – Shoreline Restoration

- A shoreline restoration and retaining wall construction was completed in 2002. This included removal of concrete sluiceways and planting of native aquatic and shoreline vegetation (Figure 4).

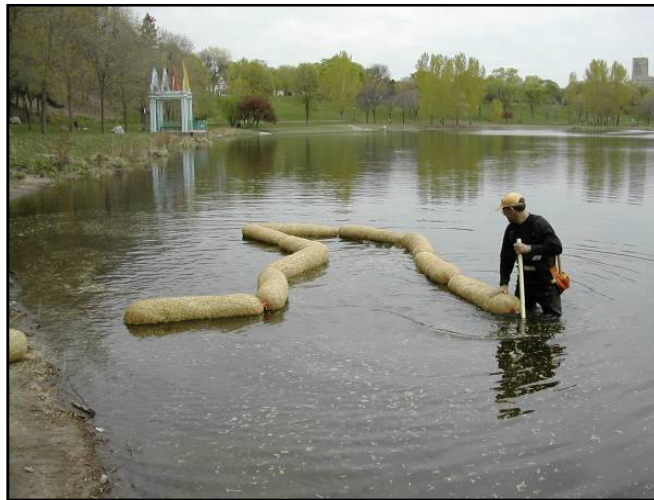
Figure 5 – Barley Straw Treatment

- Annual barley straw treatment since 2004. This approach targets microbial communities in the lake, to increase their take up of nutrients as they grow making the nutrients unavailable to algae (Figure 5).

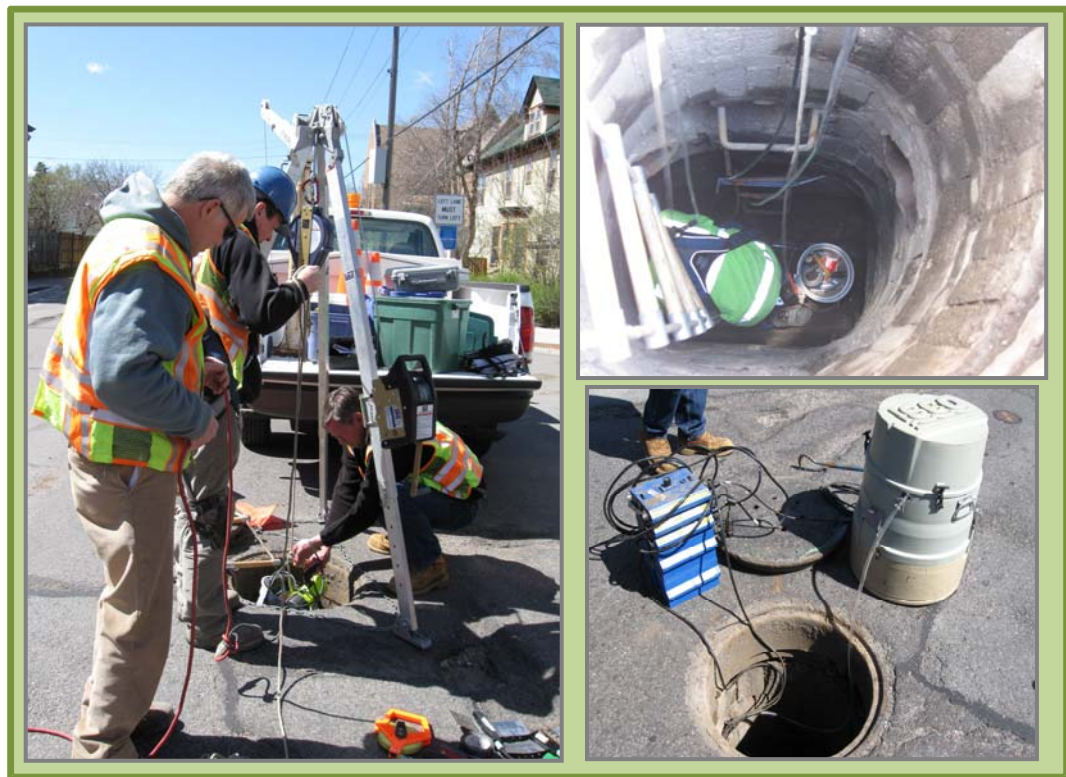
Figure 9 – Monitoring Equipment & Sites

Monitoring equipment was installed in the storm sewers at two locations to record stormwater flow for the test and control watersheds beginning in Spring 2009 through November 2011. The MPRB installed equipment & collected data for the three year period as shown in Figure 9 for one of the sites. Approximately 10 water quality samples were taken each year and analyzed for total phosphorus and total suspended solids. Equipment was removed in the winter months.

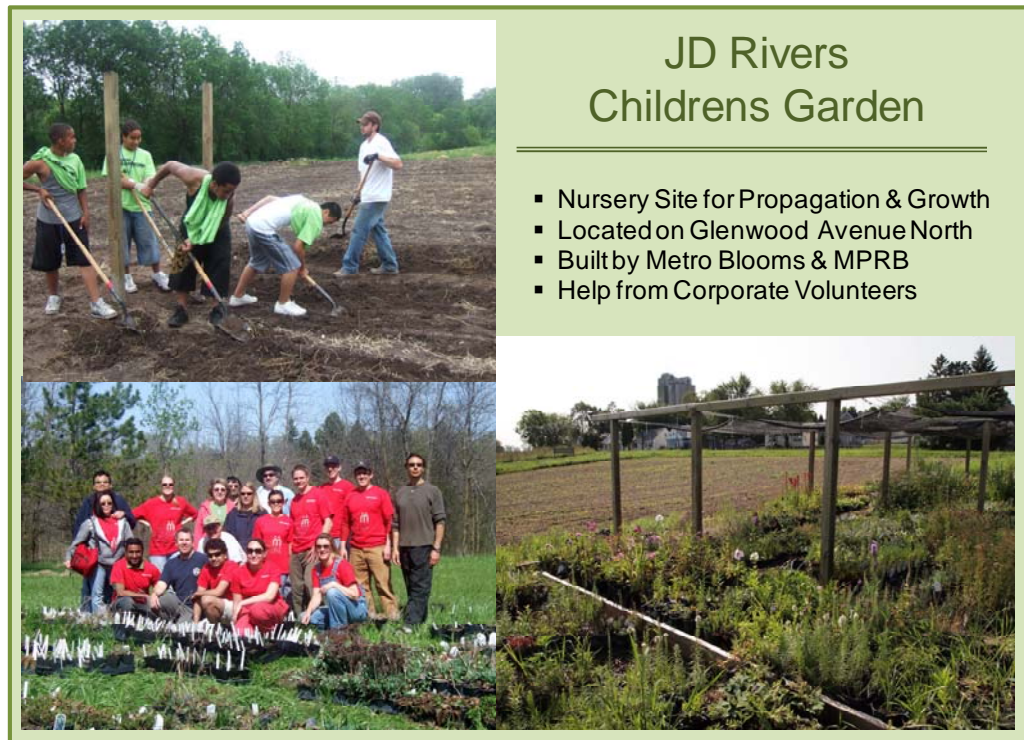
Figure 14 – Propagation Garden Developed by Team Members and Volunteers

Metro Blooms led the crew to build a shade structure for the nursery at the MPRB’s JD Rivers Children’s Garden on Glenwood at Vincent Avenue North, just east of Theodore Wirth Park (Figure 14). The supports and shade cloth protect the shade loving natives from the harsh sun in the open field. Much of the Powderhorn neighborhood is shady, with many trees. The new transplants were bedded in 2 inches of mulch and then tucked in all around with mulch to the rim of the pot in an effort to protect them through the winter.

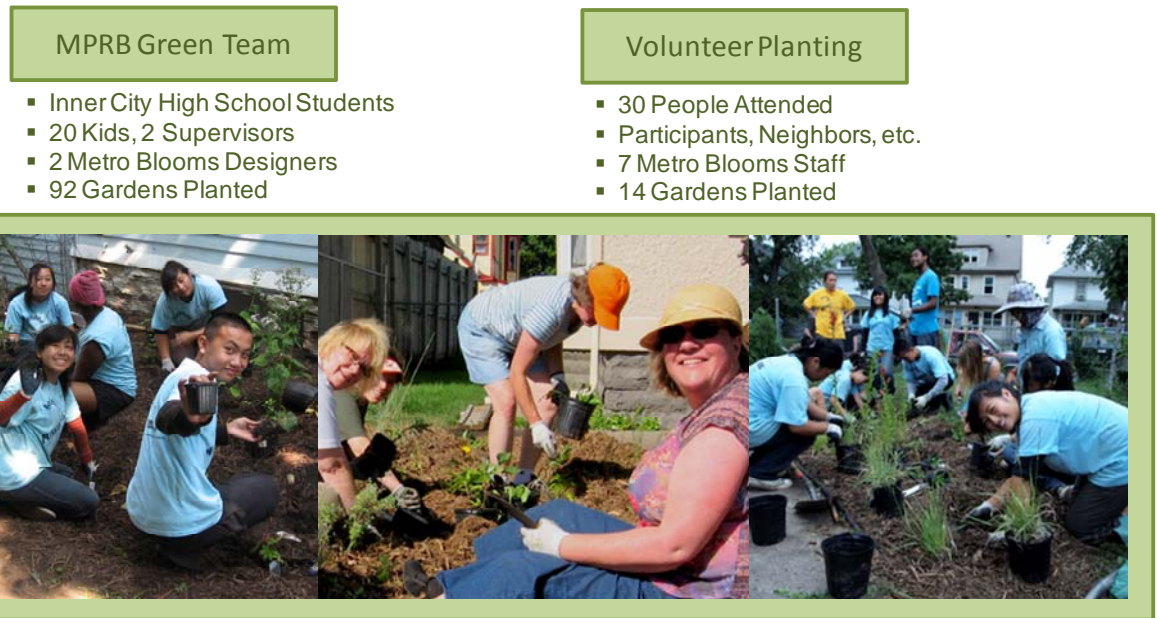
Figure 22 – Planting Process

Other plantings were performed by volunteer teams as indicated in Figure 22.

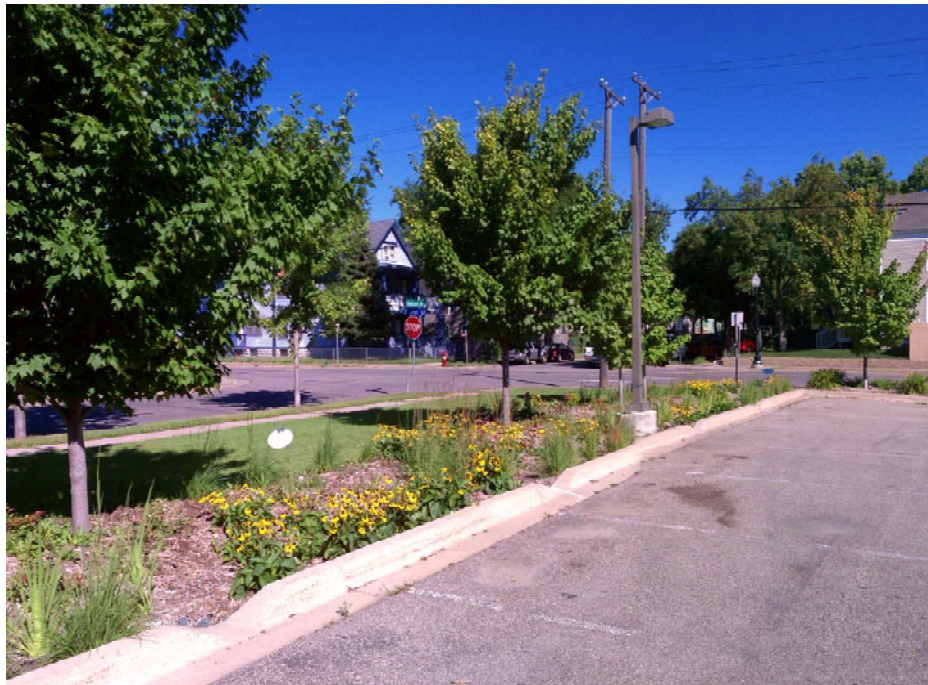
Figure 23 – All God’s Children, Metropolitan Community Church Raingarden - August 2011

Heavy equipment was used in a few instances. Five raingardens were built at churches to capture surface runoff from their parking lots (Figure 23). Three of these five were built with the help of an excavator. Much of the soil around a parking lot is heavily compacted and is

very difficult to dig by hand. Also, the scale of these gardens was much larger to accommodate the scale of the much larger drainage area.

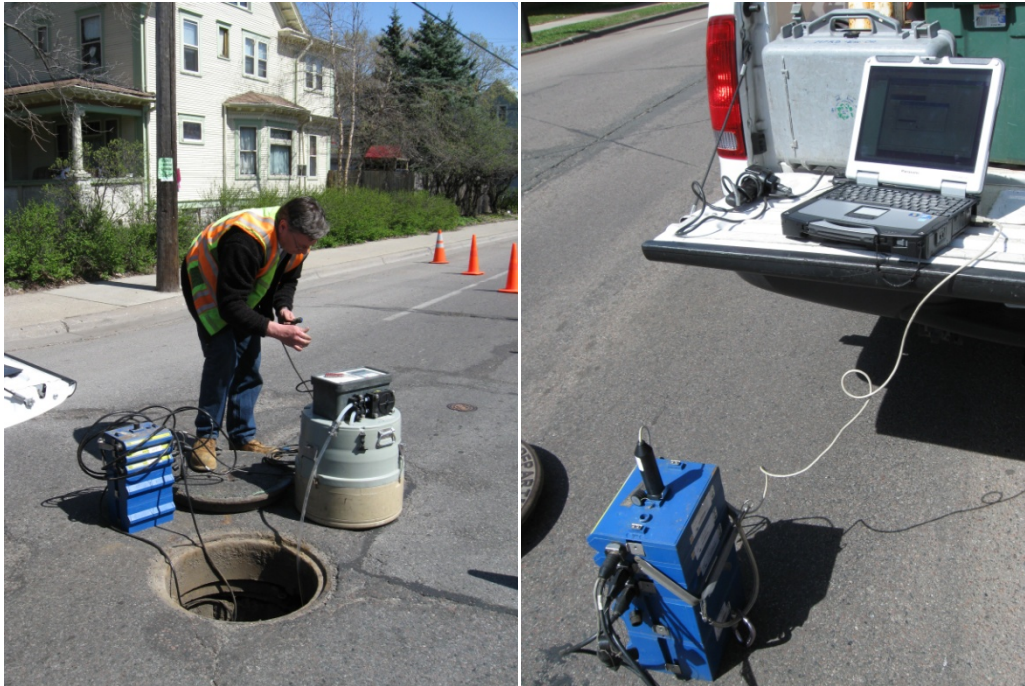
Figure 3. Flow and Water Quality Monitoring Equipment

Columbus Avenue South. The monitoring equipment was installed in 24" RCP at these new locations. An example of the flow and water quality monitoring equipment is shown below in Figure 3.

When uninstalling the monitoring equipment for the 2009 season, it was noted that both of the new sites had significant sediment accumulation around the invert AV probes. Offset AV probes were installed in 2010 and 2011 to avoid sedimentation and interference with accurate flow measurement.

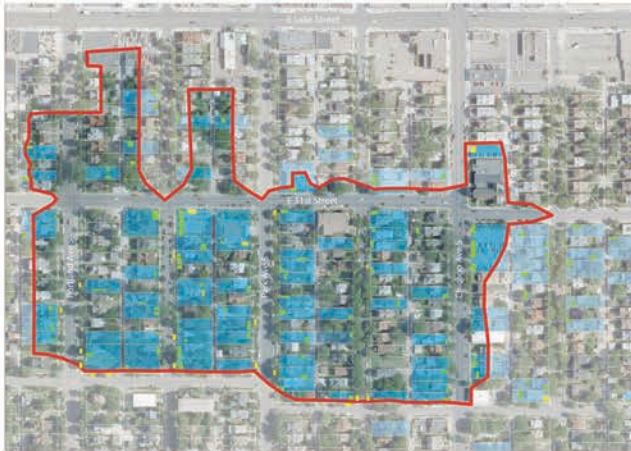
The test area gardens, highlighted in green below, are located between Lake Street on the north, 32nd Street on the south, Portland Avenue to the west and 10th Avenue to the east. Please view the raingardens that are visible from the public sidewalk only.
