# **Bridge 9103 Rehabilitation Study Final Report Red Wing, Minnesota**

**August 2013**

**Submitted to  
Minnesota Department of Transportation**

**Prepared by  
HDR Engineering, Inc.  
and  
Gemini Research**

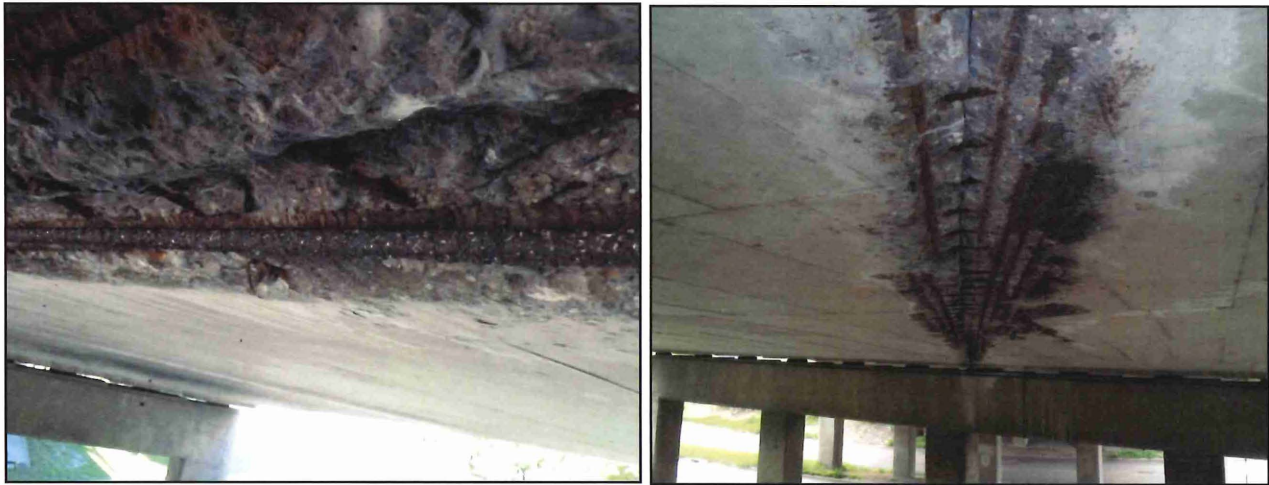
In some areas, the spalling and delamination of the concrete on the underside of the slab are so deep that the bottom reinforcing steel running parallel to TH 63 (longitudinal) is no longer bonded to the concrete. This is evident at 8 to 10 longitudinal bars in each of Spans 2, 3, 4, and 5 along most of their length. This steel is the main reinforcing steel in the middle of the spans. It is corroded and section loss has occurred all the way around many of the bars (Figure 8). Although 8 to 10 bars comprise only 5% to 6% of the total longitudinal bars, the affected bars are concentrated within a design strip width. Two exposed reinforcing bars that were completely debonded from the concrete were measured and found to have a remaining

diameter of approximately  $\frac{3}{4}$ ". These bars were originally 1" in diameter, which equates to a 44% loss in cross sectional area. (See Section 7.0; see also Page 4 of Appendix G.)

Figure 8. Exposed and debonded reinforcing in Span 3.

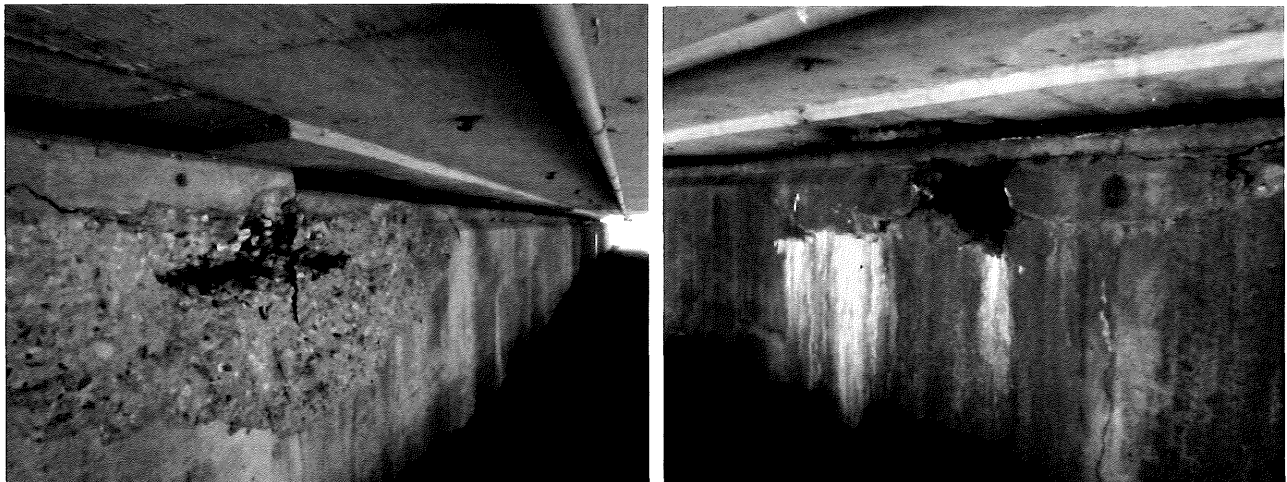
The abutments have vertical cracks with some leaching in the front face. Both abutments also have areas of delaminated concrete on the front face, which measure approximately 8 square feet and 70 square feet for the south and north abutments, respectively. The south abutment has spalled areas that measure approximately 12 square feet, and the north abutment has random and horizontal cracking that measures approximately 35' in length. Typical examples of the deterioration found on both abutments are shown in Figure 9. The slope paving in front of the North Abutment has several areas of severe settlement, up to 12" in depth. According to inspection records, the settlement and erosion at the north abutment began at least five years ago but it is unclear if it has stabilized or getting worse.

Figure 9. Spalled and delaminated concrete on the north abutment.

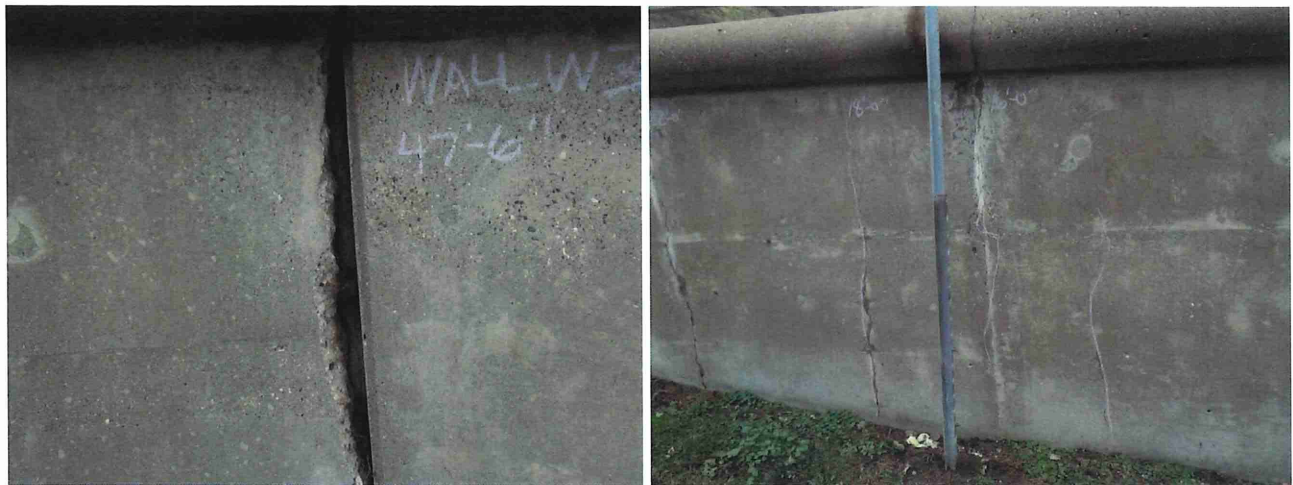
The cast-in-place retaining walls that support the southern approach roadway on retained fill are supported on spread footings. They are in generally good condition with some hairline vertical cracks. The hairline vertical cracks are typically spaced at 10' or more with the exception of the first 40' of the west wall where the crack spacing varies from 2' to 5'. There are minor corner spalls at three of the vertical joints but they are all 3" x 4" or less in size and less than 3' long. See Figure 10 for typical cracks and spalls.

Figure 10. Typical spalls and cracks in the approach retaining walls.

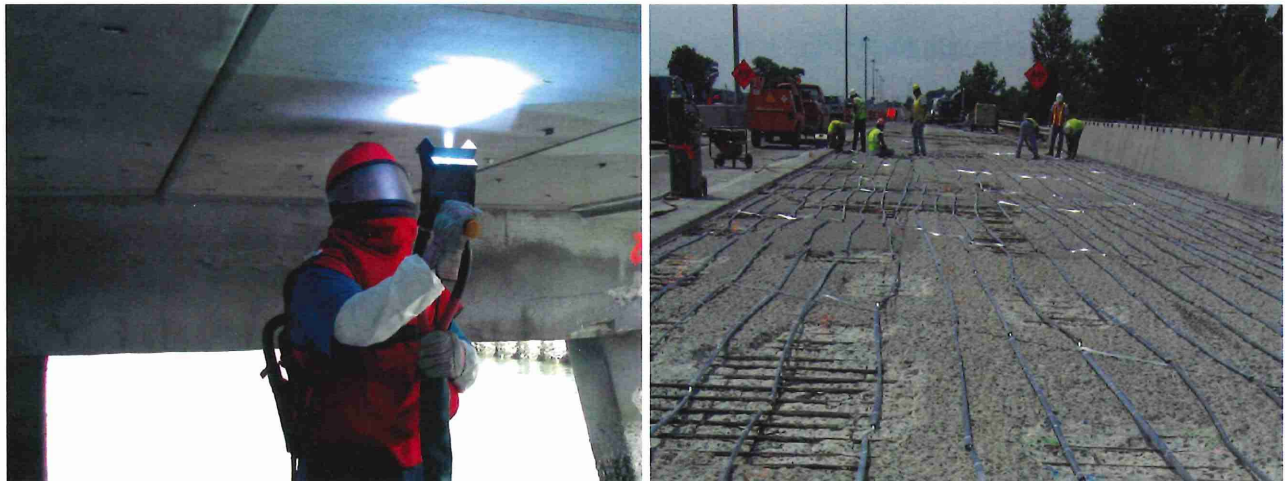
Figure 13. Cathodic protection: arc-spraying a zinc coating (left) and embedding sacrificial anodes in the top of a slab (right).

electrochemically protect the reinforcing steel from the chlorides that already exist in the structural slab. CP would be installed after the low-slump concrete overlay has been removed and after the central 10'- to 15'-wide strip of the slab has been replaced and additional areas of deteriorated concrete have been patched and sealed. The recommended type of CP is a galvanic system, a type that does not require an external power source to provide an impressed current. On the bottom of the slab, threaded rods would be embedded into the slab where they would connect with the bottom reinforcing bars. The rods would be spaced about 15' apart in a grid pattern and their ends would project slightly. The bottom surface of the slab would be lightly sandblasted and cleaned of sand and dust with pressurized air. A zinc mesh plate, about 4" x 4" square, would be bolted to the end of each threaded rod. The lower slab surface would then be arc-sprayed with an activated zinc coating (Figure 13). The coating would be between 0.01" and 0.02" thick and grayish-white in color. It would have a glint or metallic sheen from the zinc. The coating and mesh plates would be visible on the lower surface of the slab.

On the top of the slab, the process to mill away the overlay would also remove an approximately 1"-thick layer of the existing concrete slab to expose the reinforcing steel. Sacrificial zinc anodes up to 7.5' long would be embedded longitudinally about 1' to 2' apart where they would make contact with the reinforcing steel (Figure 13). The final required spacing would be determined in detailed design. A new concrete overlay would then be placed over the anodes.

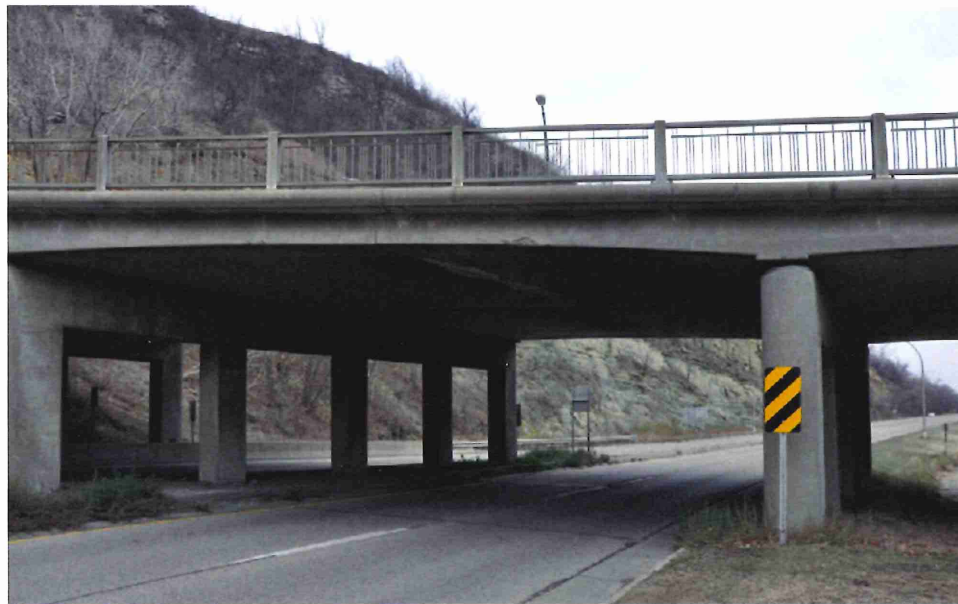
Photo 6. Span 3 and TH 61 southbound lanes; note vehicle damage on slab fascia (facing east)

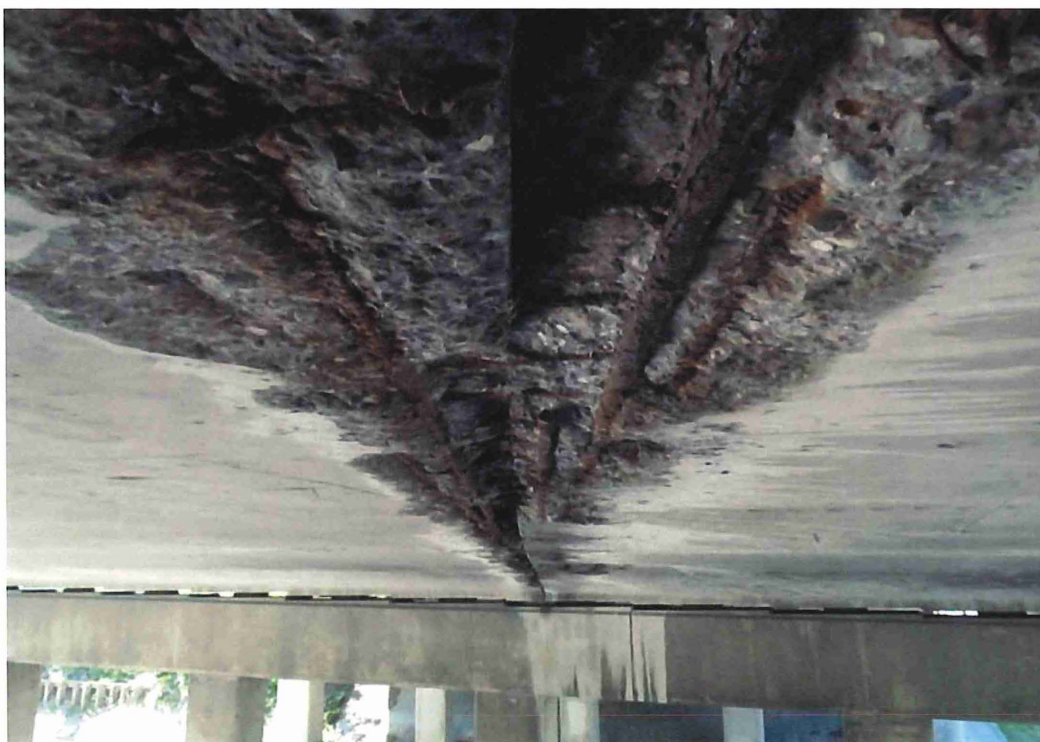
Photo 12

Span 3 - Close-up view of spalled areas. Approximately 2' to 3' either side of centerline joint is either spalled or delaminated full length of span. The exposed reinforcement bars have advanced corrosion with some initial section loss and the spall depth extends up to 3" to 4" deep.

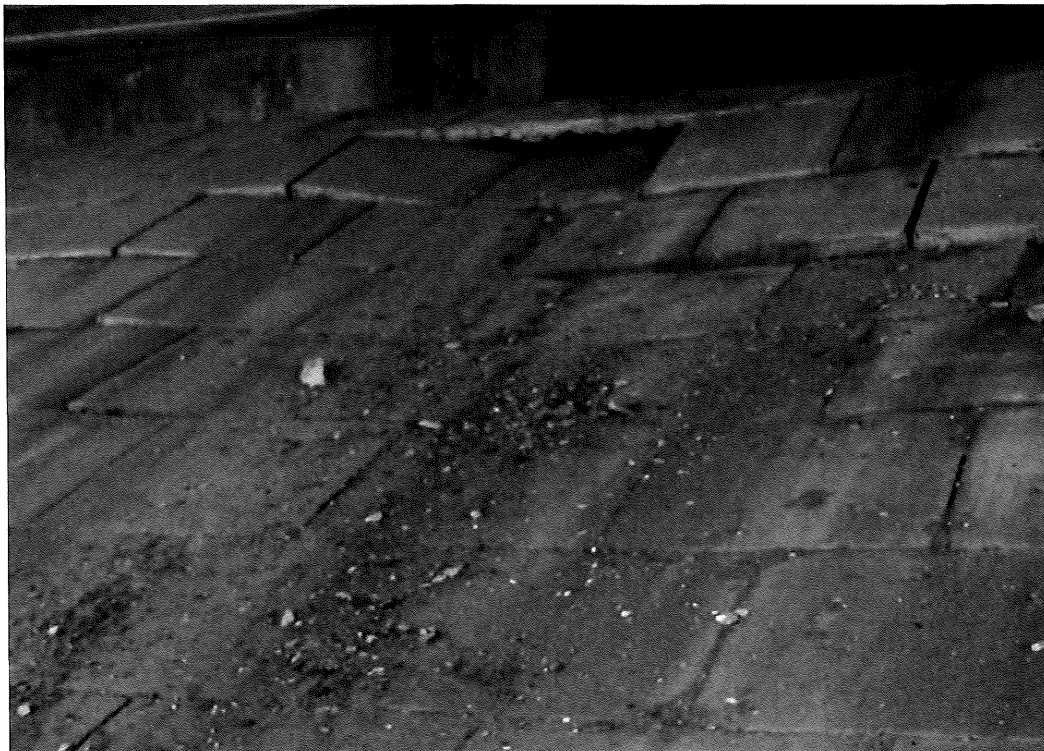
Photo 23

North Abutment slope paving - Additional photo of severe settlement.

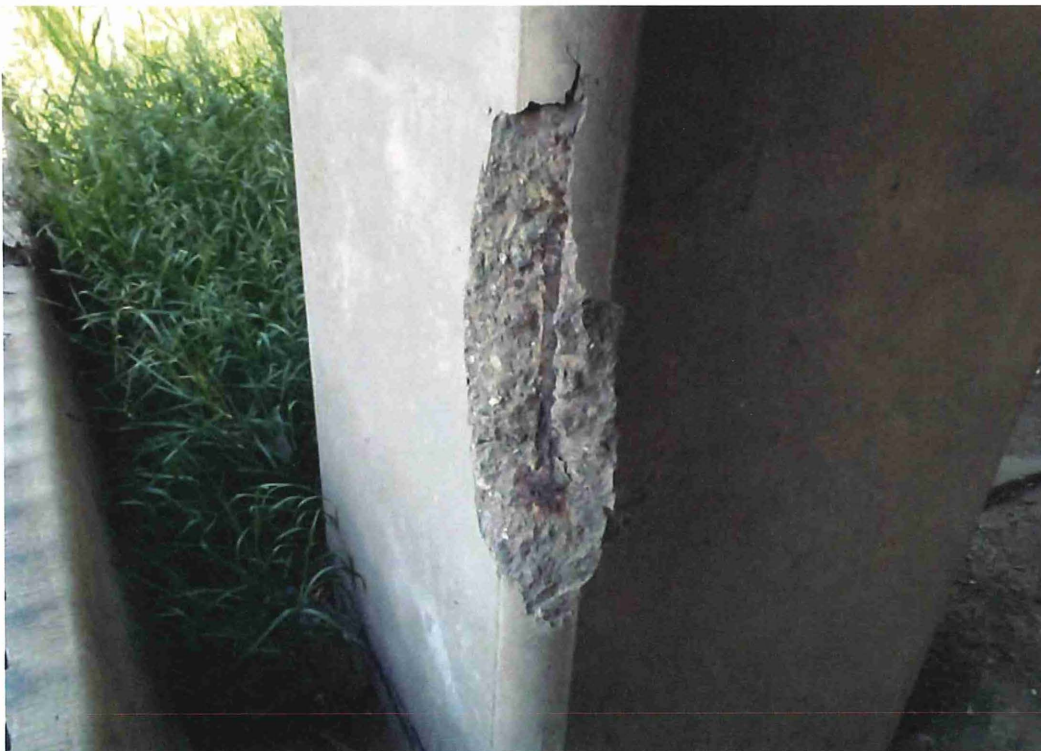
Photo 28

Column (typical) - Typical minor spalling on some of the pier columns.

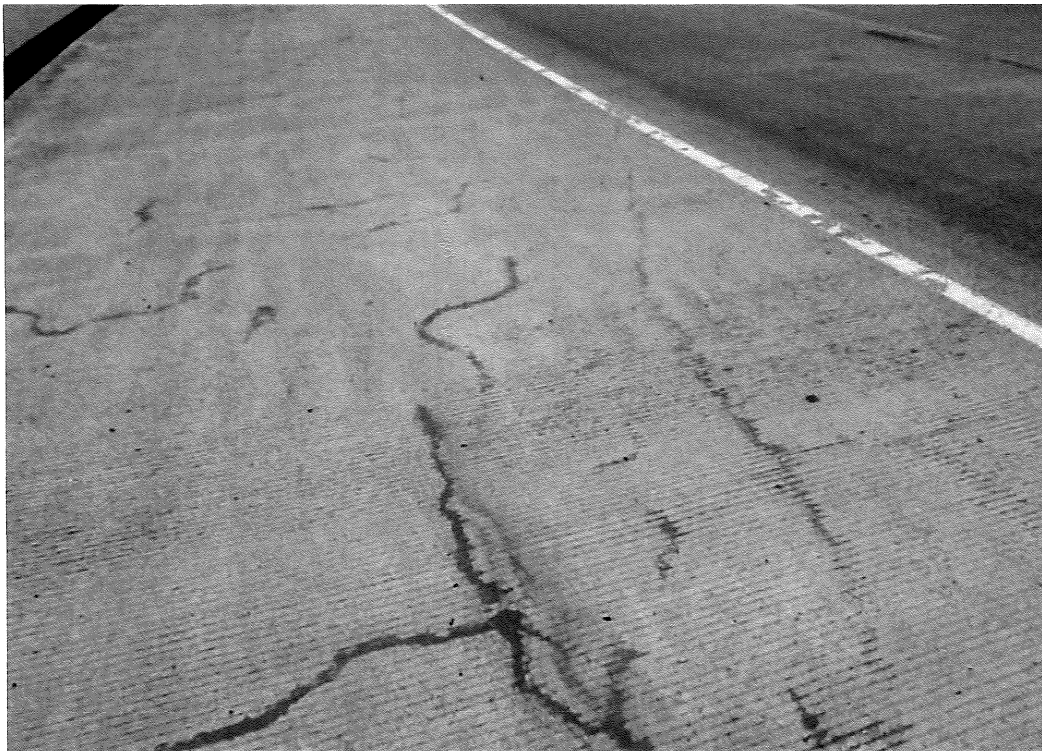
Photo 36

Deck surface, Span 2, NB lane - Structural crack with delamination along length.

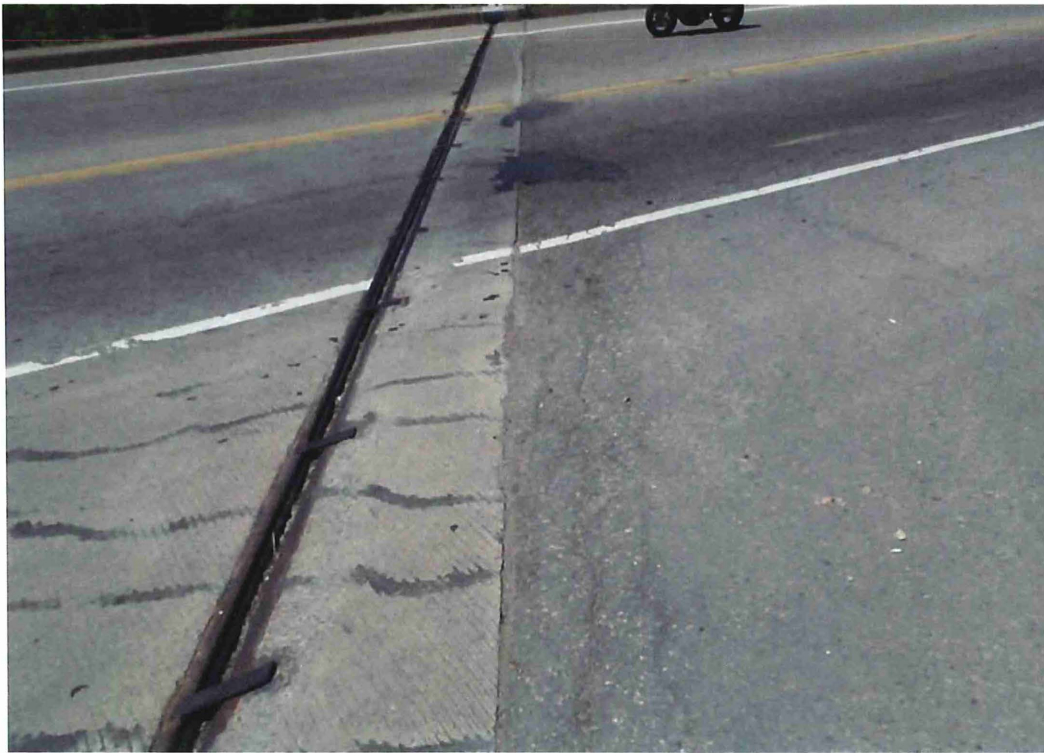
Photo 39

North approach pavement - Evidence of settlement full width of approach.

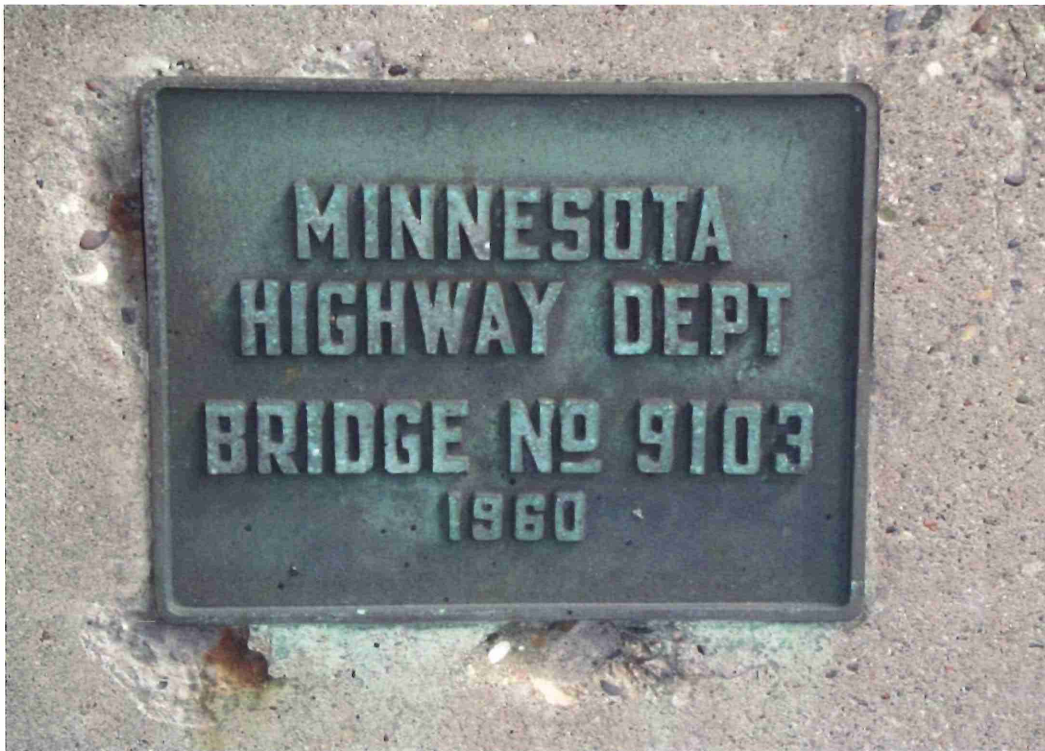
Photo 1

Bridge Name Plate

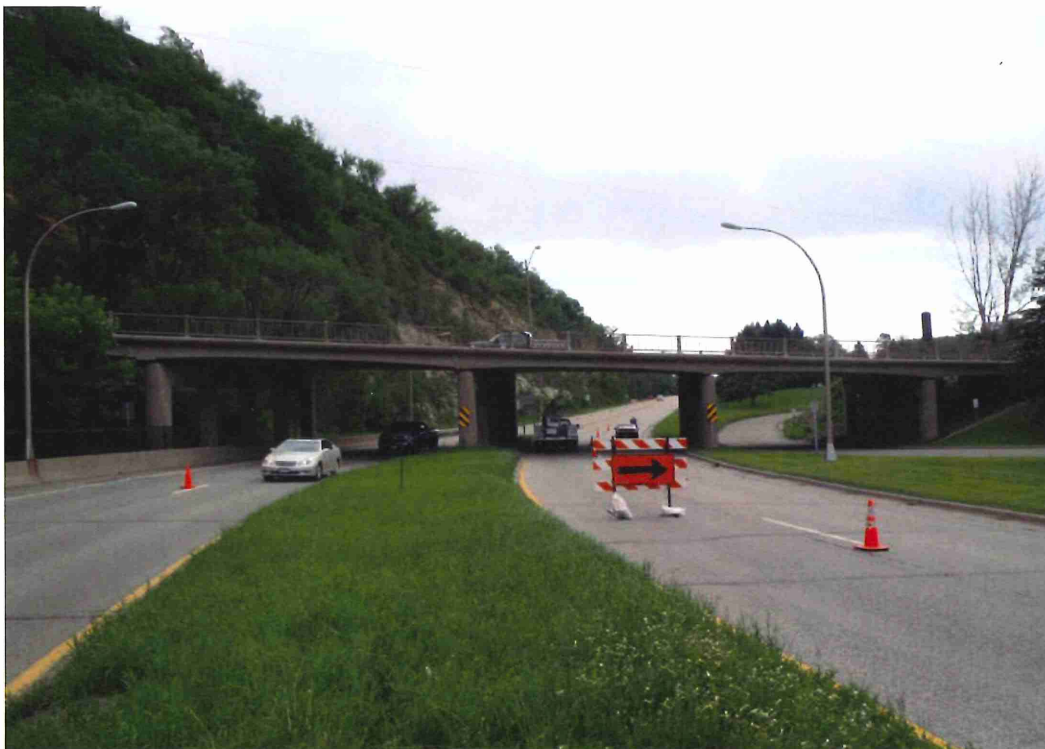
Photo 2

West Elevation

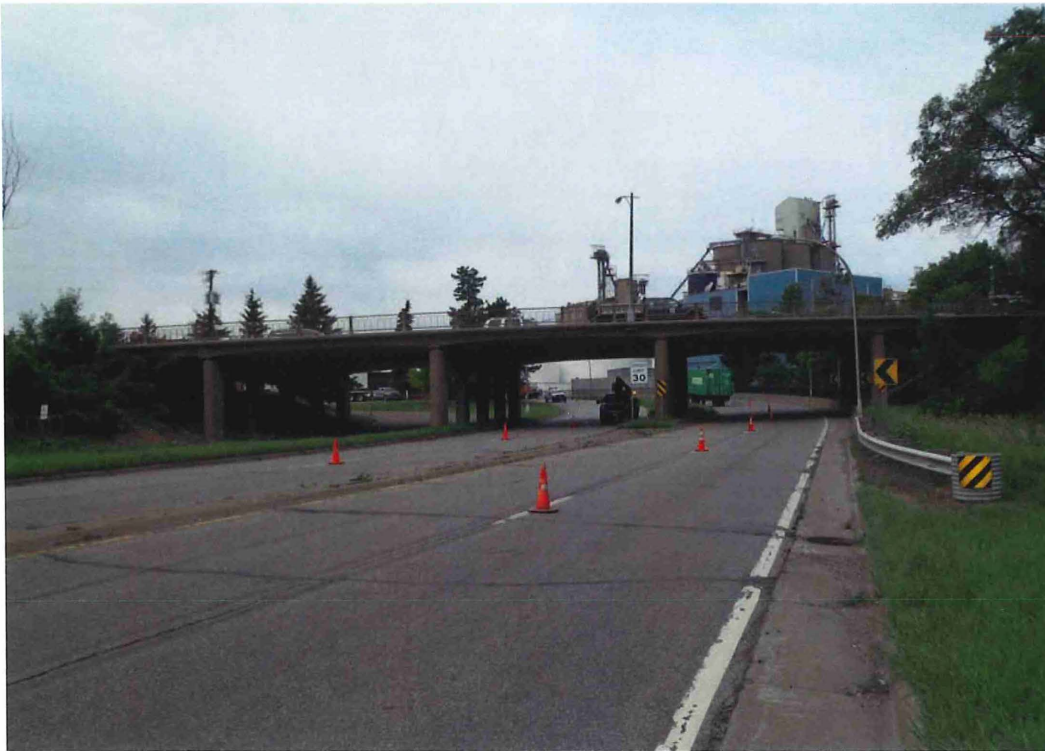
Photo 3

East Elevation

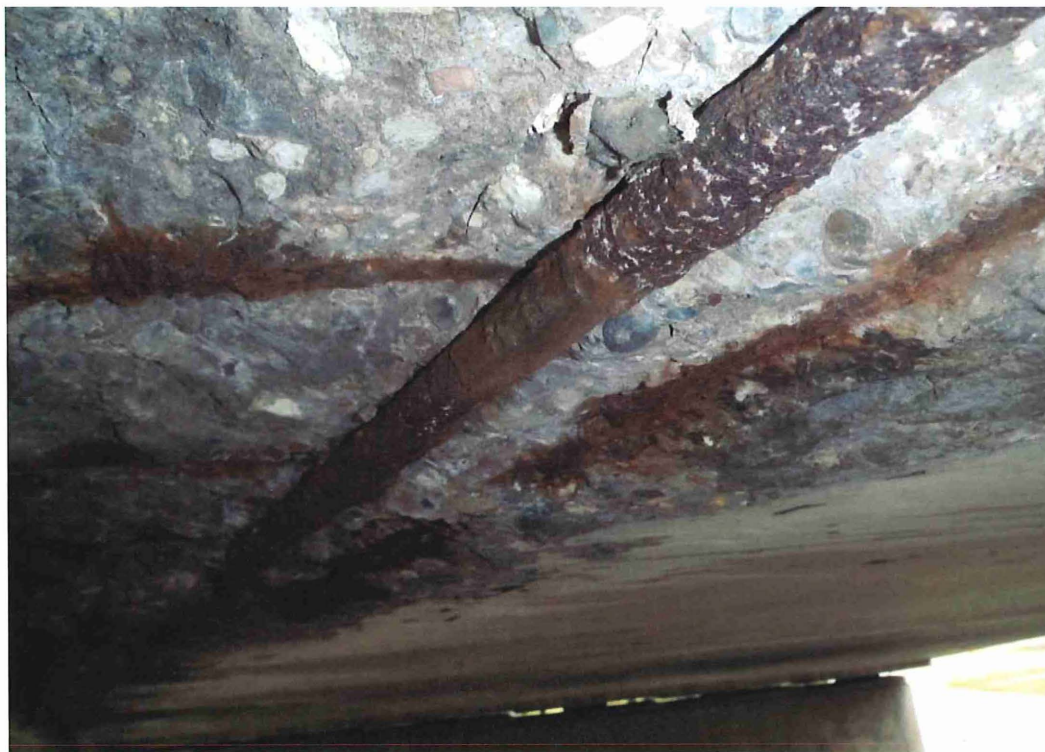
Photo 4

Span 3 - Section loss in two bars, 7/8" remain, starts 12' from Pier 3 and continues to midspan.

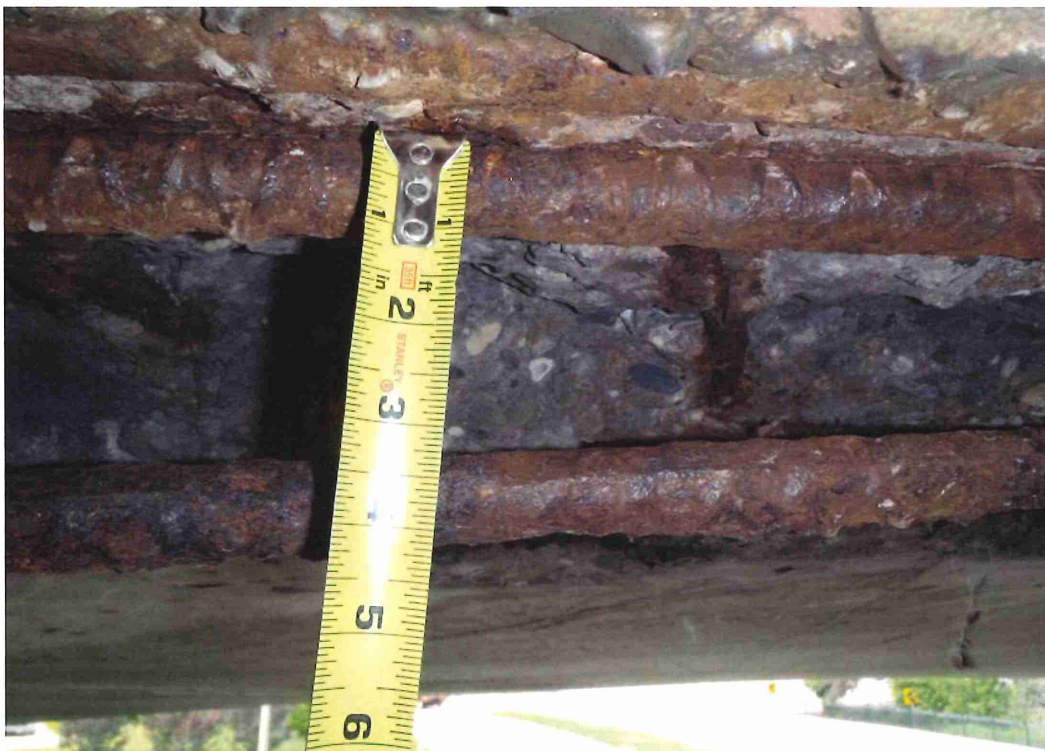
Photo 5

Span 3 - Section loss in two bars, 7/8" remain. Loss starts 12' from Pier 3 and continues to midspan

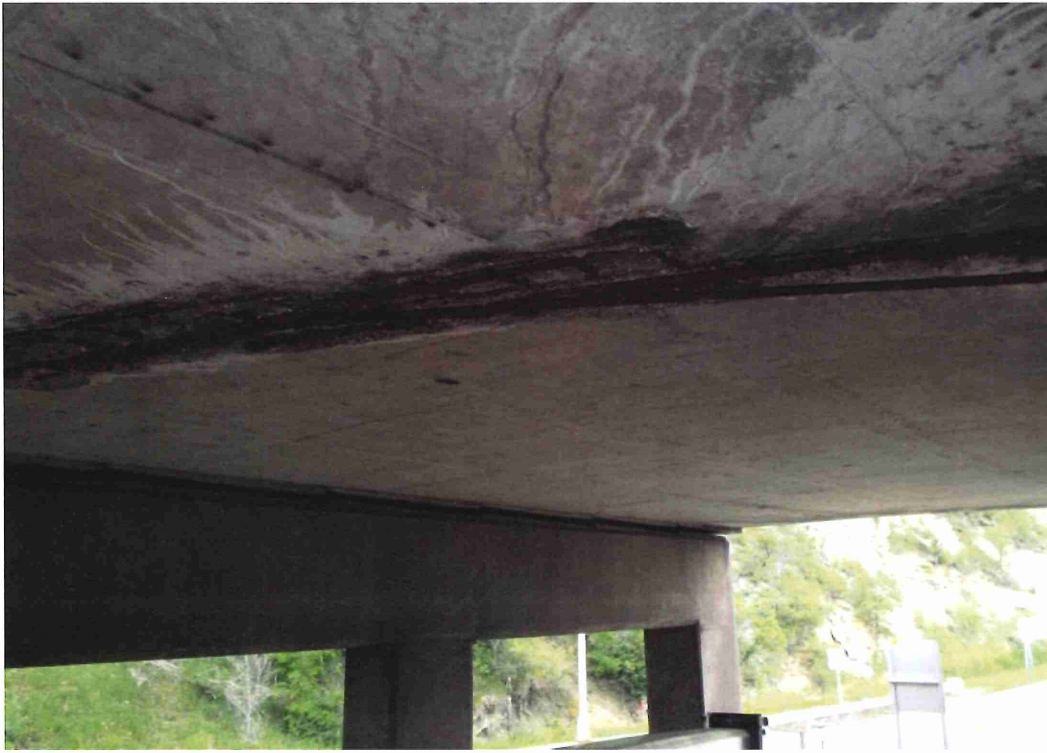
Photo 9

Span 3 - General view perpendicular to the street looking at the North half of the span.

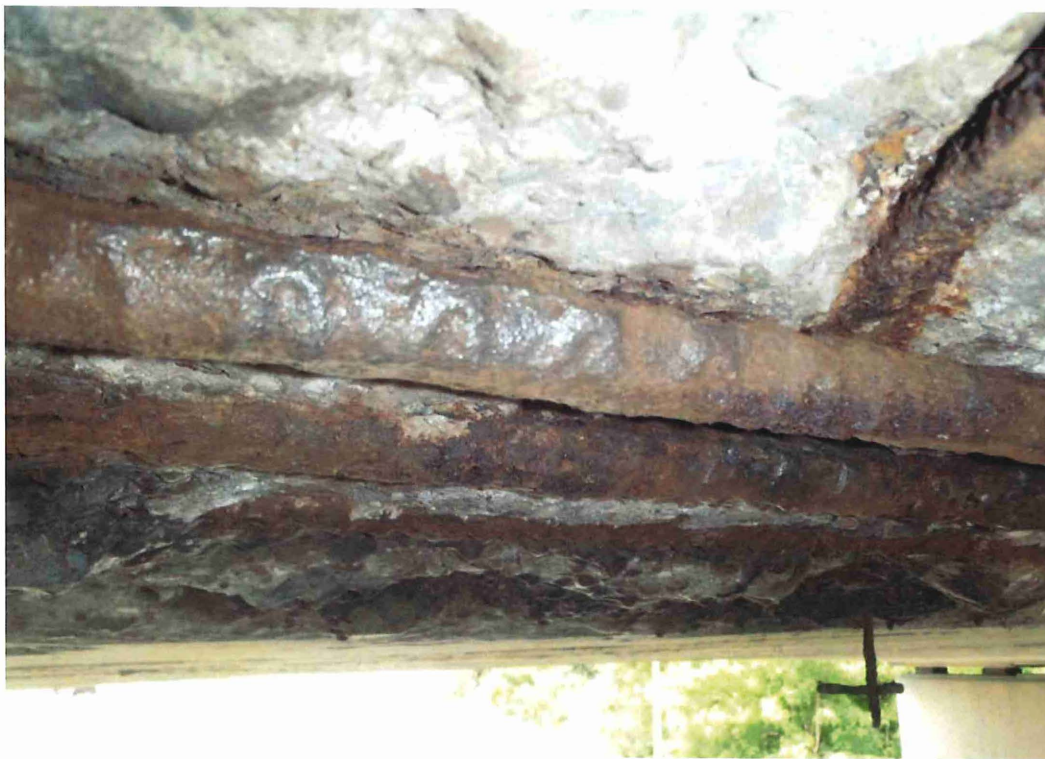
Photo 11

Span 4 - Close up of section loss at midspan, West side of the street.

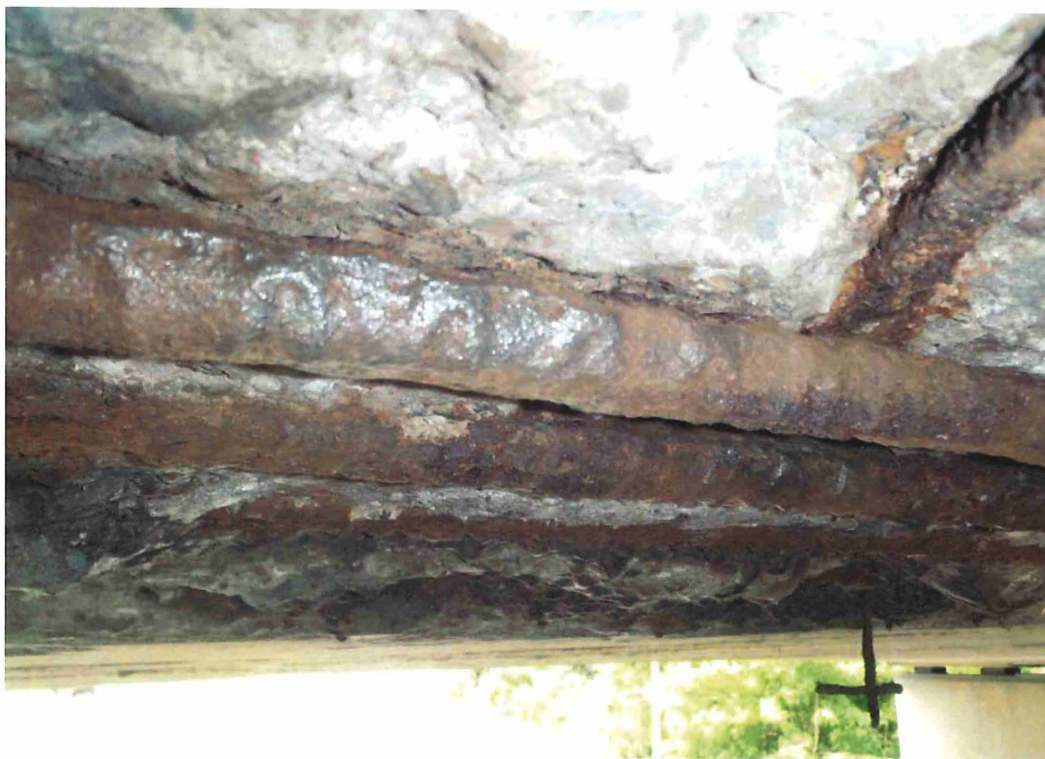
Photo 12

Span 4 - Section loss at midspan of the first rebar, East side of the street.

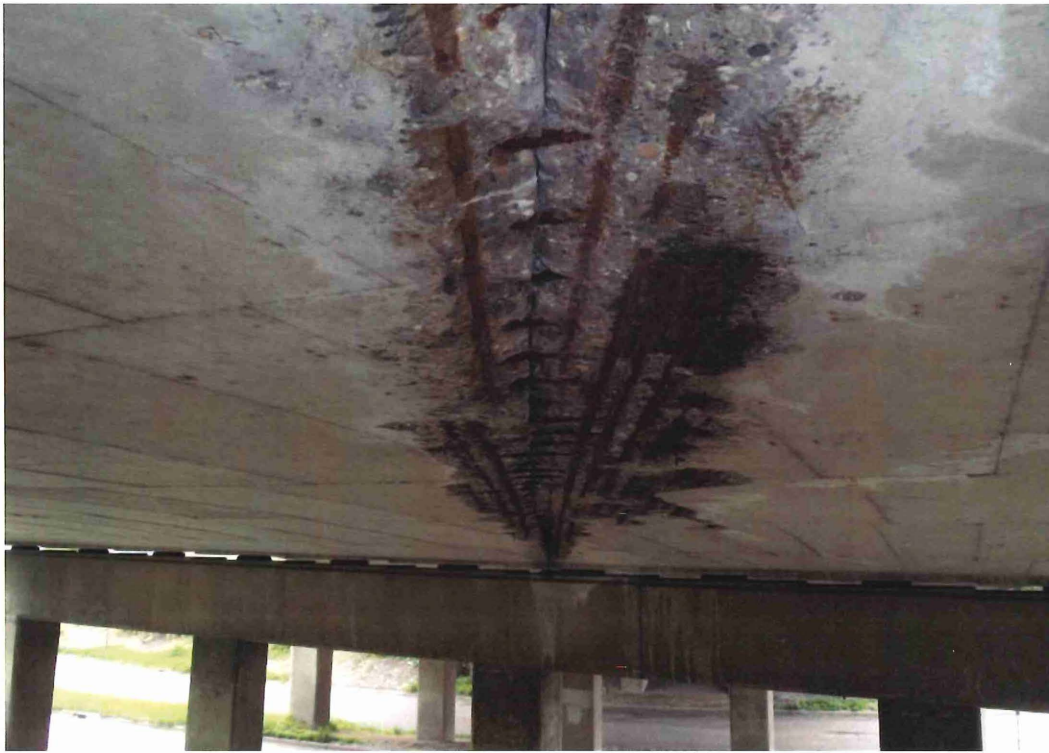
Photo 13

Span 4 - General view along the centerline.

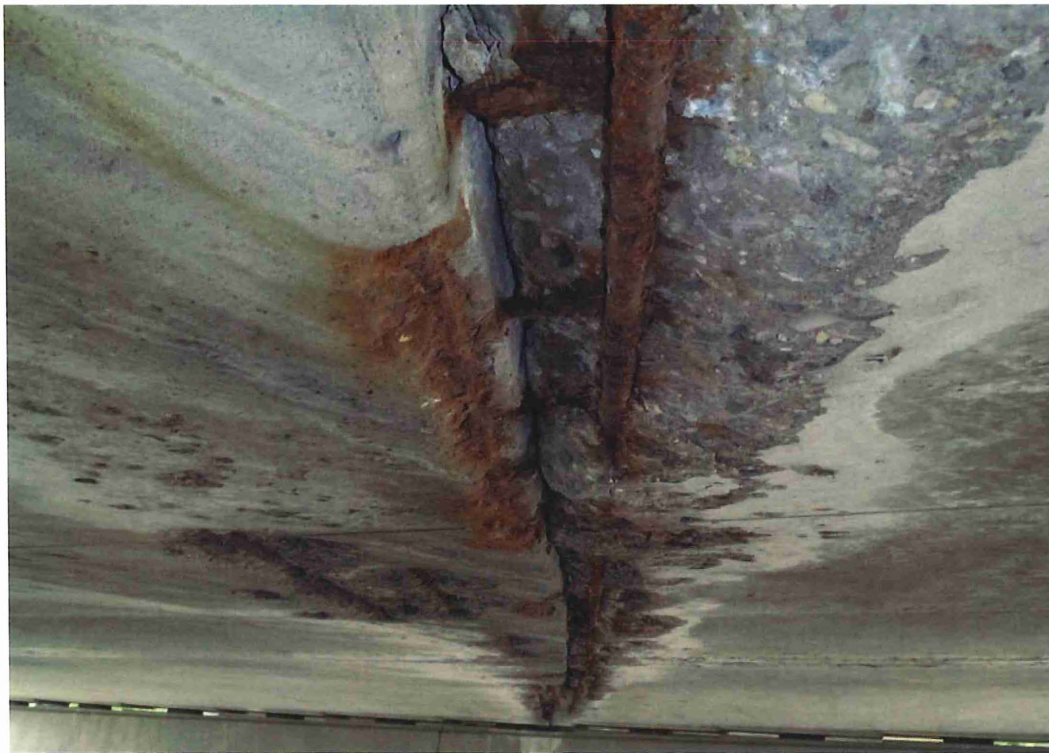
Photo 15

Span 3 - General view along centerline.

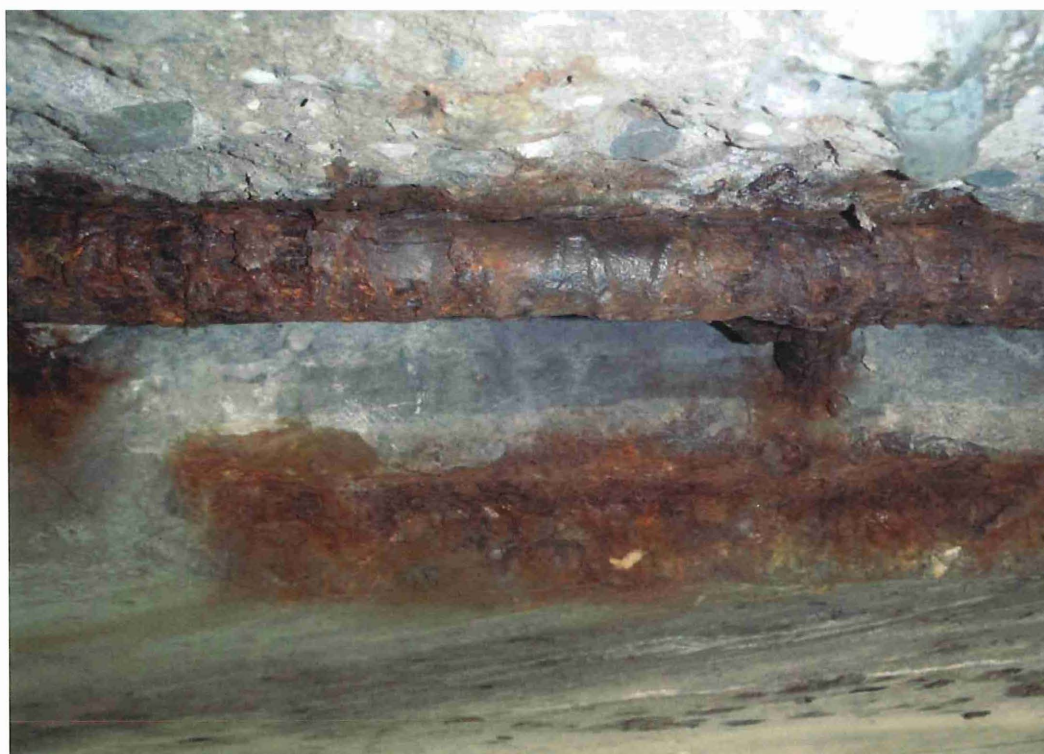
Photo 16

Span 3 - Section loss at the South end of the span.

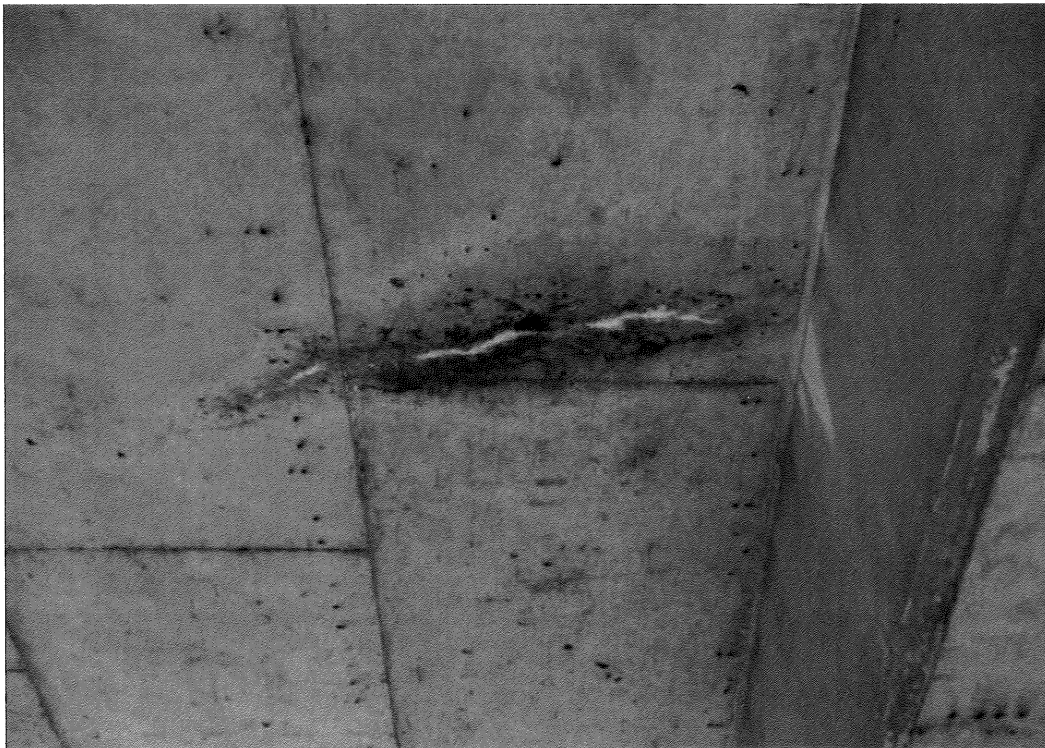
Photo 22

Span 5 - Hairline crack with efflorescence, concrete is sound.

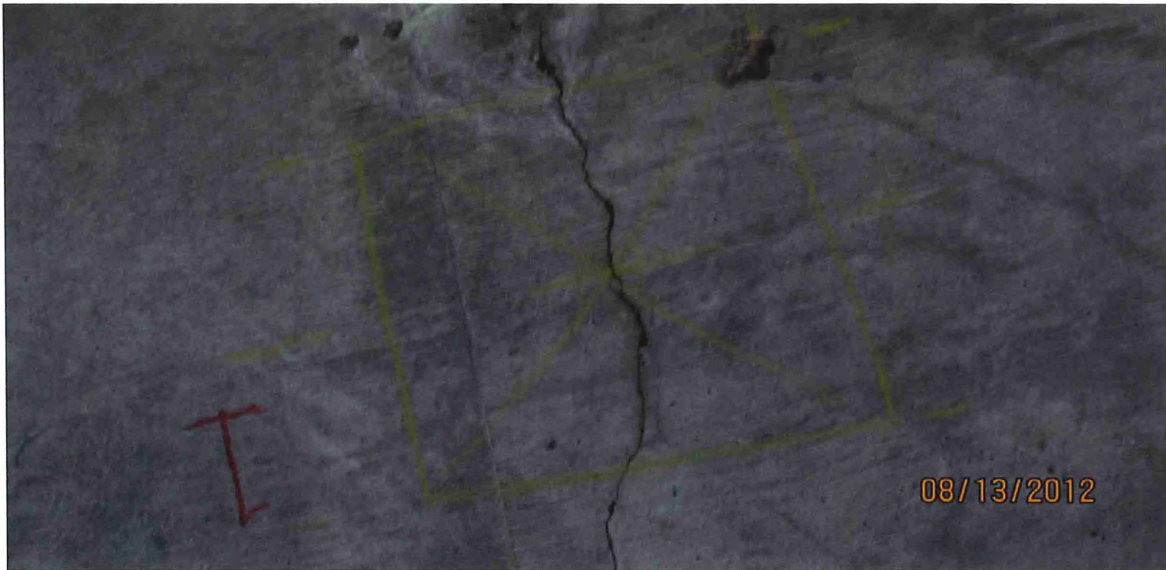
Bridge 9103 Destructive Testing 8/13/2012

Bridge No. 9103 is located in the City of Red Wing, North Hwy 63, District 6. The District Structures Section agree to perform destructive testing on the underside of the bridge deck to assess the extent of the concrete delamination and the condition of the reinforcing steel in the lower portion of the deck. We selected six sample locations which were agreed upon during an earlier meeting. The sample locations were selected near cracking that seemed to represent suspect areas of the under deck, and away from the center line joint where deterioration could be easily observed.

The Owatonna Bridge Crew did the sampling for us. The predetermined sample locations were marked out and labeled on a Bridge map of 9103 produced in an earlier inspections. The sample areas are approximately 1'x 1' in area exposing one or two rebar in most samples. We found that in most cases there was little or no rust on the reinforcing steel. The sample areas were then sealed with paint to slow down future rusting from exposure. I have attached photos below illustrating the results of our assessment. If we can assist you in any other manner concerning Bridge 9103 please let us know. Thanks!

Sample # 1 Location 2' North of South abutment centered over a crack east of center line.
