# **Bridge 9103 Rehabilitation Study Final Report Red Wing, Minnesota**

**August 2013**

**Submitted to  
Minnesota Department of Transportation**

**Prepared by  
HDR Engineering, Inc.  
and  
Gemini Research**

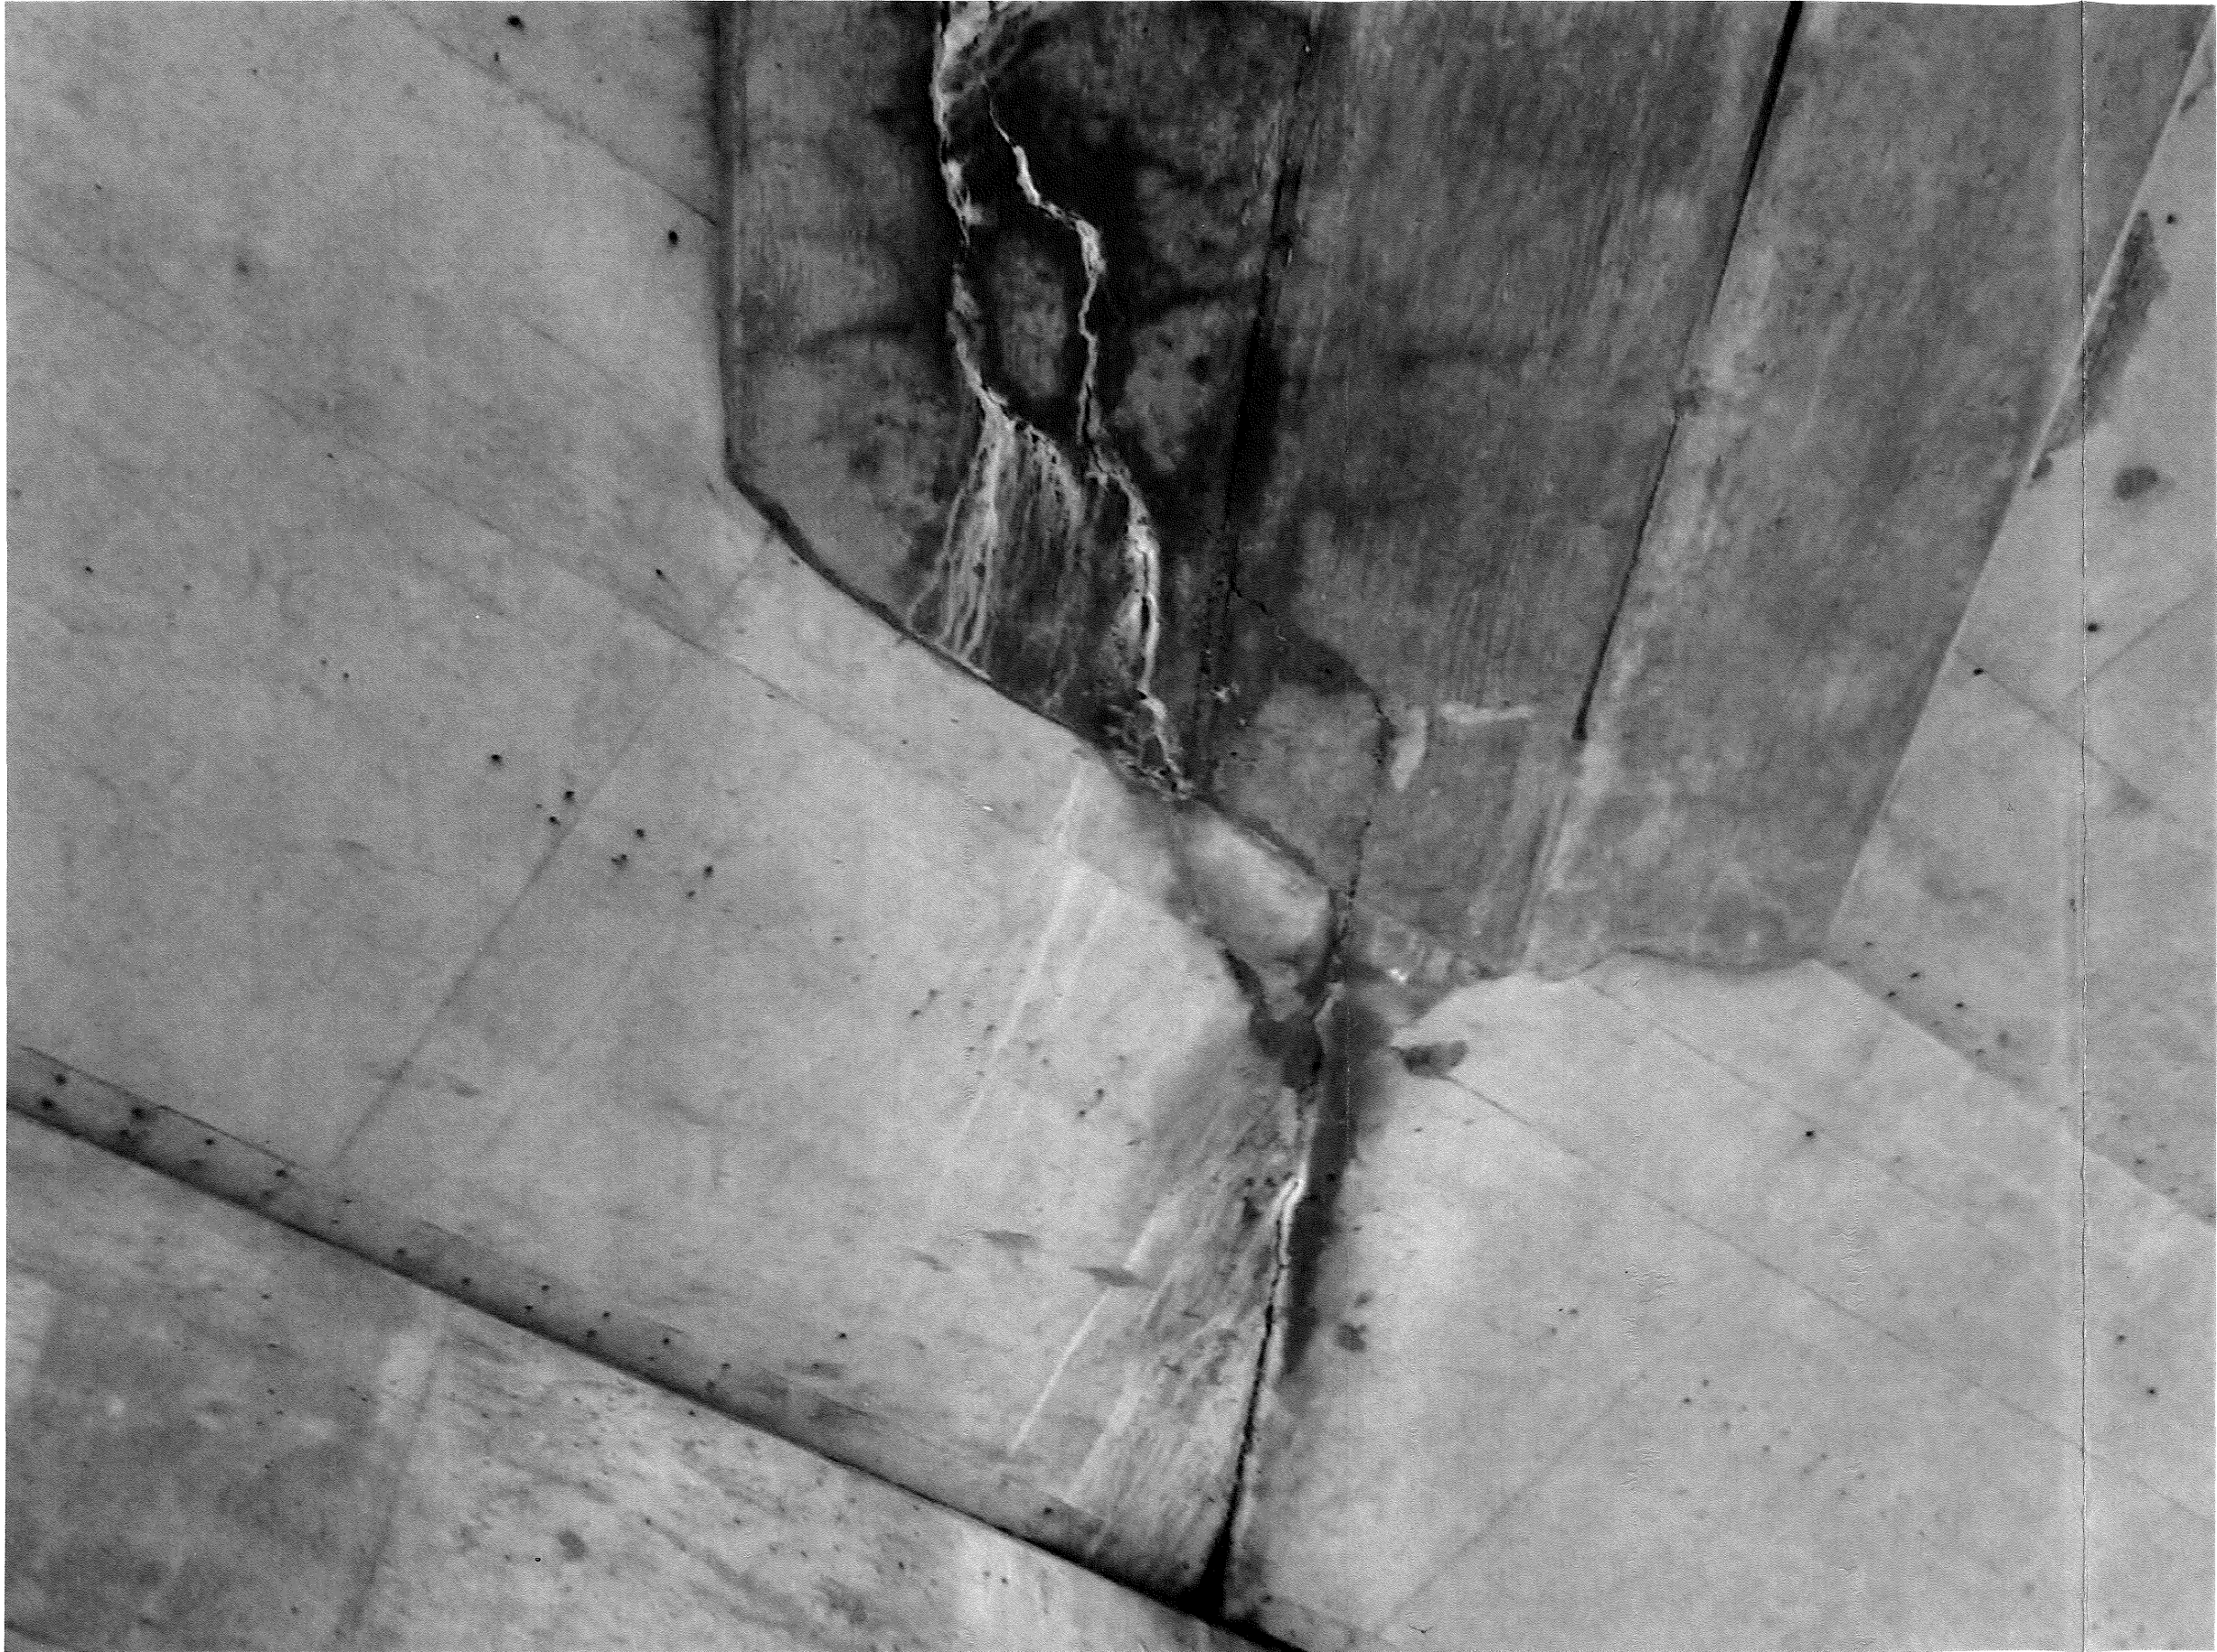
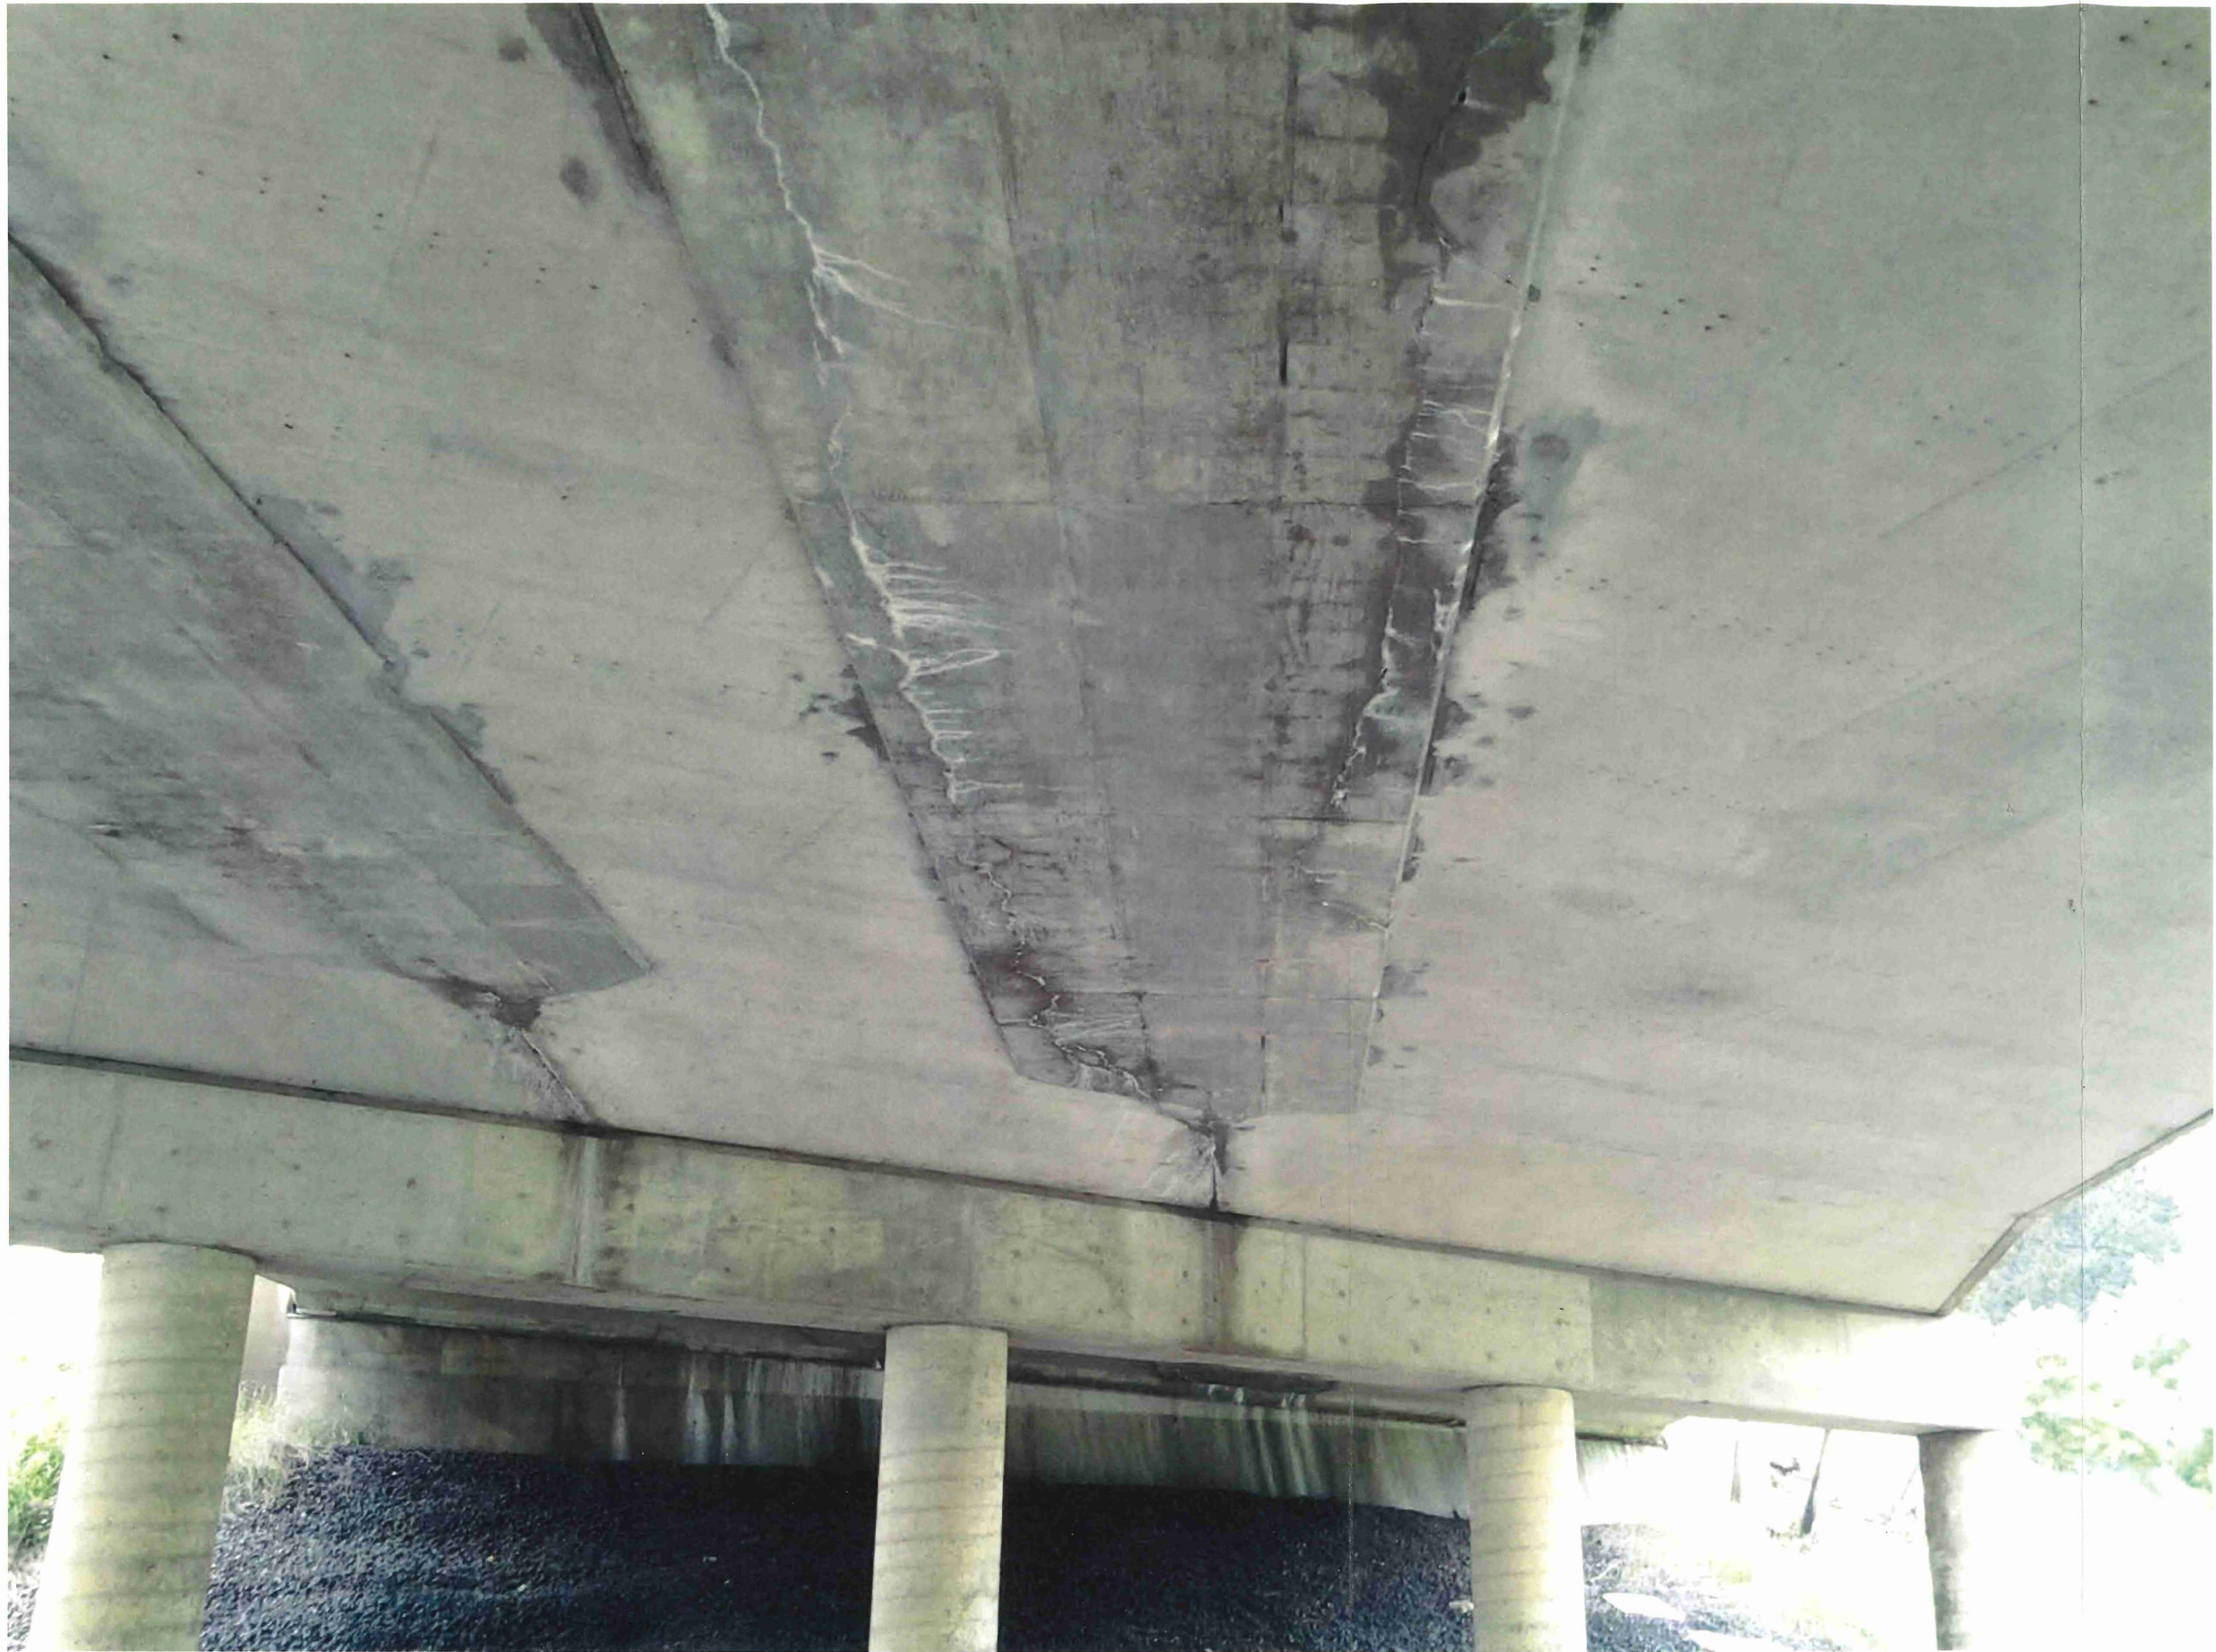
Bridge B-17-0054 (I-94 westbound over USH 12 in Menomonie Wisconsin):

- Originally built in 1959
- Deck repair/replacement in 1984
  - Consisted of removal and replacement of 3 feet wide section along longitudinal construction joints
  - Overlaid after full depth repair was made
- Deck repair/replacement in 2003
  - Full depth repair from 1984 was redone due to failure
  - Structure was re-overlaid after full depth repair was made
- Pictures of current condition attached, 2013
  - Full depth patch is failing
  - Appear that the deterioration is spreading into the original concrete

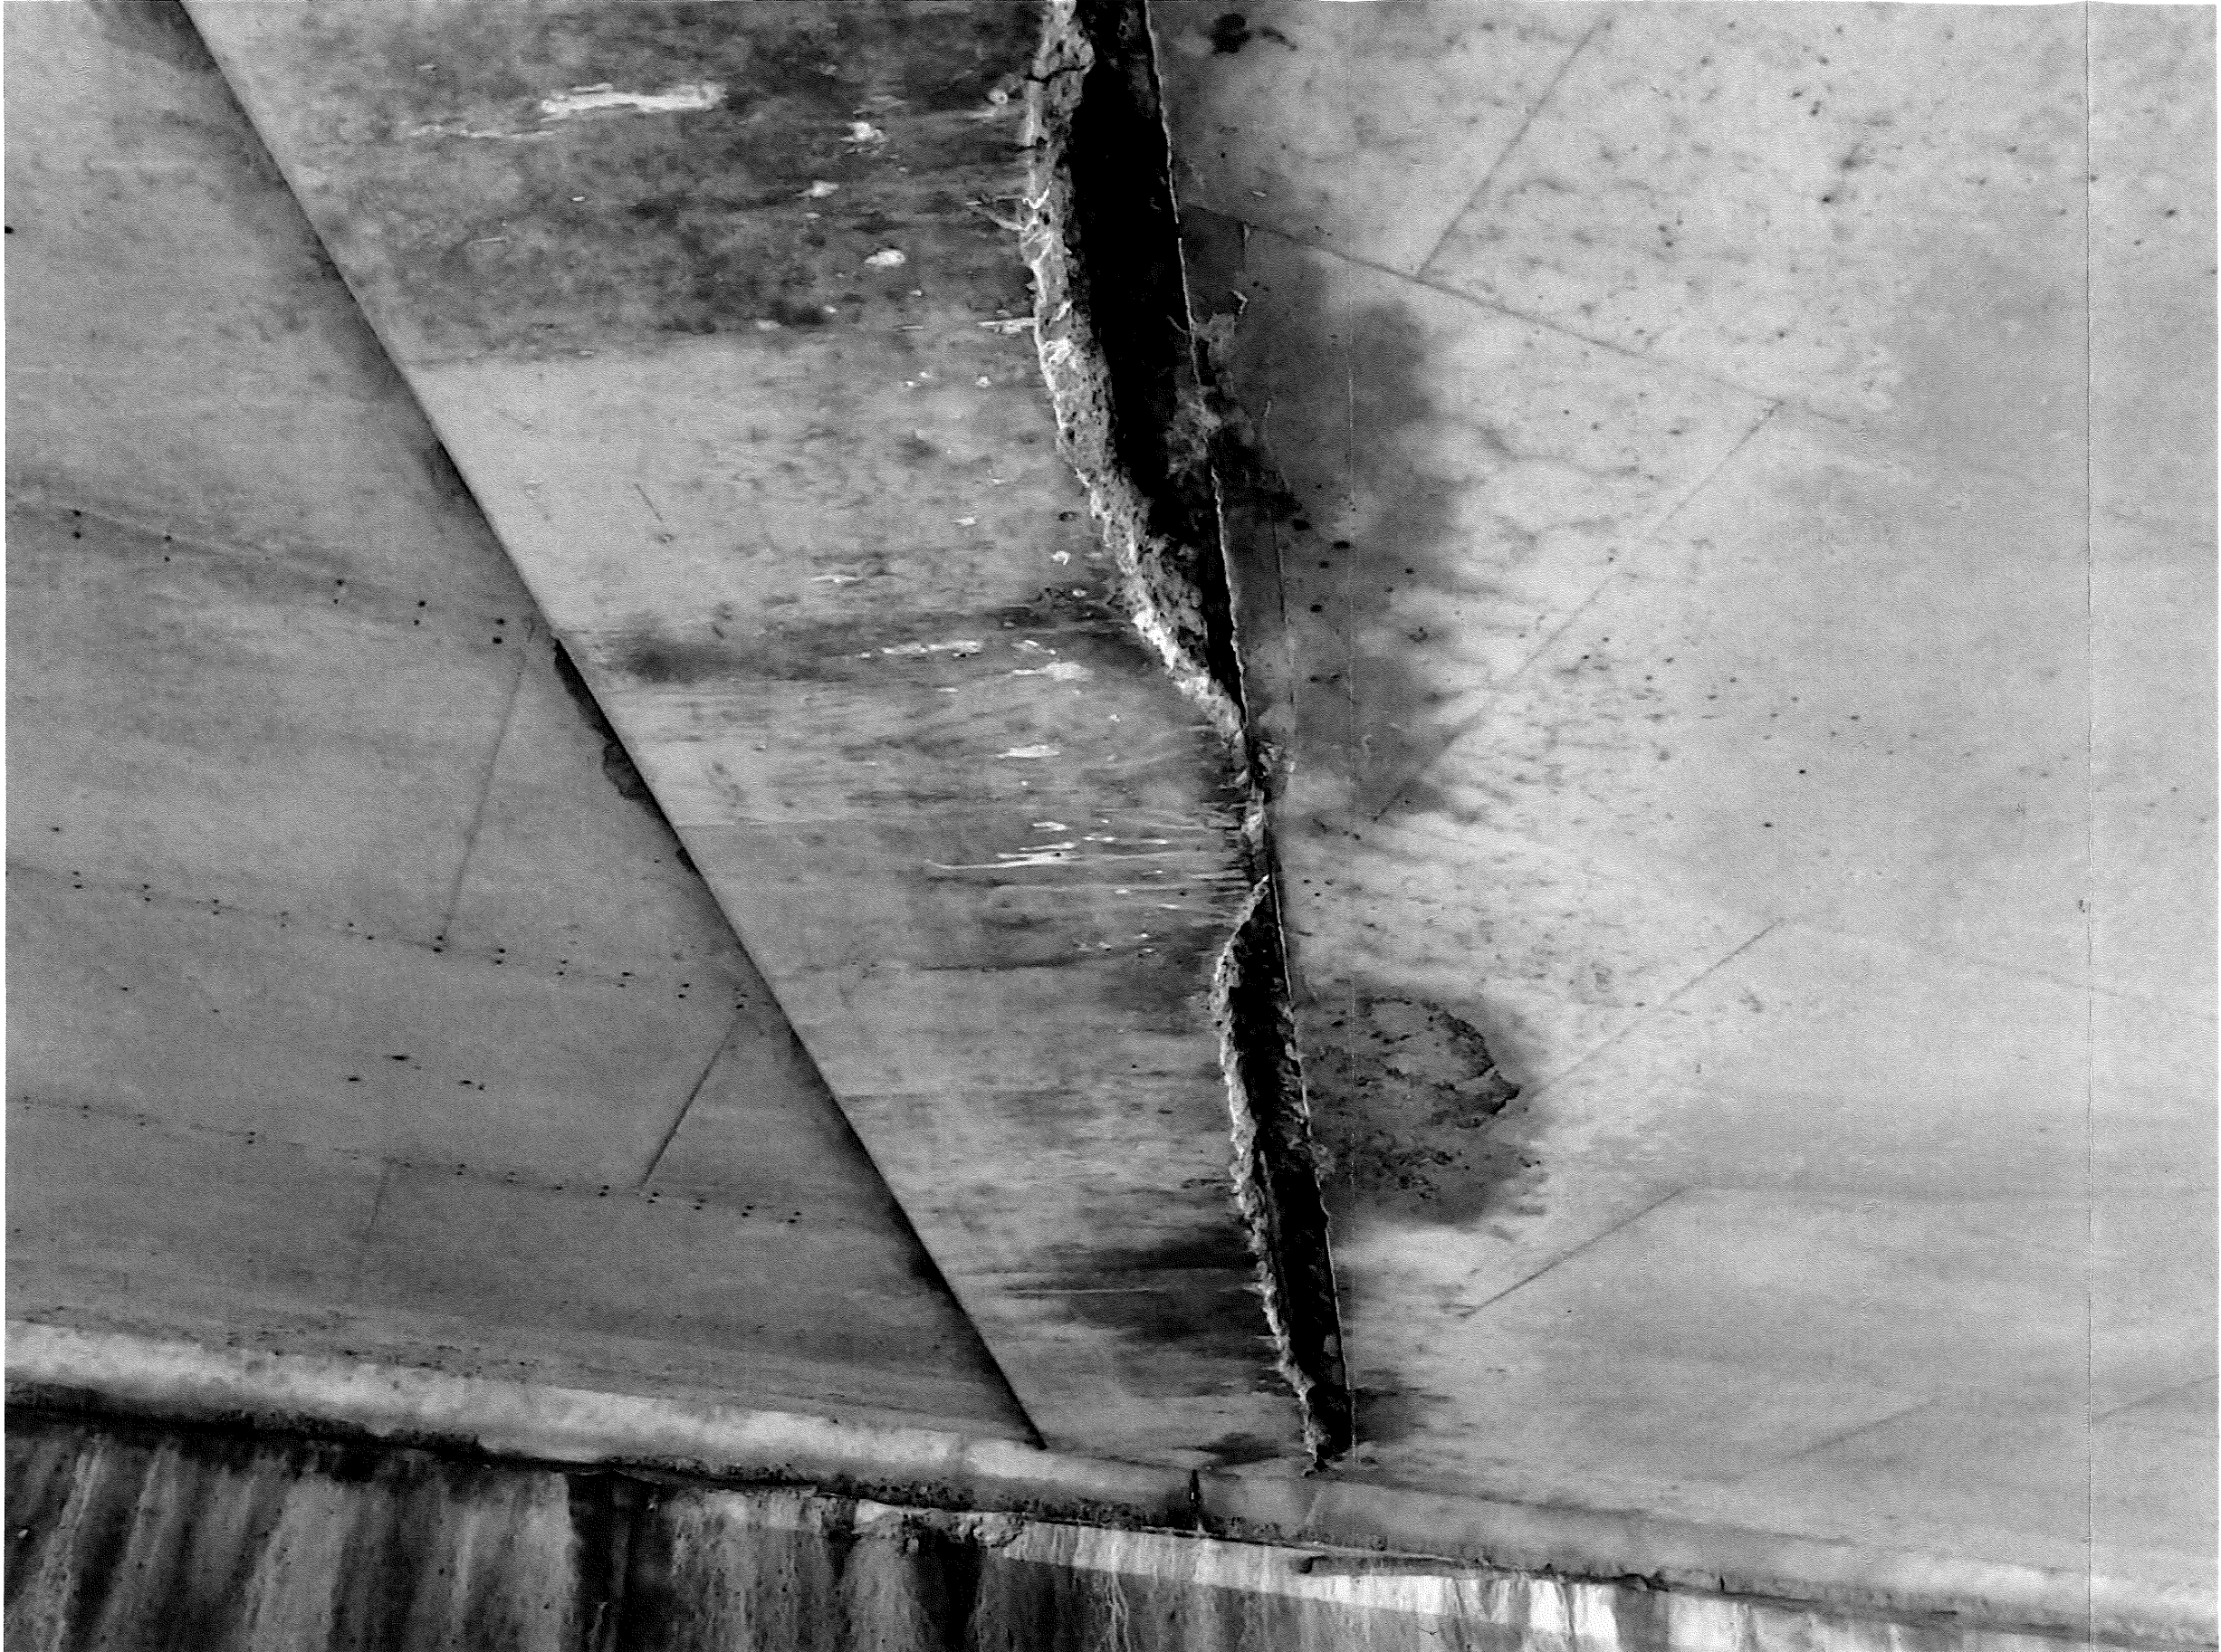
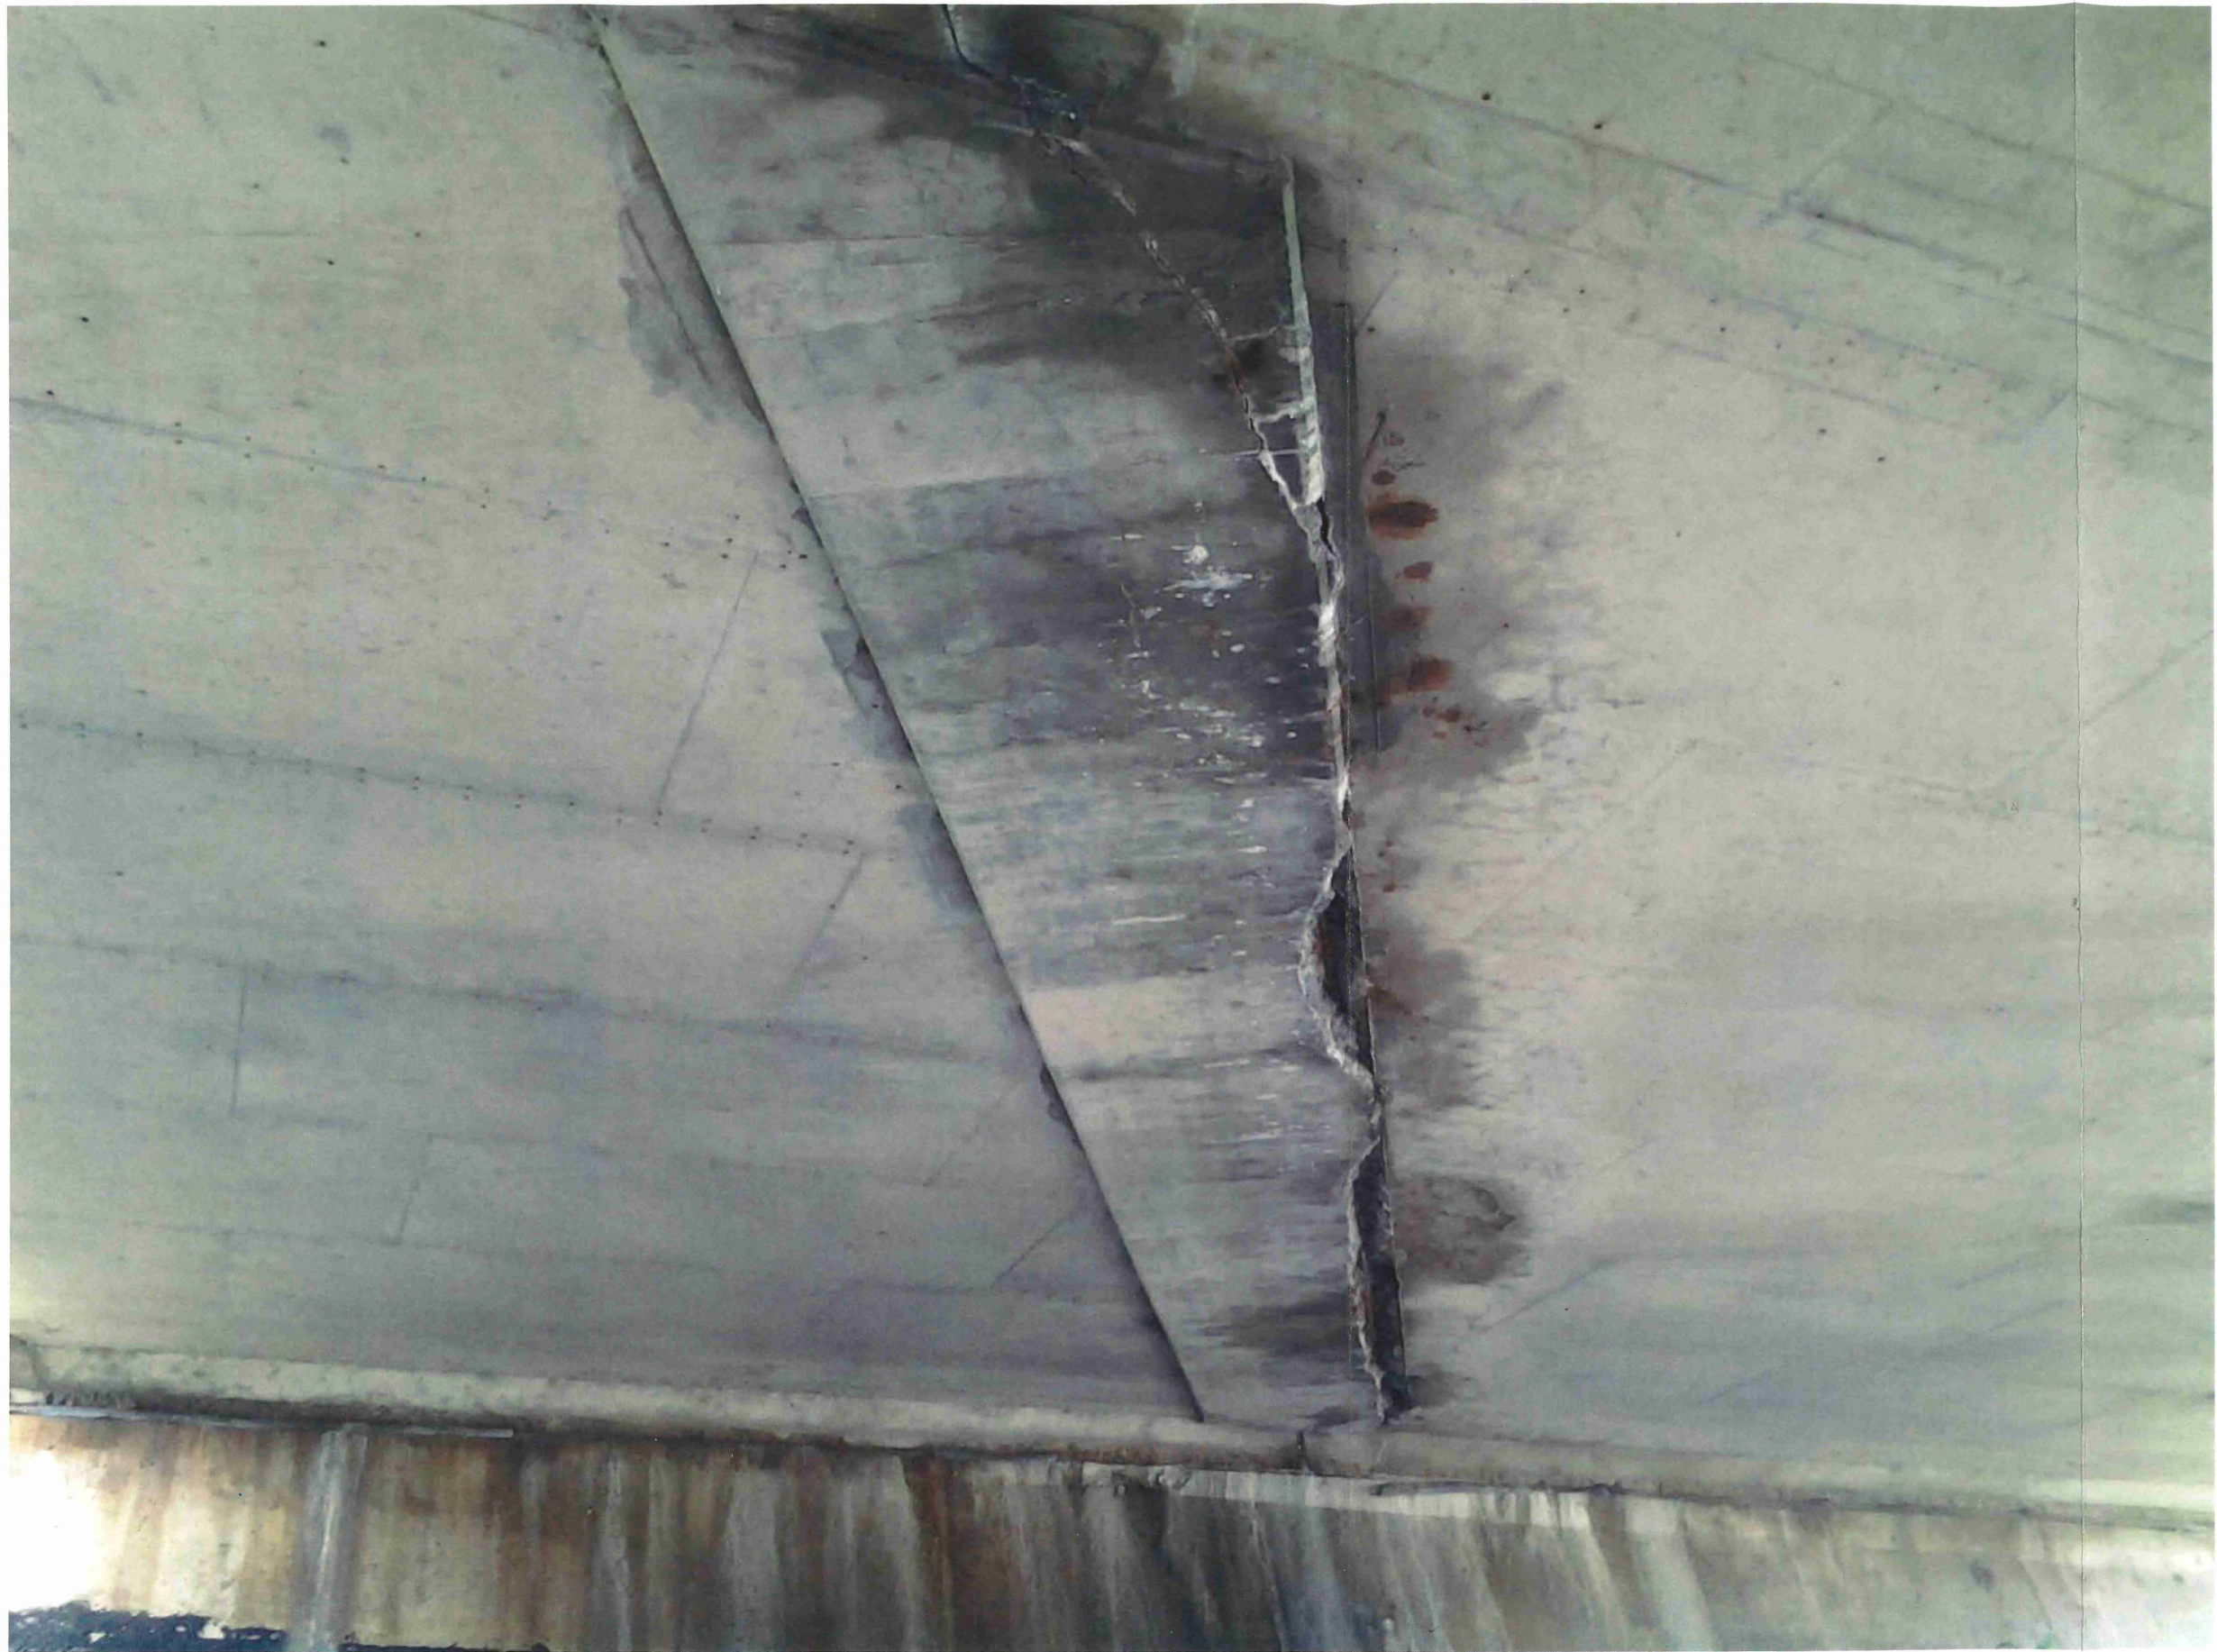
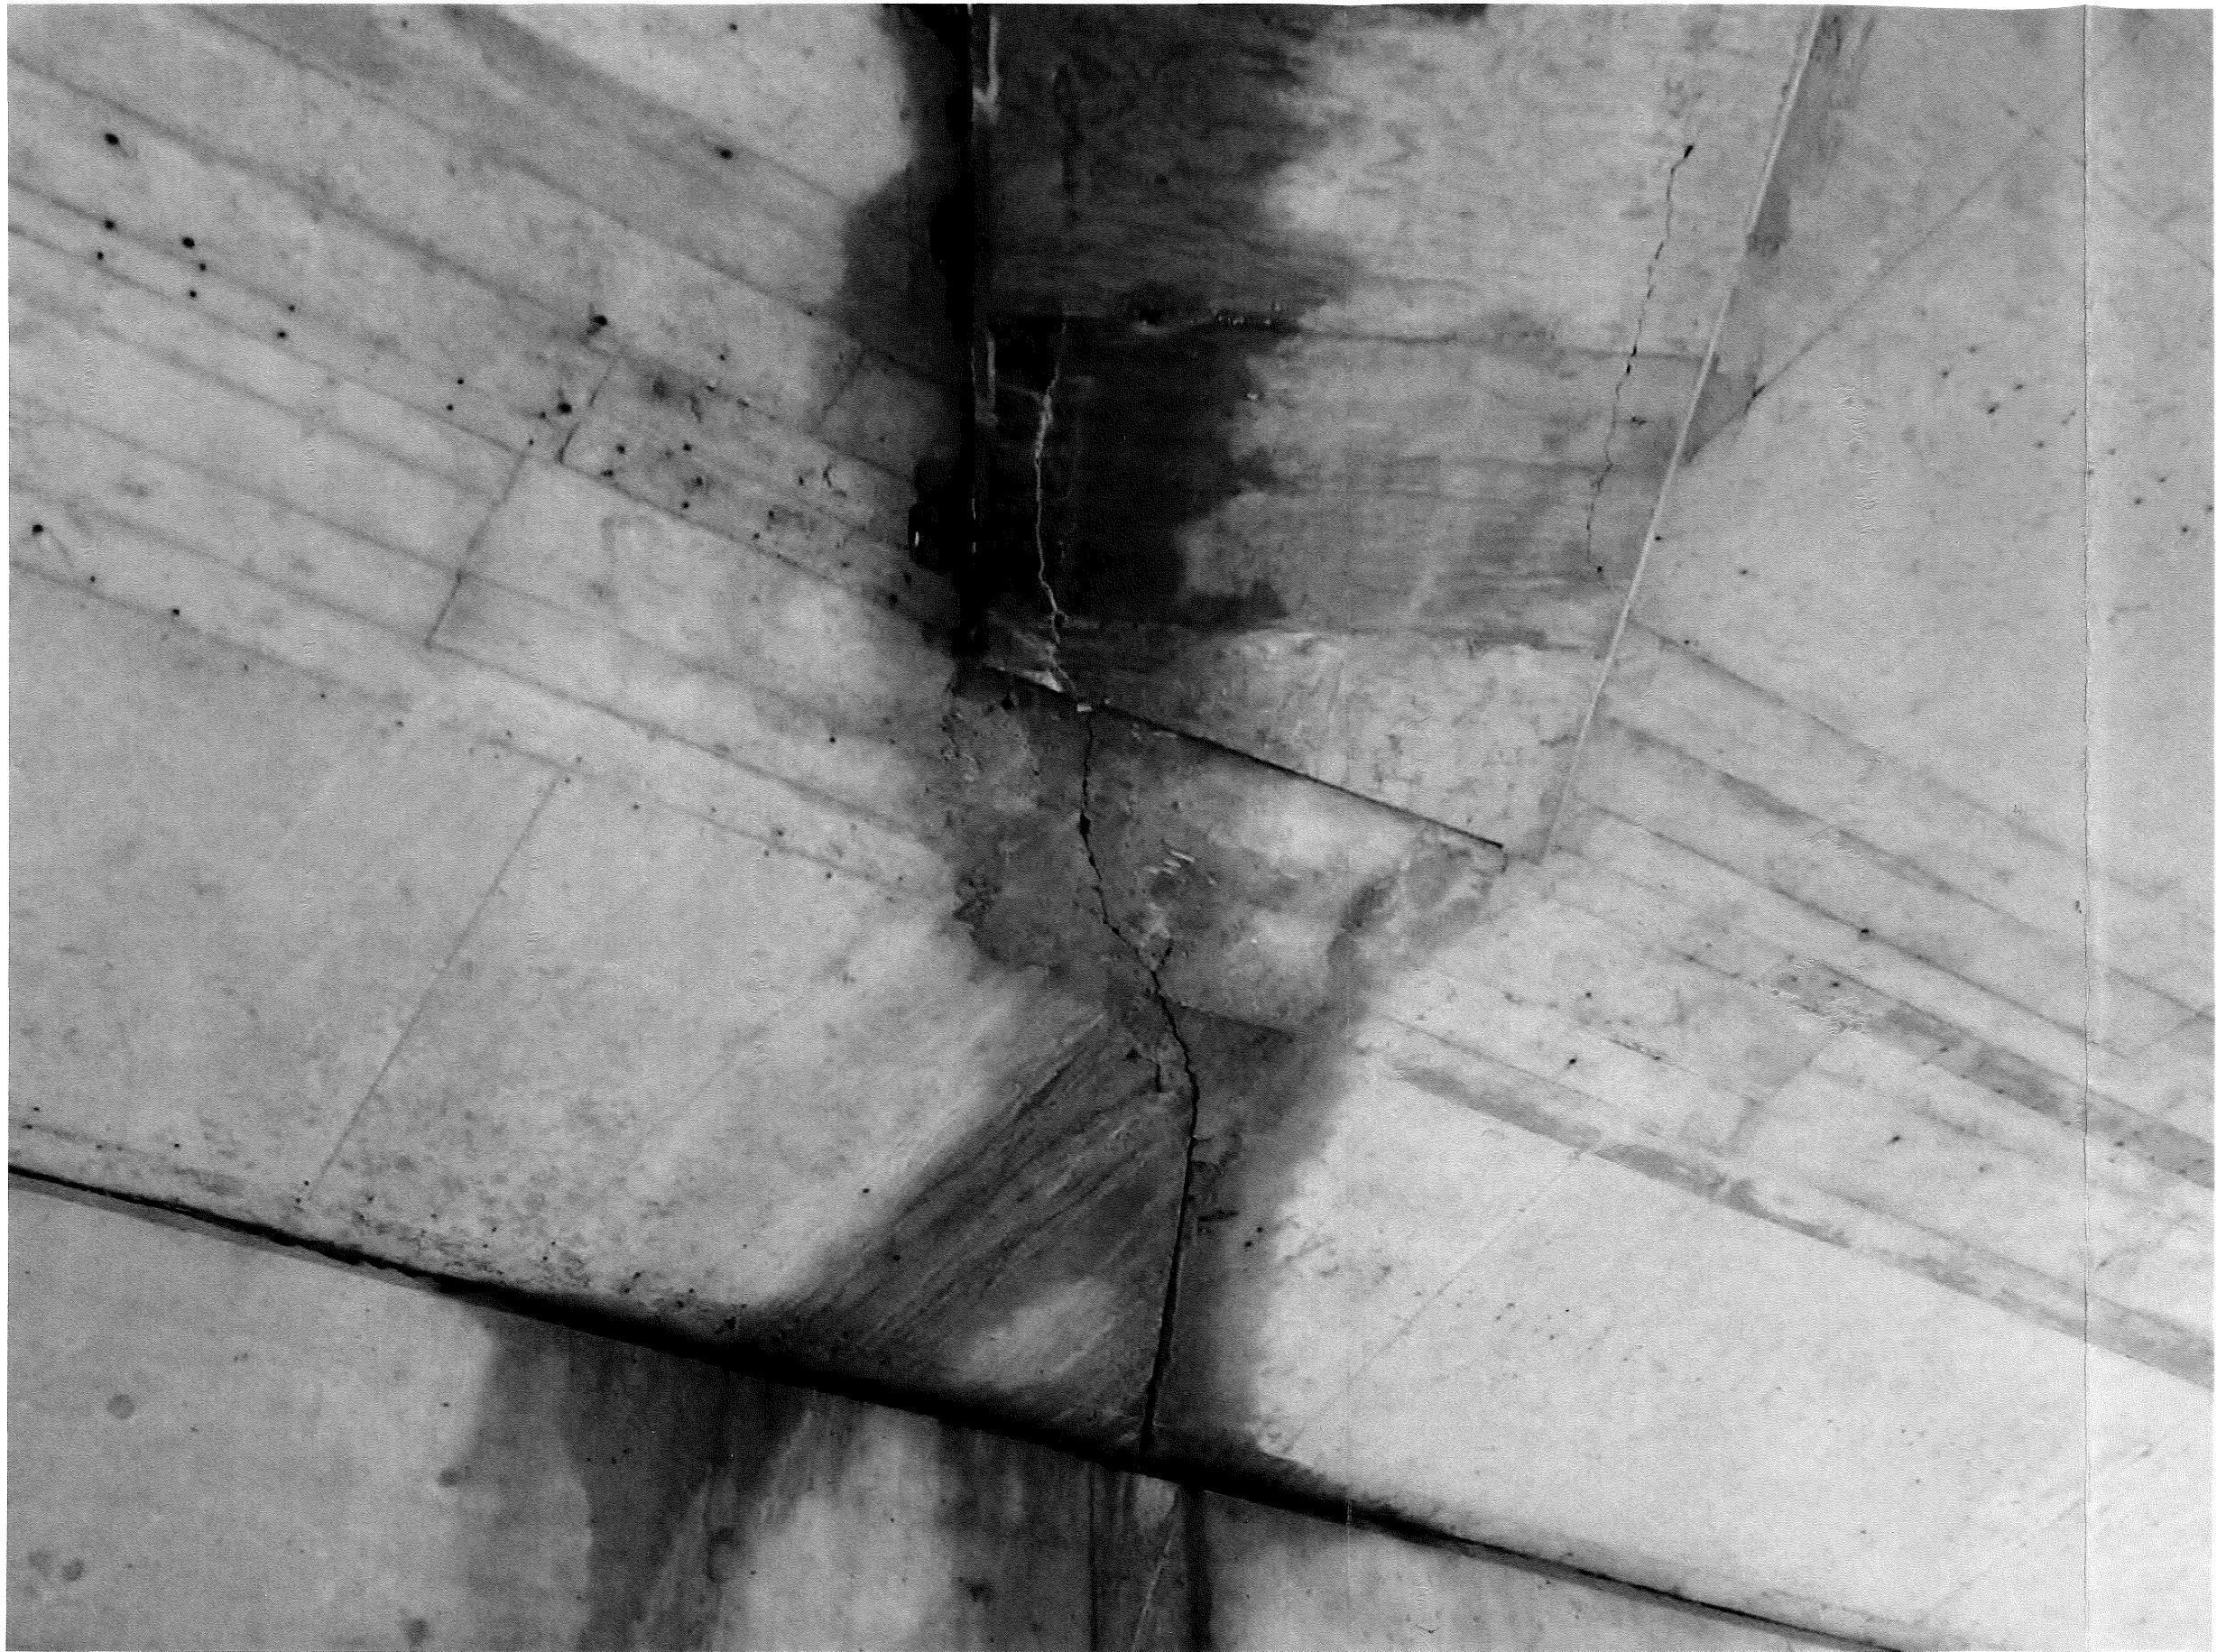
- Consisted of removal and replacement of 3 feet wide section along longitudinal construction joints
  - Overlaid after full depth repair was made
- Deck repair/replacement in 2003
  - Full depth repair from 1984 was redone due to failure
  - Structure was re-overlaid after full depth repair was made
- Pictures of current condition attached, 2013
  - Full depth patch is failing
  - Appear that the deterioration is spreading into the original concrete
