# **Bridge 9103 Rehabilitation Study Final Report Red Wing, Minnesota**

**August 2013**

**Submitted to  
Minnesota Department of Transportation**

**Prepared by  
HDR Engineering, Inc.  
and  
Gemini Research**

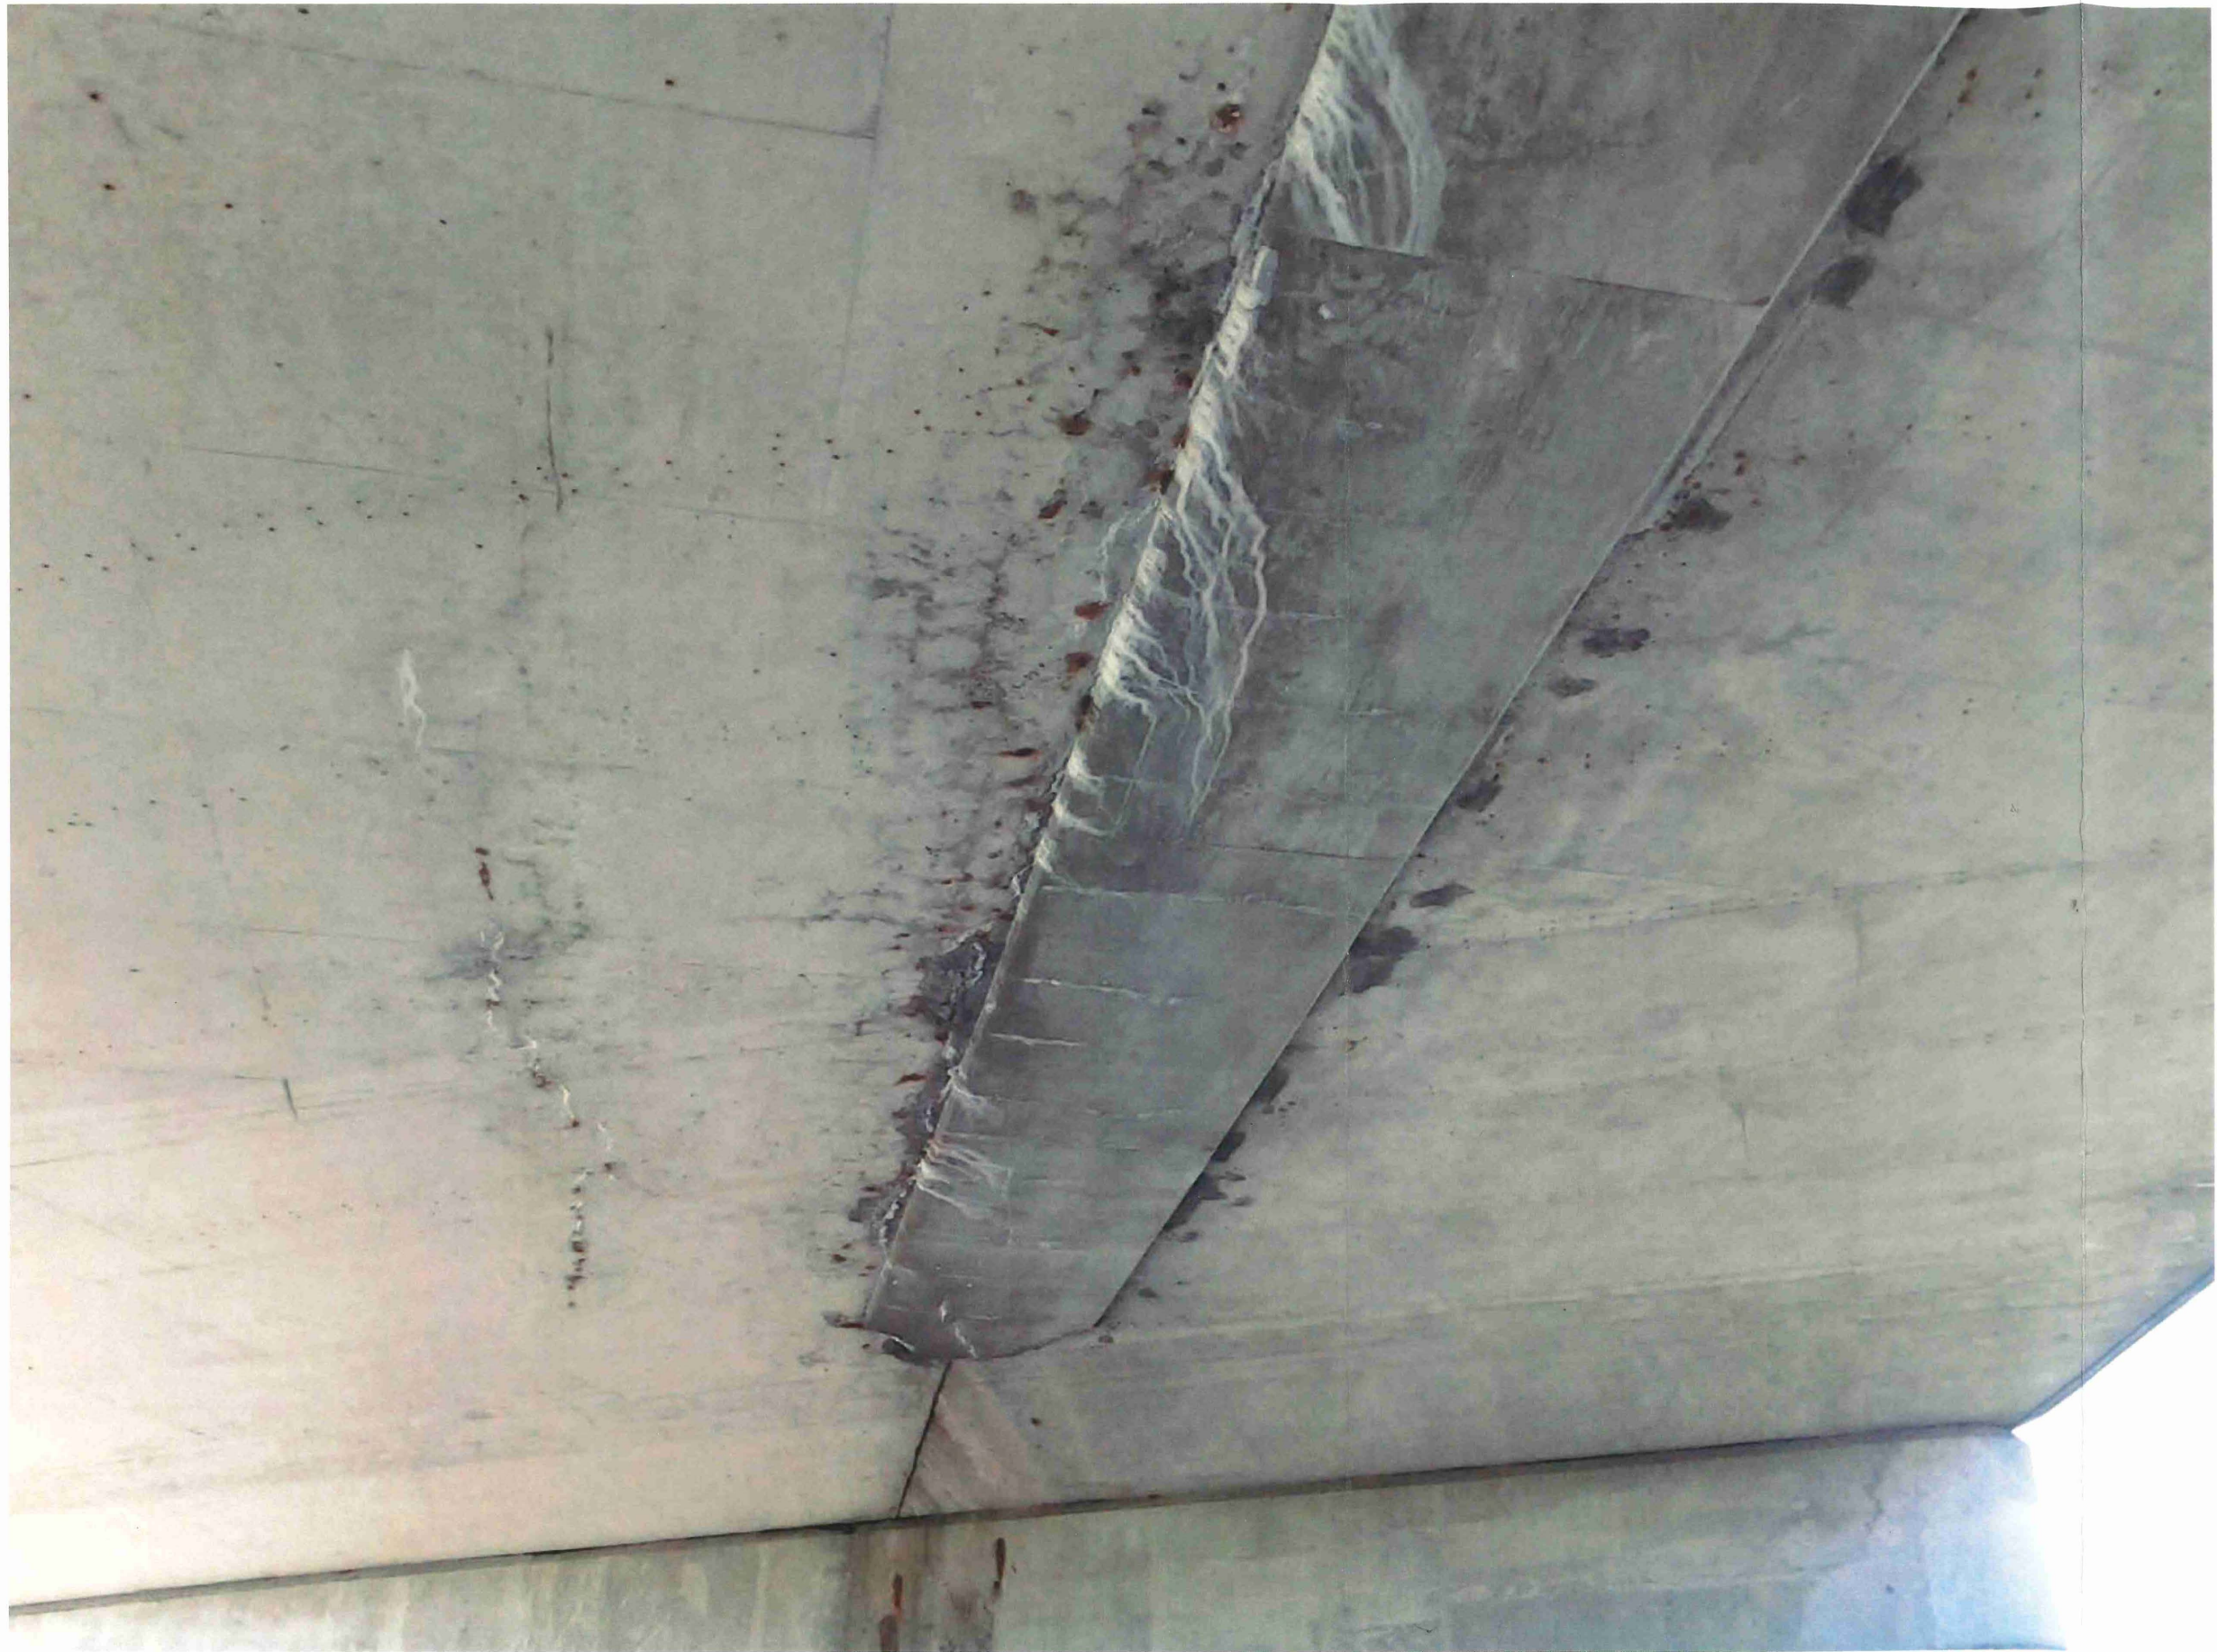
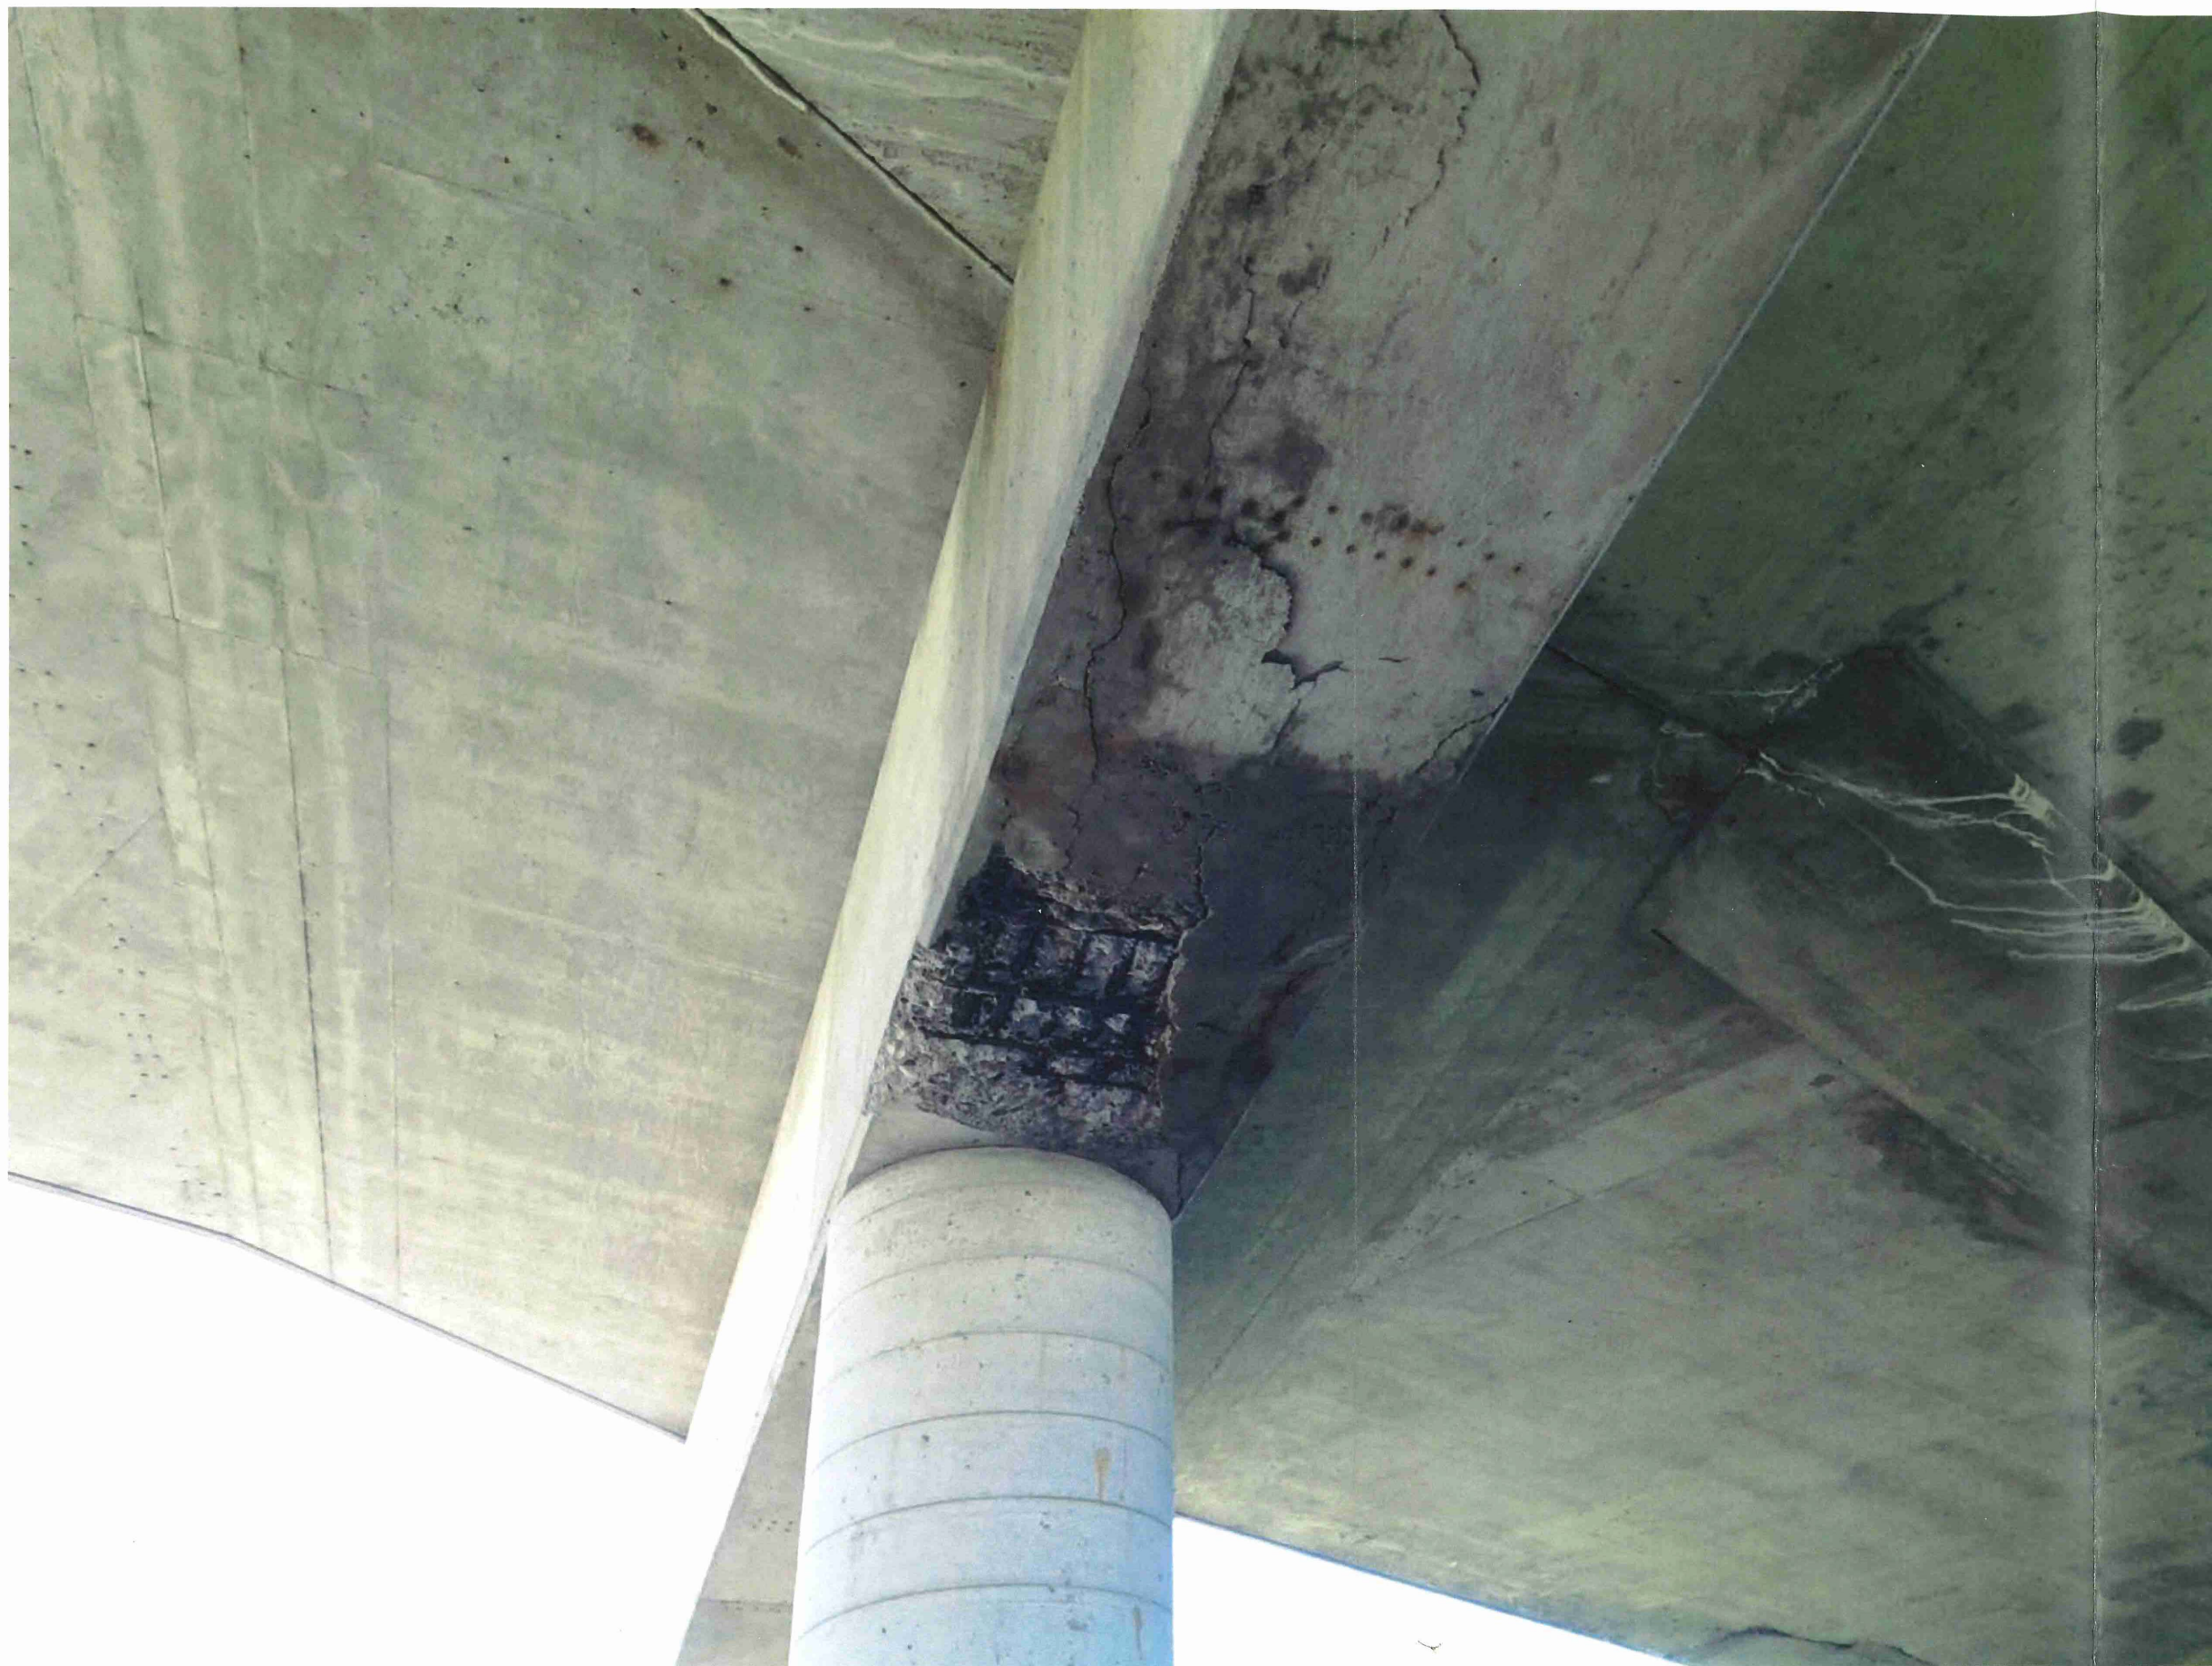
- Consisted of removal and replacement of 3 feet wide section along centerline construction joint
- Overlaid after full depth was repair made
- Deck repair/replacement in 2001
  - Full depth repair from 1981 was redone due to failure
  - Structure was re-overlaid after full depth repair was made
- Pictures of current condition attached, 2013
  - Failure of the full depth patch area is imminent
  - Leaching through the patch has caused corrosion and section loss in the pier
