LEGACY FUND RESTORATION EVALUATION REPORT

Technical Panel Findings and Recommendations—Fiscal Year 2015

Report to the Legislature

October 2016

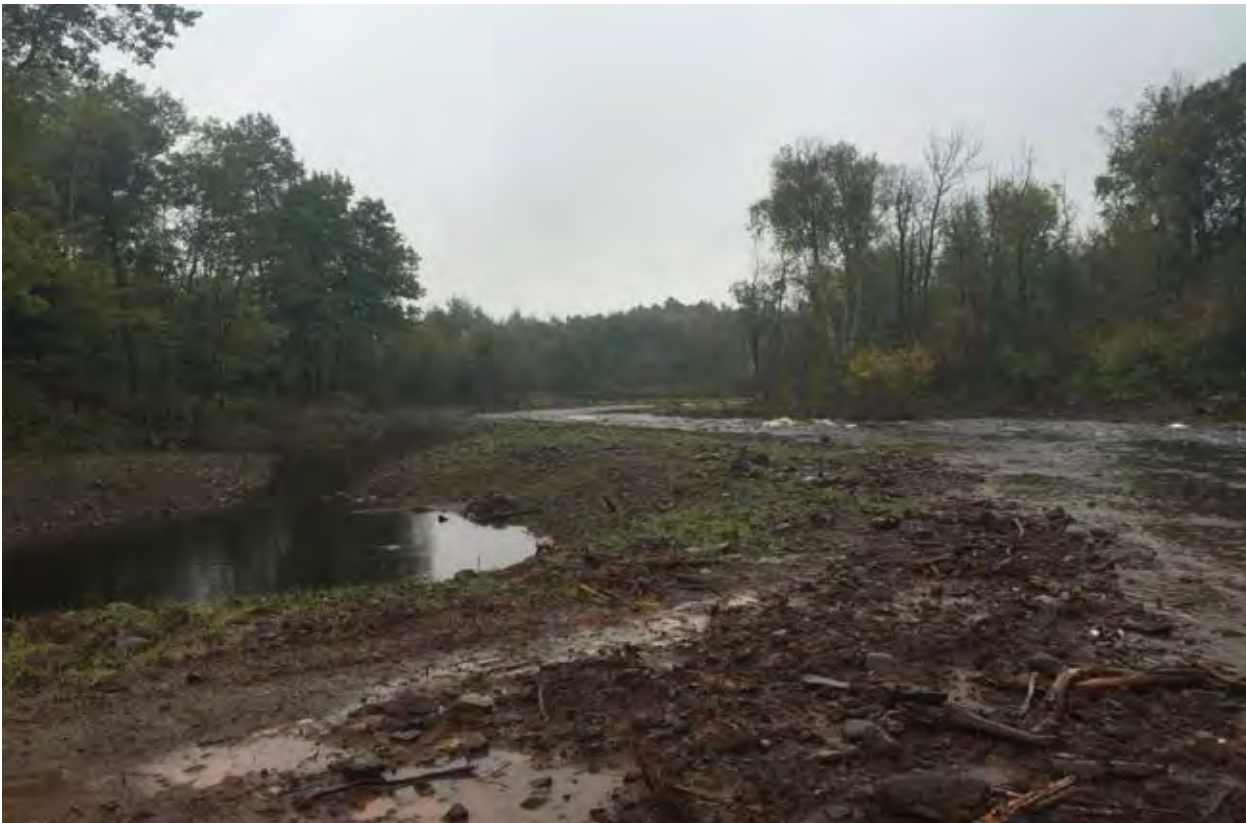
Figure 4 - Representative image of one of the created ponds (left).

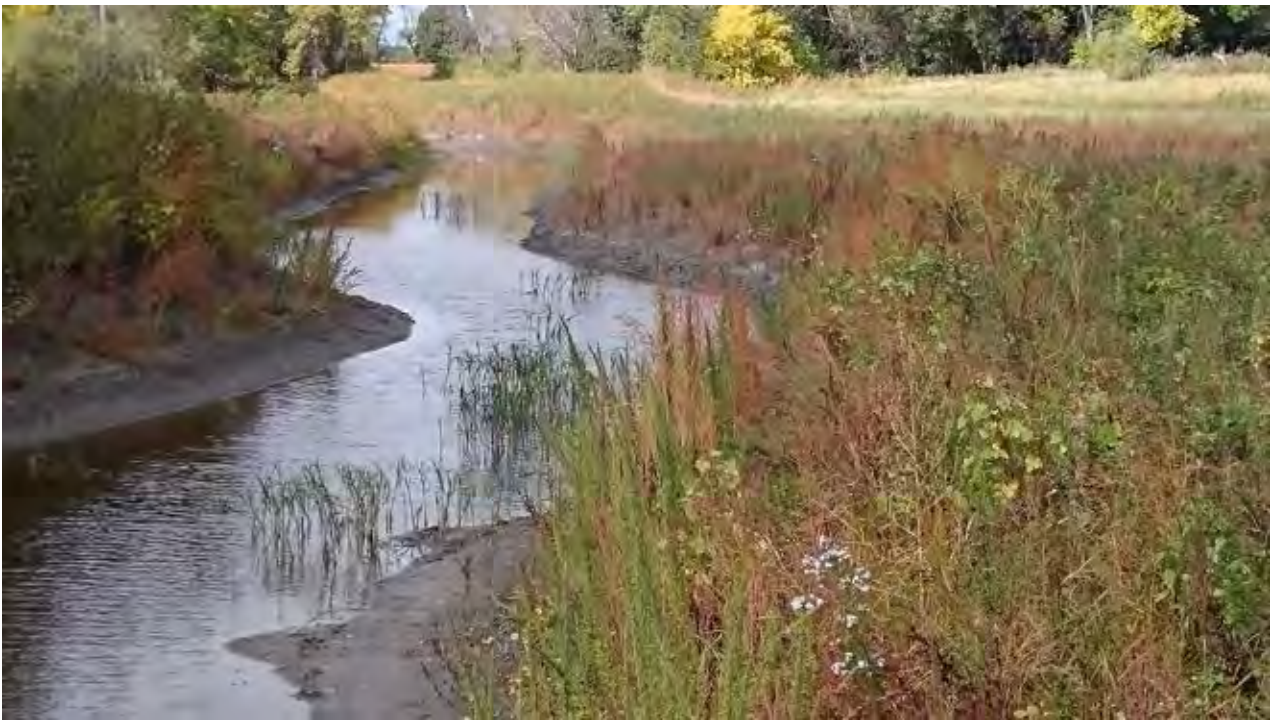
SR Photo 24: Vegetating slopes dominated by annual forbs.

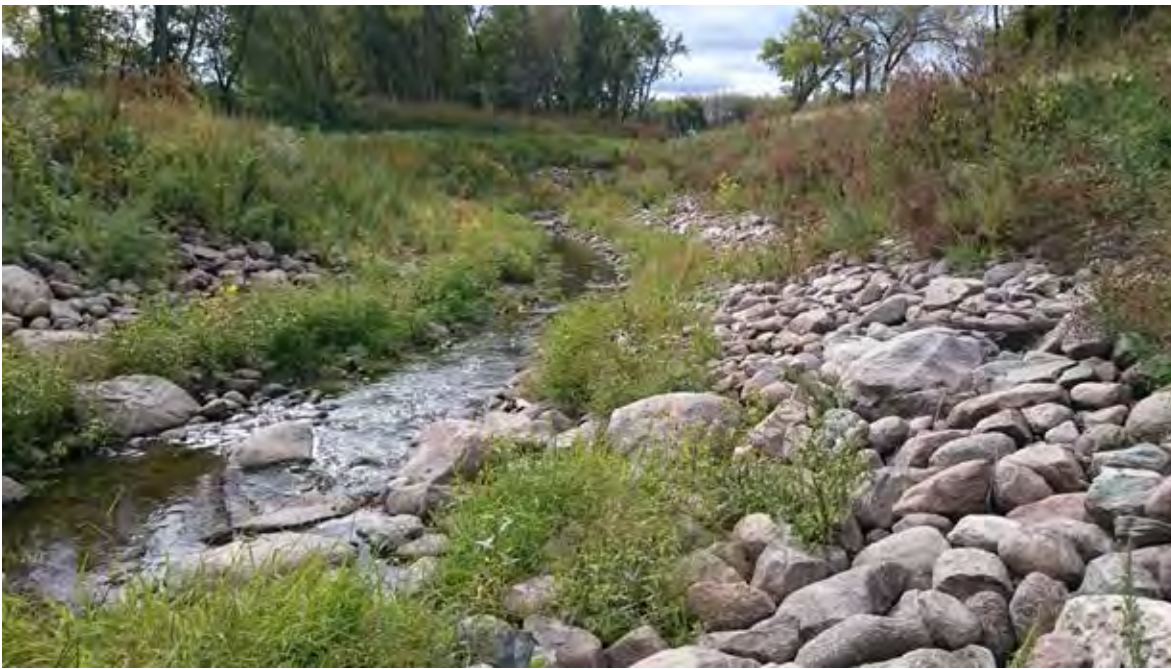
SR Photo 35: V Channel Riffle.
