ARCHITECTURAL  
ASSESSMENT FOR  
PRAIRIE CORRECTIONAL  
FACILITY

Appleton, Minnesota

Final Report

January 5, 2018

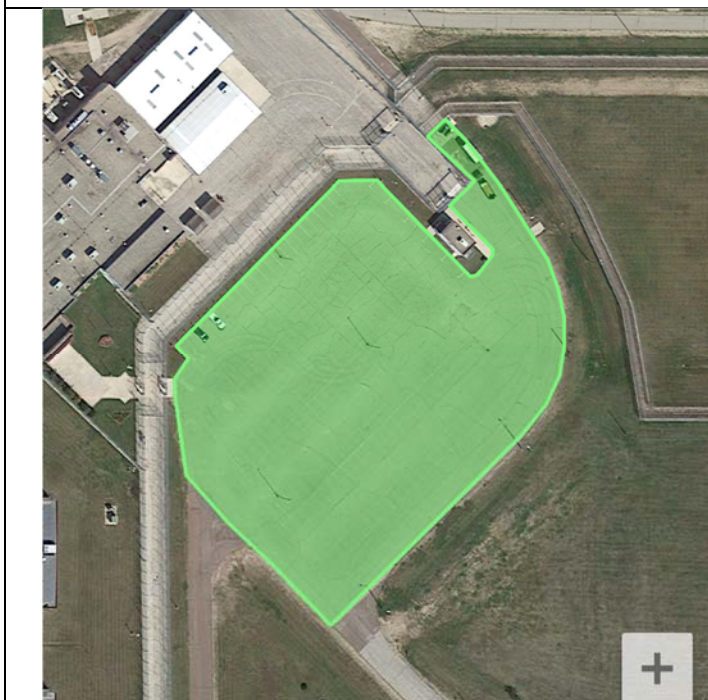
**Photograph No. 2**

Main car park

9,950 Square Yards

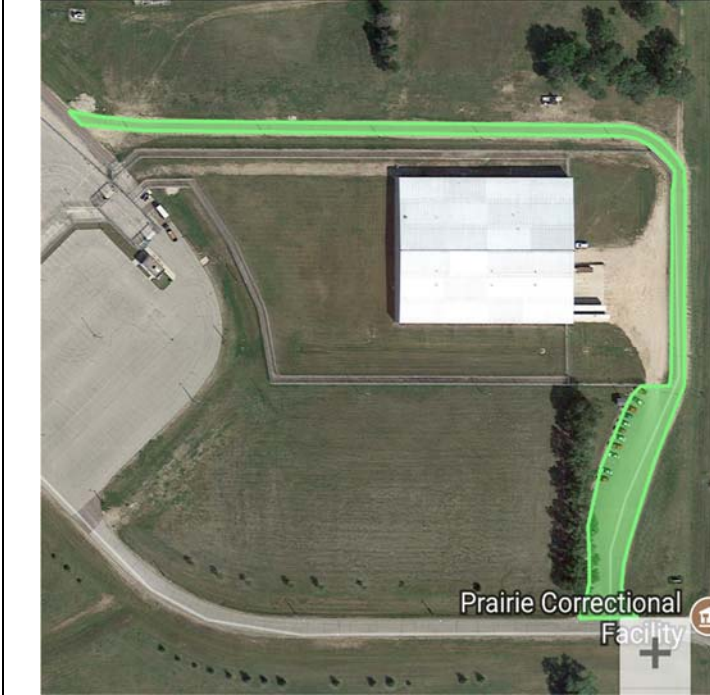
**Photograph No. 5**

Jacobs building parking and perimeter road

4,200 Square Yards

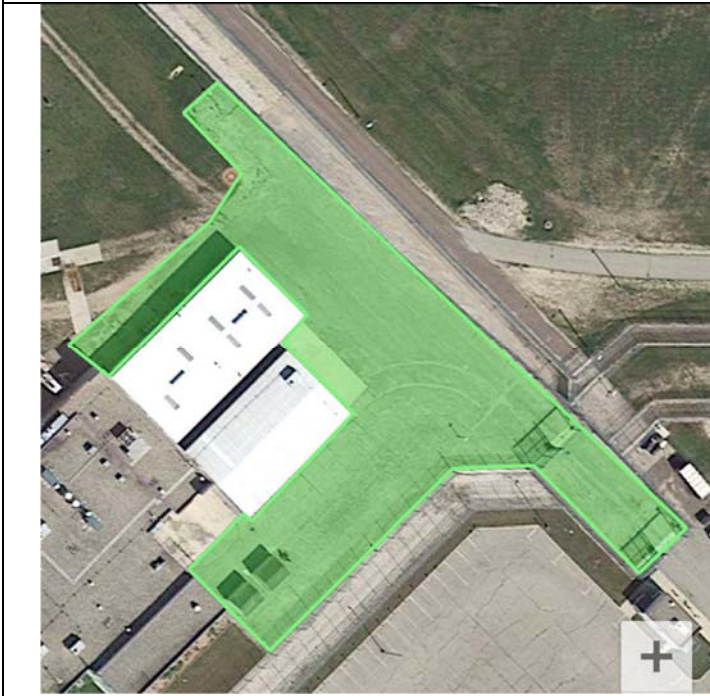
**Photograph No. 6**

Inner courtyard and sally port

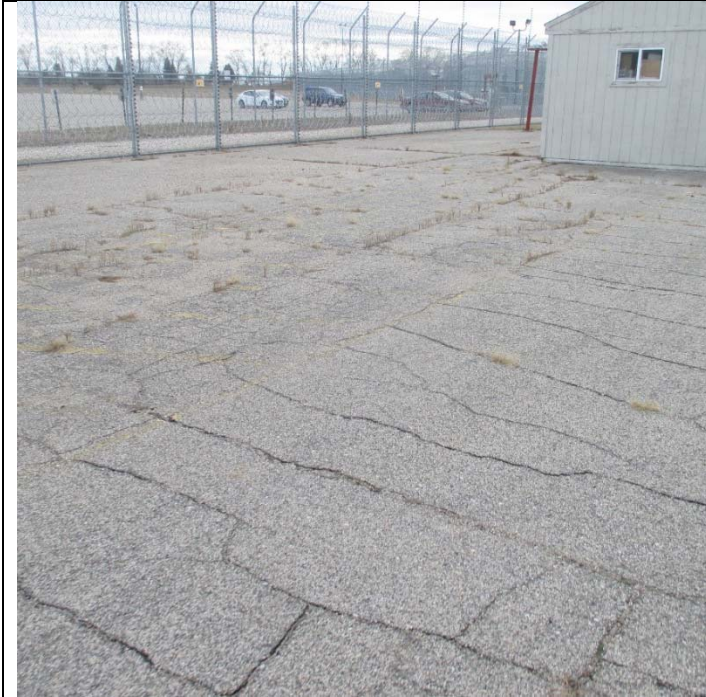
**Photograph No. 9**  
Inner courtyard area

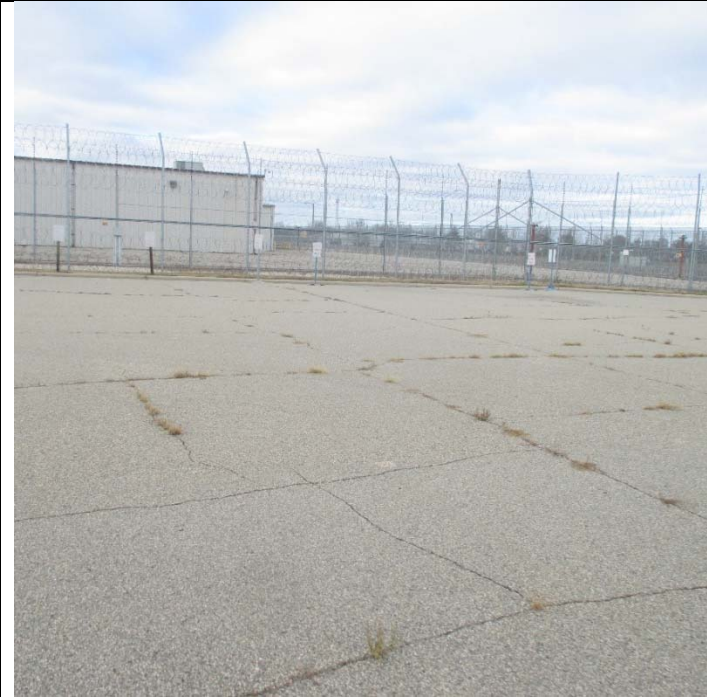
**Photograph No. 13**

Carpark overview

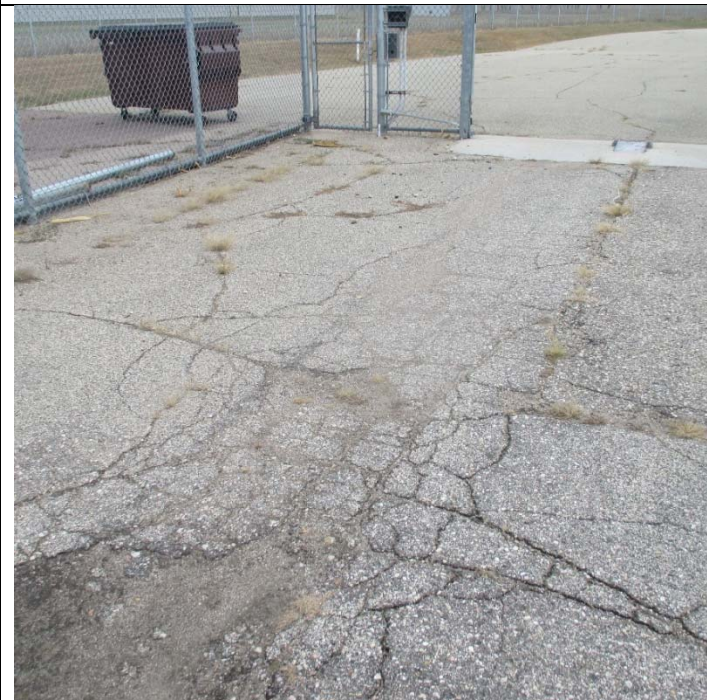
**Photograph No. 14**

Sally Port

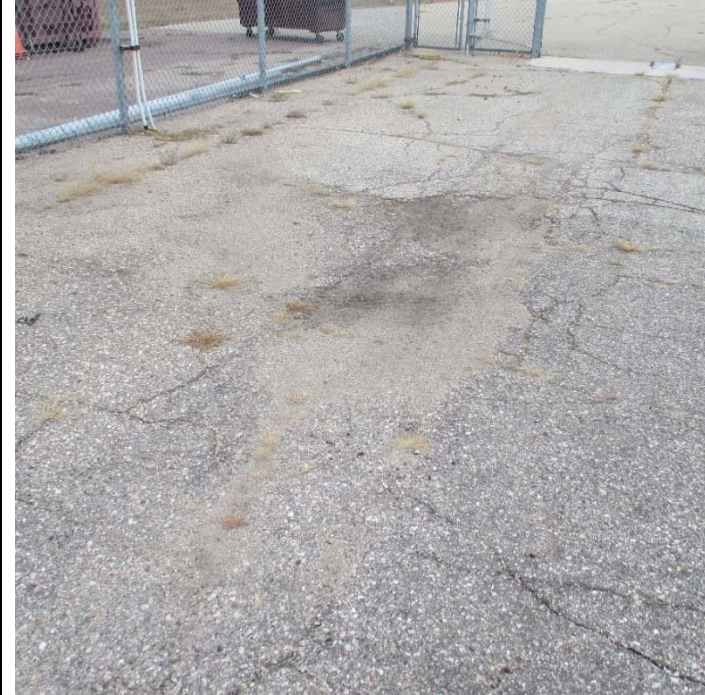
**Photograph No. 15**

Sally Port

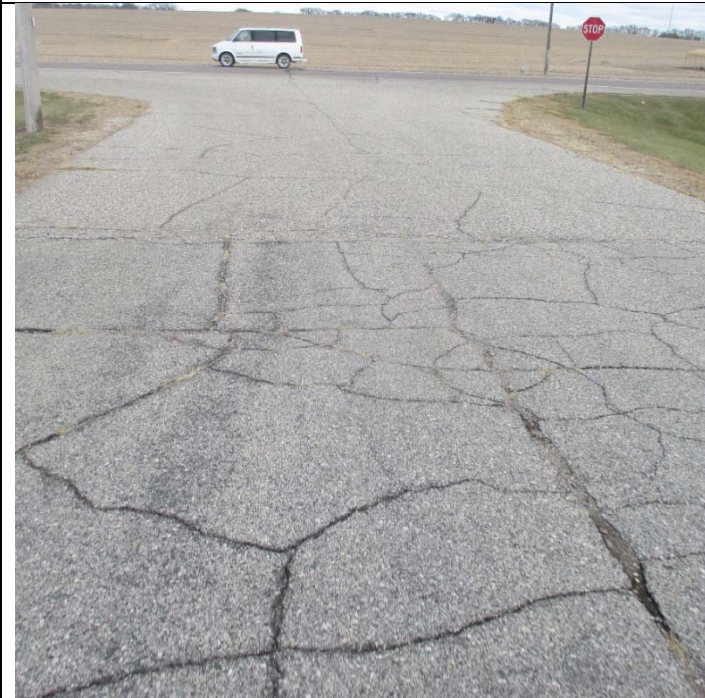
**Photograph No. 16**

Main access road

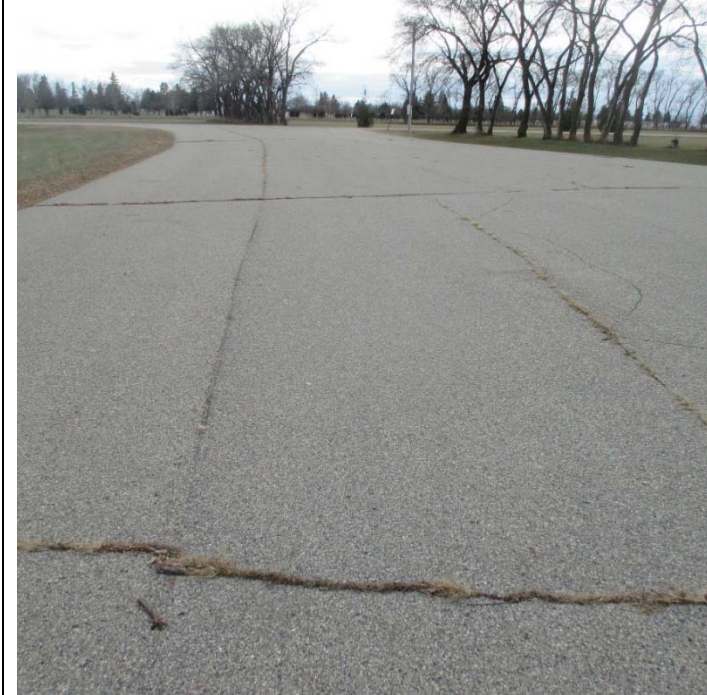
**Photograph No. 17**

Main access road

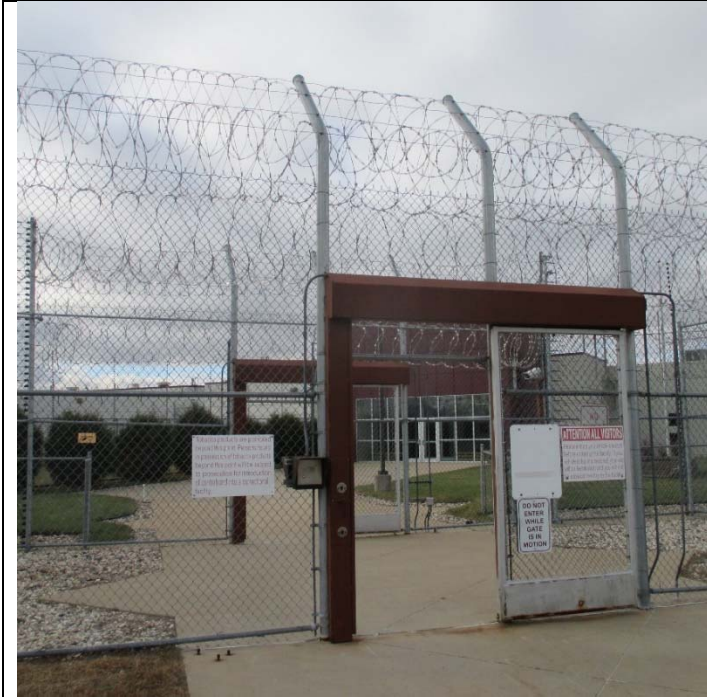
**Photograph No. 19**

Main entrance

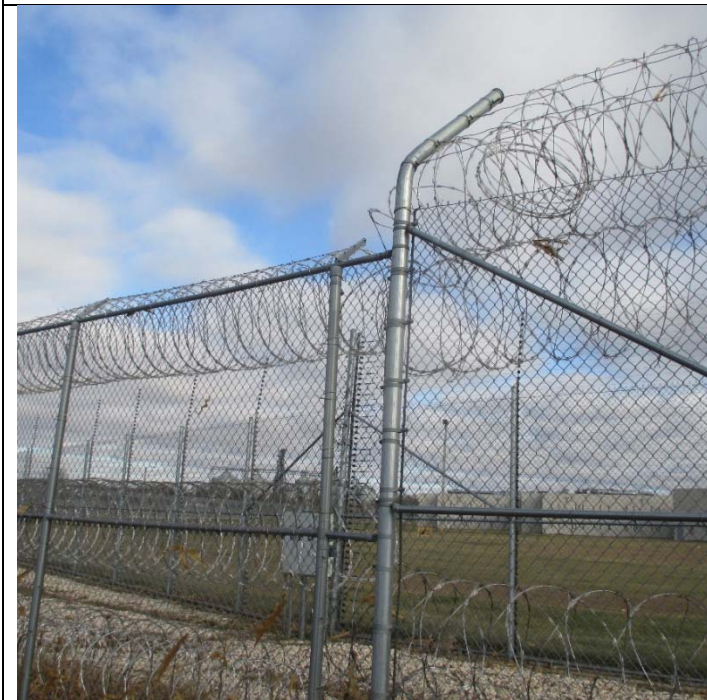
**Photograph No. 20**

16- and 14-foot fencing height change adjacent to guard tower

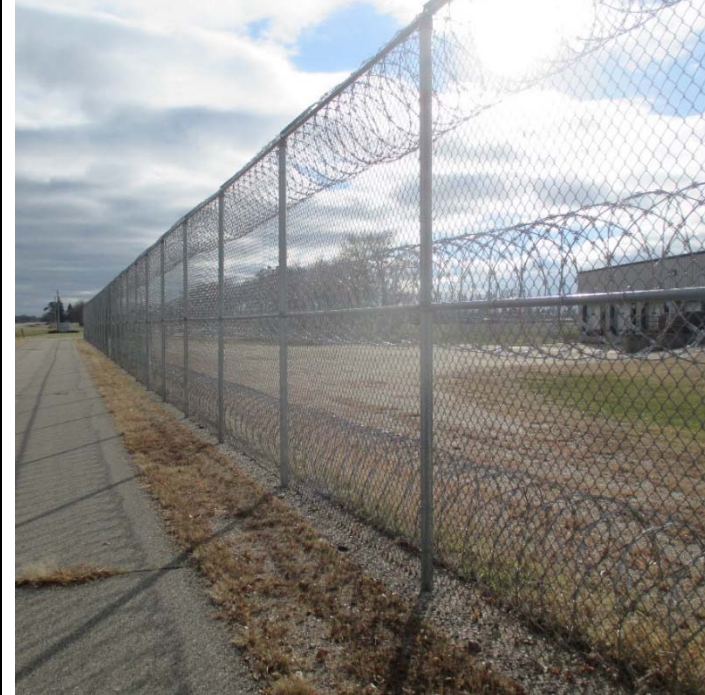
**Photograph No. 21**

Single 10-foot fence around  
Jacobs Building

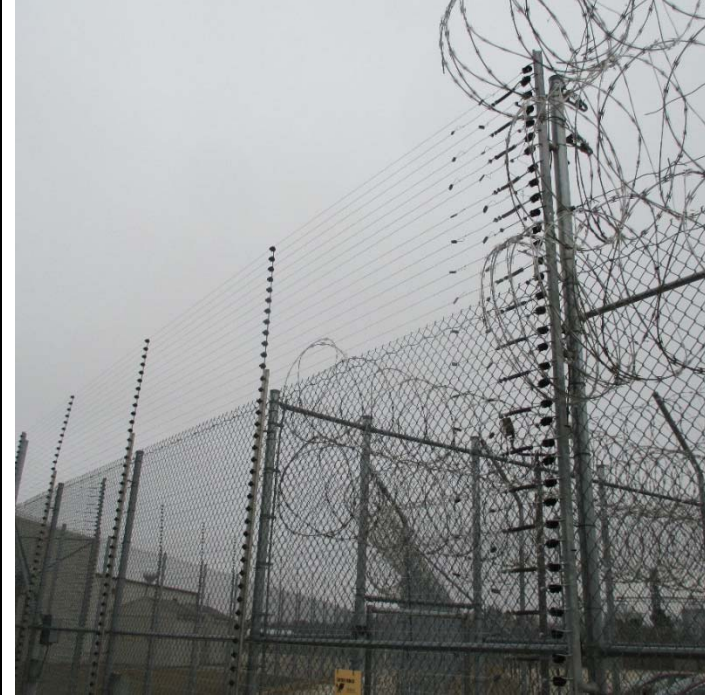
**Photograph No. 23**

Overview of high tension cable at main entrance.

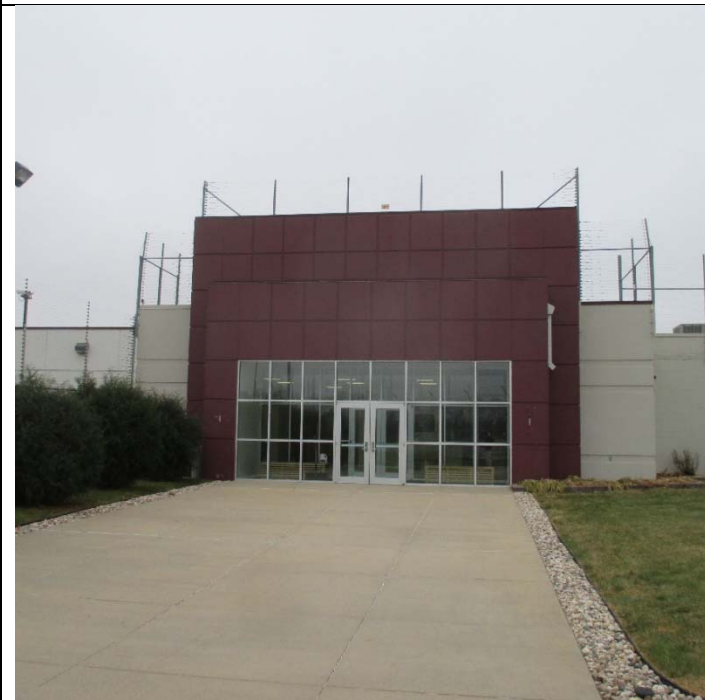
**Photograph No. 24**

25-foot high tension cable fence on roof of main entrance

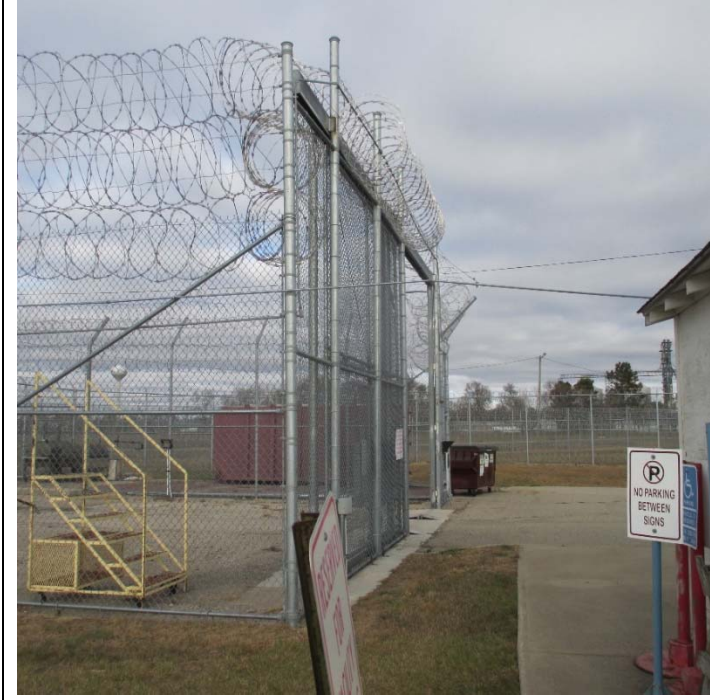
**Photograph No. 25**

Overview of entrance to Sally Port

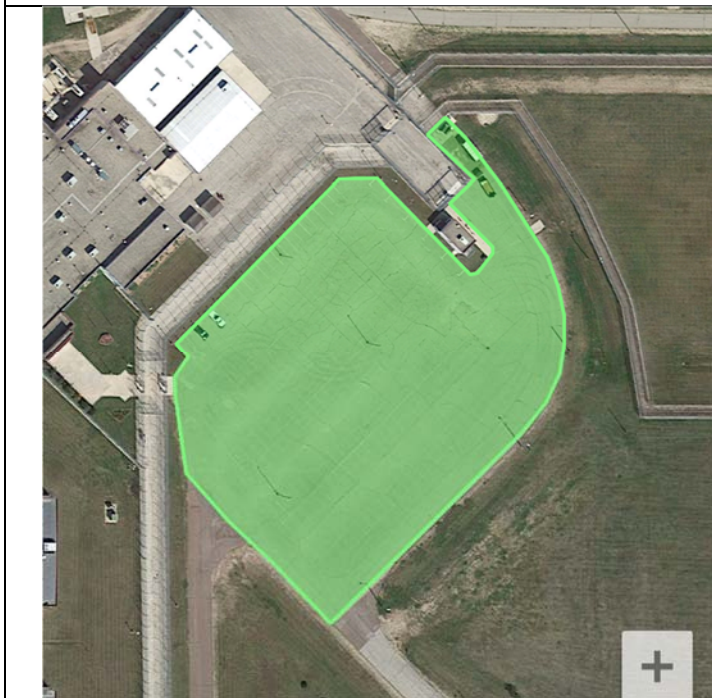
**Photograph No. 2**

Main car park

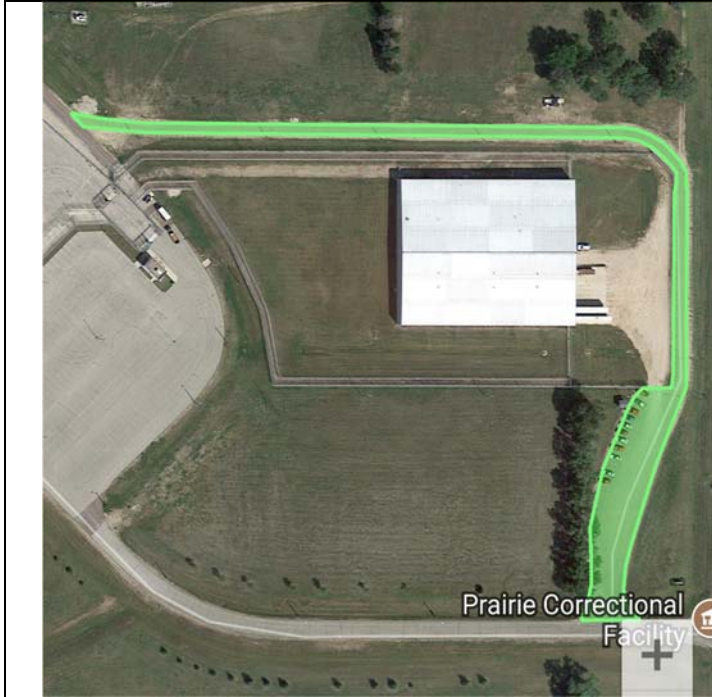
**Photograph No. 5**

Jacobs building parking and perimeter road

4,200 Square Yards

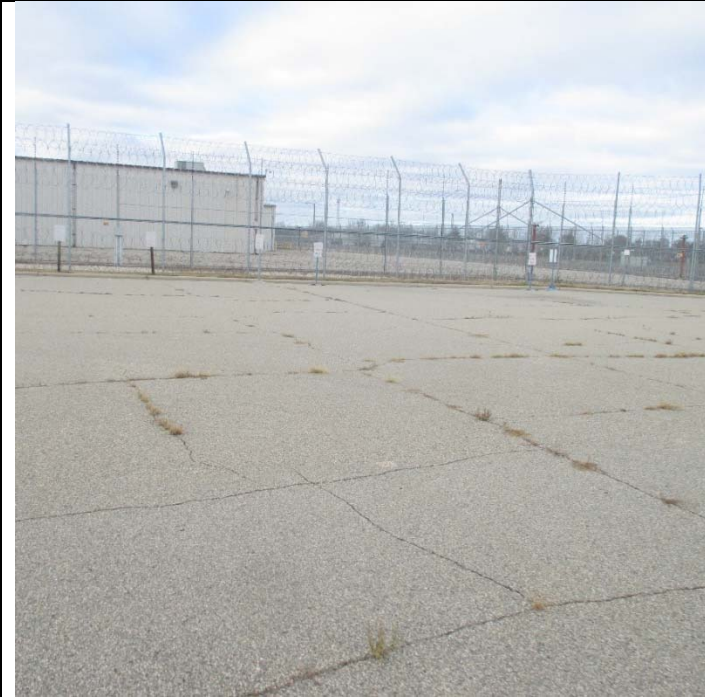
**Photograph No. 13**

Carpark overview

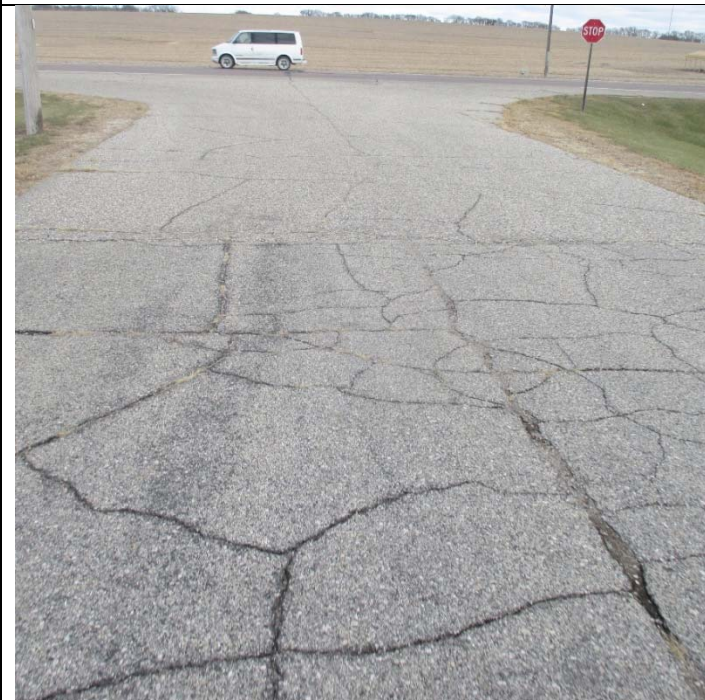
**Photograph No. 16**

Main access road

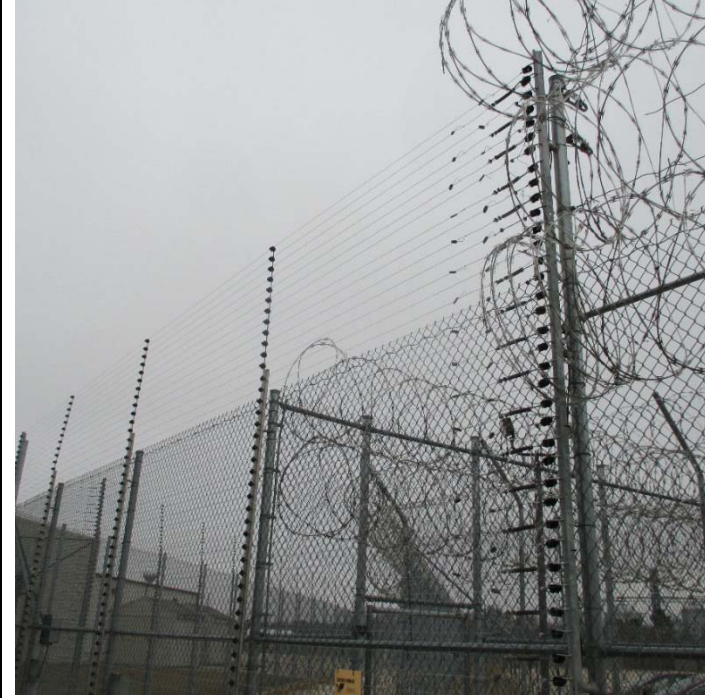
**Photograph No. 23**

Overview of high tension cable at main entrance.
