# ***Study Memorials / Monuments Capitol Complex***

***August 2013  
RECS #: 02CP0034***

**Consultant's Report**

Re: Study Memorials / Monuments, Capitol Complex  
RECS # : 02CP0034

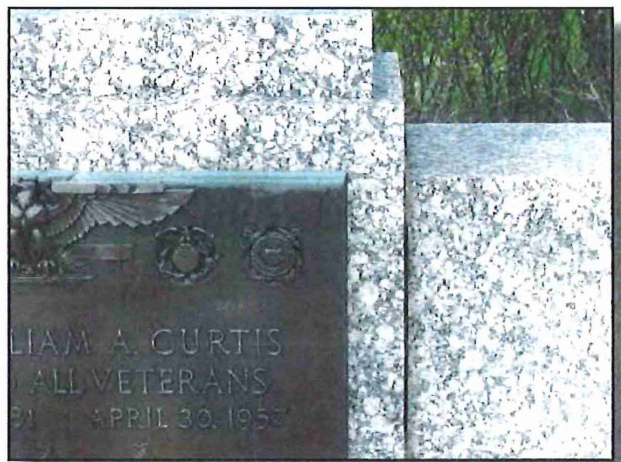
*Conservation of plaque required.*

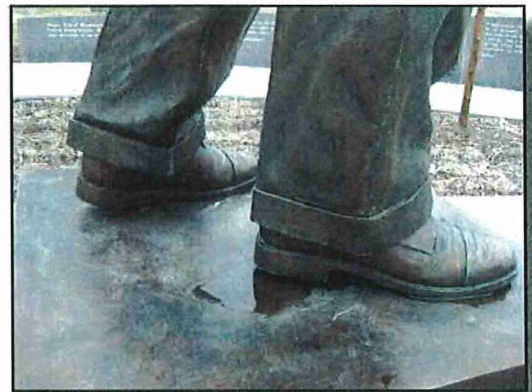
*Sculpture requires conservation.*

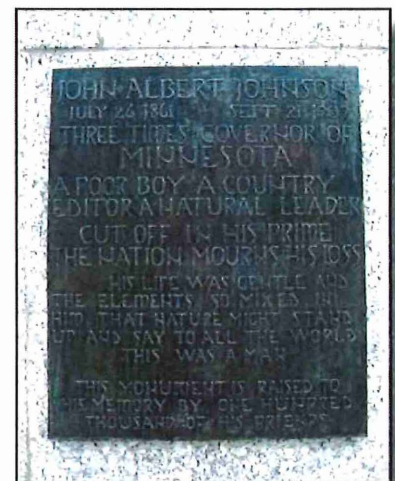
*Plaque needs conservation.*

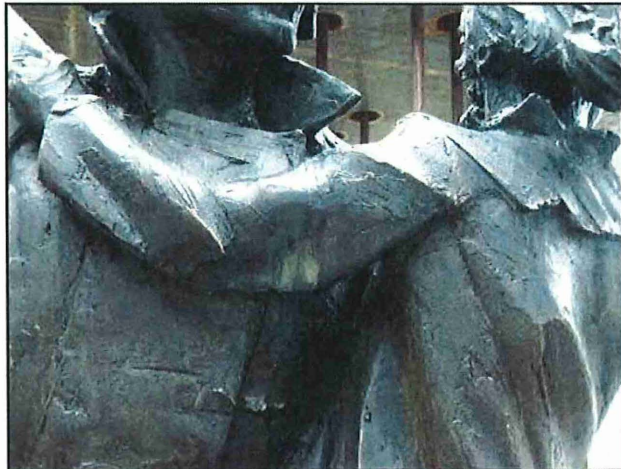
***Sculpture needs conservation treatment.***
