**MINNEAPOLIS METRODOME**

**DECEMBER 2010 ROOF DEFLATION ASSESSMENT**

**SUMMARY AND RECOMMENDATIONS**

Walter P Moore Project S02.10026.01

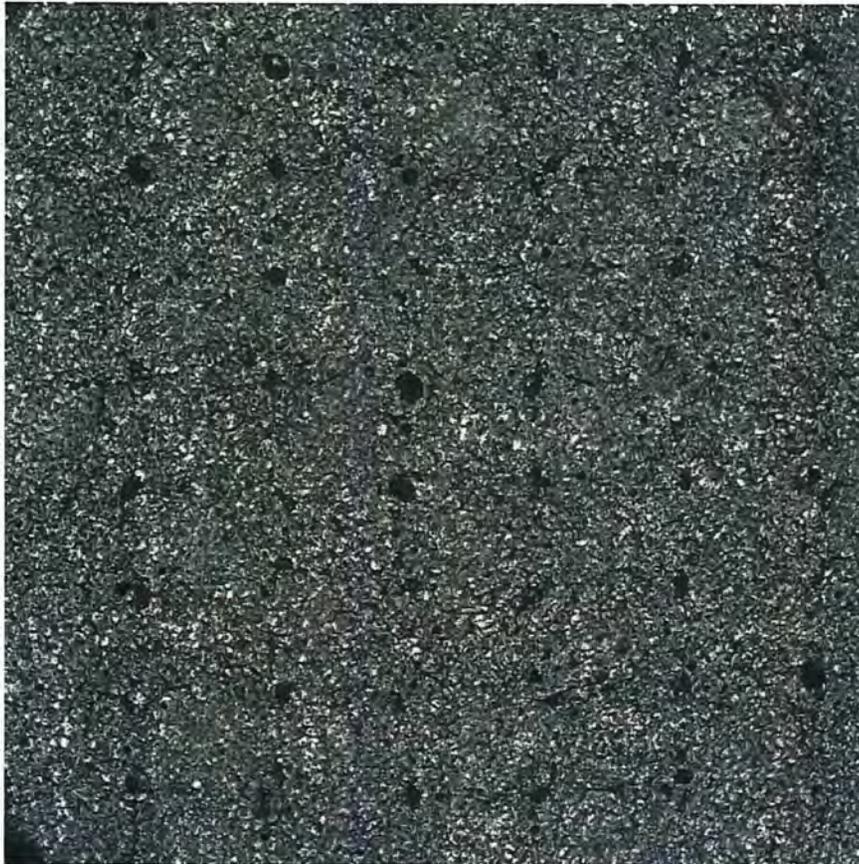
Figure 22: Microscopic Image Panel 72

Because of the above concerns, a small piece of the Panel 72 material was observed under an electron microscope at the State University of New York Buffalo. Images are shown in Figures 22 through 28. Of note are the occurrence of a regular pattern of "holes" in the PTFE coating that appear to align with the intersection points of the crossing warp and fill yarns. The microscopic images show these holes to be filled with dirt. It is not apparent from the images the depth of the hole, but if they are assumed to be spherical the depth appears to be above the level of the underlying glass yarns.

vertical spacing as 10 holes in 10.5mm = 1.05mm o.c.  
horizontal spacing as 8 holes in 10.6mm = 1.32mm o.c.  
SF-2 has 24 warp yarns, 19.5 fill yarns per inch  
1/24 inches - 1.06mm o.c.  
1/19.5 inches - 1.30mm o.c.  
Fill yarns are running vertically in the photo, warp yarns are horizontal

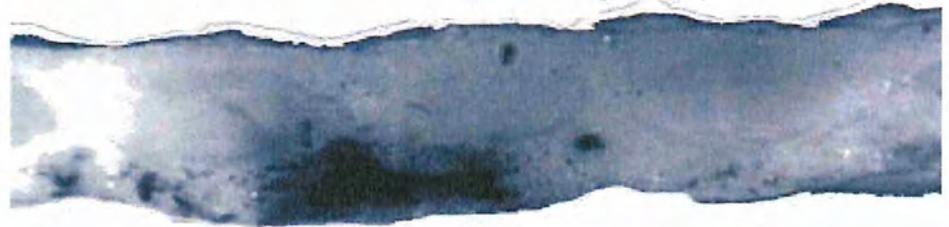
Figure 29: Cross Section of PTFE-Fiberglass Fabric from BC Place Showing Ink Penetration Test

Similar observations were made of the fabric at BC Place in Vancouver, British Columbia following the 2007 deflation of that roof (Hightex, 2007). Figure 29 is reproduction of an image from the Hightex report showing ink penetration through the cross section of a similar hole. The ink did not reach the glass yarn. A similar test on material from Panel 41 of the Metrodome is underway at the time of this report.
