I-35W BRIDGE OVER THE MISSISSIPPI RIVER: COLLAPSE INVESTIGATION

BRIDGE NO. 9340
MINNEAPOLIS, MINNESOTA

FINAL REPORT
NOVEMBER 2008
WJE No. 2007.3702

Prepared for:
Minnesota Department of Transportation
Bridge Office
Oakdale, Minnesota

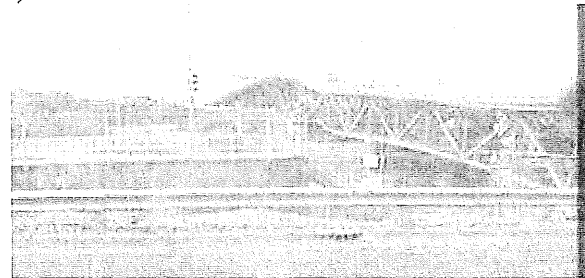
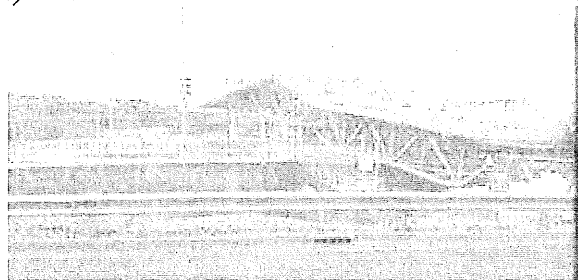
The lock and dam facility includes several security cameras. One of these cameras, positioned below the falls at the end of the lock, has a view of the deck truss from approximately Node 11W to the north end of the bridge. This camera footage captured the collapse on August 1 shortly after initiation. As can be seen in the series of video frames in Figure 3.2, initiation of the collapse appears to occur off camera to the right or south followed by failure of the river crossing span in the vicinity of Node 10'W. The bridge structure appears to remain nearly horizontal as it falls into the river.

Figure 3.2. Video images capturing collapse from a U.S. Corps of Engineers security camera. Note first node on right edge of Frames 1 through 6 is Node L11W.

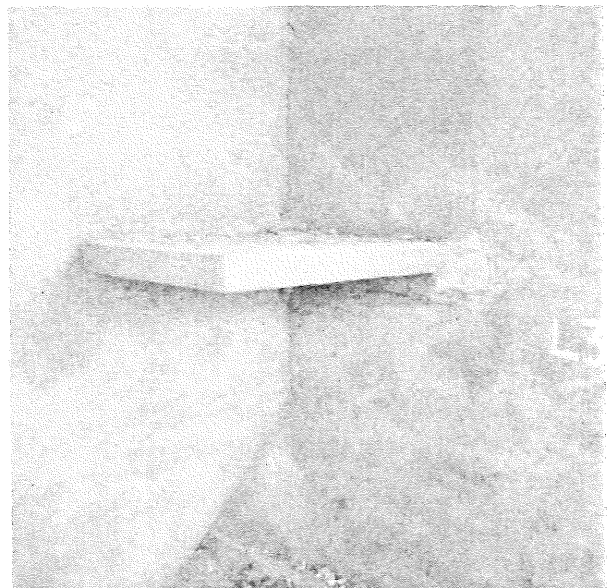
a) Truss box member L2-L3 west. Note eight connection tabs.

*b) Views of 3 1/2 in. x 3 1/2 in. x 3/8 in. bar connectors showing 1/4 in. fillet weld (single side).
Figure 4.69. Typical intermediate diaphragm connection.*
